Residential Solutions
7062545330

Home Inspection Report

Inspected By: Christopher Cooke
Inspected On Sat, Feb 7, 2026 at 9:00 AM

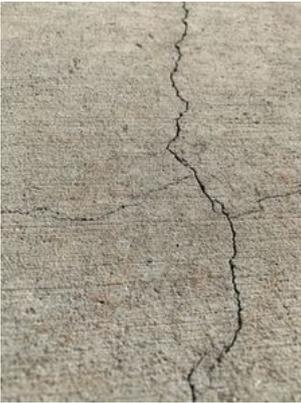
There is some cracking in the front porch slab. At the time of the inspection there was minimal horizontal or vertical displacement. These kind of cracks are not uncommon just from the curing process of the concrete overtime. I would still monitor to see if there's any growth in the crack overtime. Most settling in curing cracks become apparent within the first 5 to 10 years of the life of a structure.

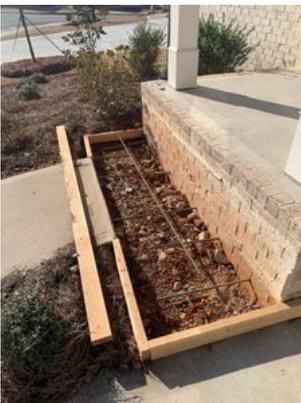
Comment 3

The front step looks to have been removed. It would appear that was previously removed because it was not level. Would make sure to keep track of the new steps to ensure that they remain level and do not need replacement in the future.

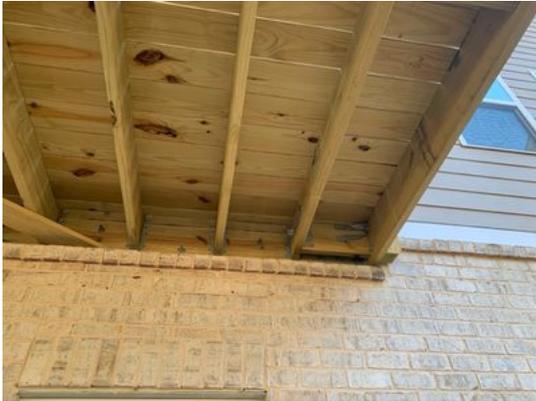
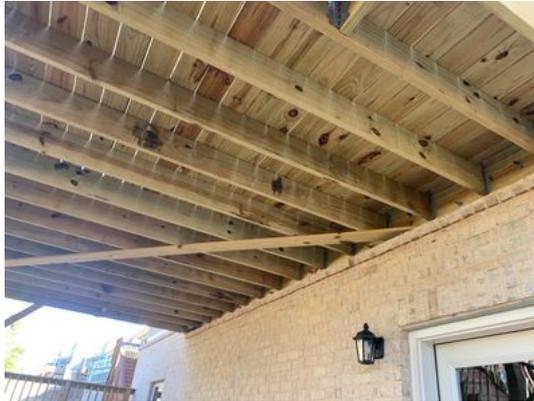
Structural craftsmanship of the deck was in good condition at the time of the inspection.

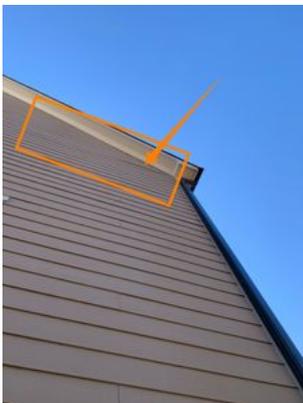
There were a couple places where the hardy type plank was either not properly secured or not sitting flat.

I was not able to get a depiction of the separation of the siding along the back right corner of the structure. The last picture was the most clear depiction I was able to capture at the time of the inspection.

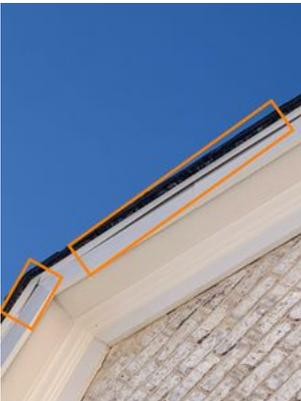
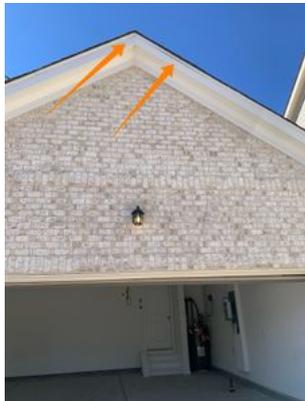
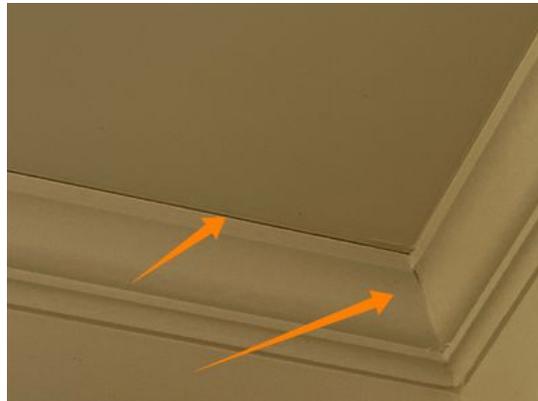
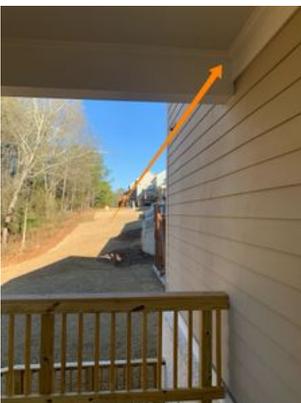
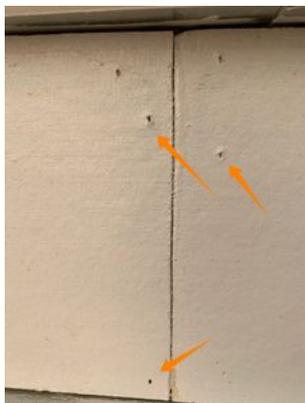
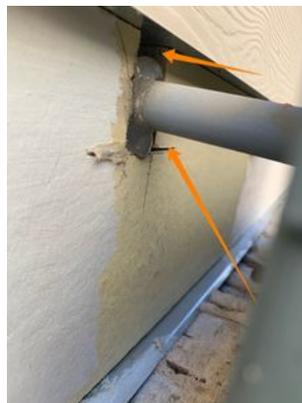
The indicated drip edge is not properly secured.

The indicated trim work along the back porch needs to be properly caulked and repainted.

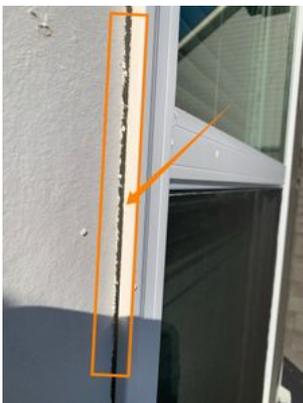
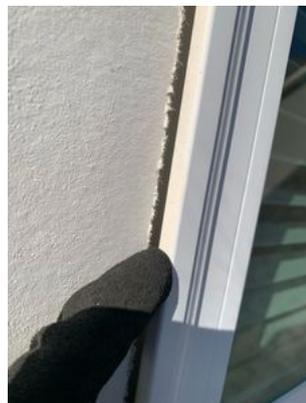
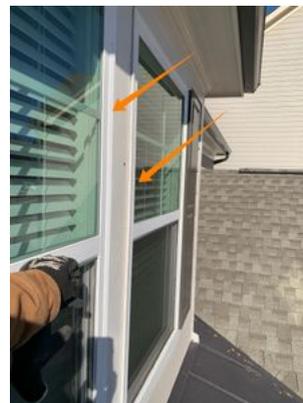
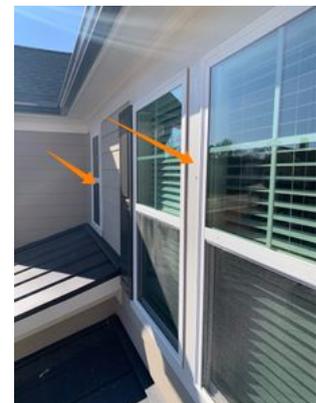
Comment 11

Neighboring homes have these areas properly attended to.

These pictures are for reference to the areas and types of repairs that may be needed. They are not exhaustive. It was pretty much every exterior window trim that needed to be addressed. Would recommend having the contractor sweep the entire exterior.

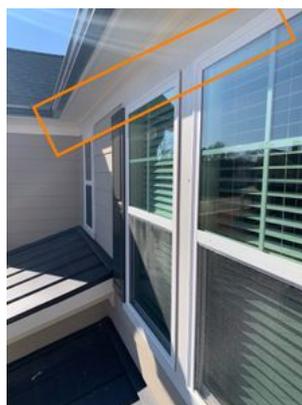
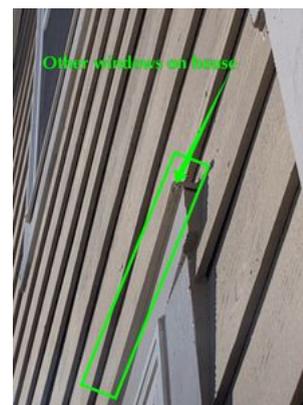
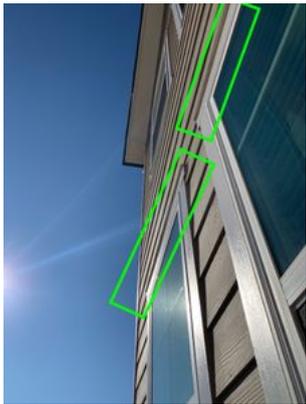
The drip cap or drip edge is missing above the indicated windows. Not only is this an industry standard for new builds, but all other houses in the area built by the same builder have these specific windows, those along the front upstairs area, with drip edge installed along the top of the window.

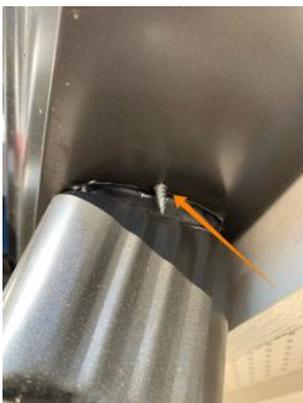
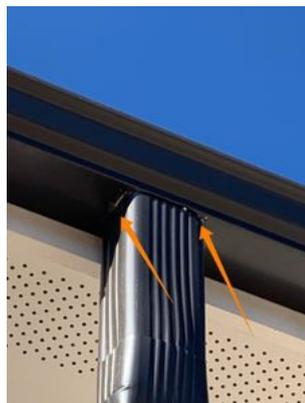
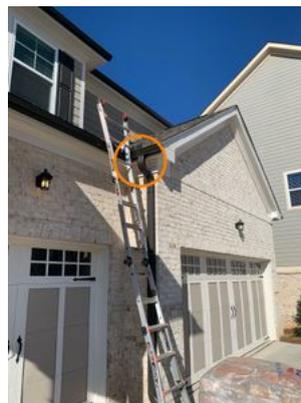
Screws in downspout should be in the sides where water is not likely to eventually penetrate.

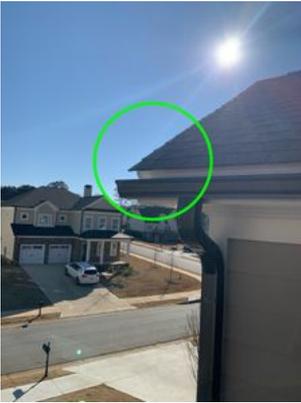
The indicated corner of the roof has shingles that are not properly secured to the decking. The last set of pictures indicates how shingles should be properly adhered so that wind does not come along and damage them.

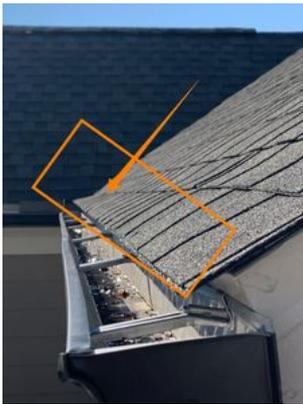
Comment 15

There are two areas where there is some improper sloping and dipping in the roof line. These areas will wear out quicker than the rest of the shingles. Would recommend having the roofer come out and assess for repairs.

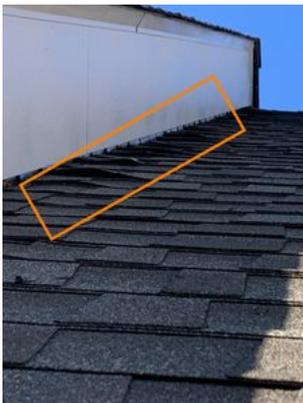
Comment 16

There were quite a few shingles along this side of the house are not laying flat. This may be due to nail pops or improper installation. Would recommend having the roofer come out to assess and repair.

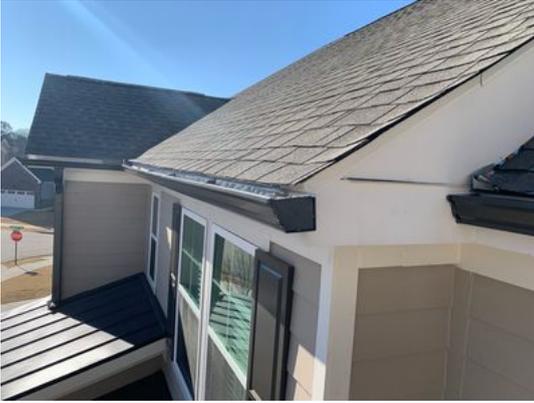
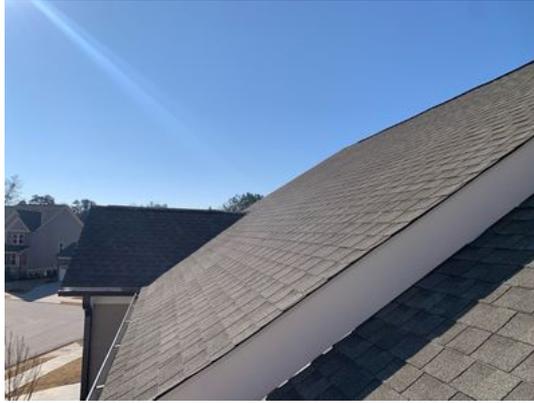
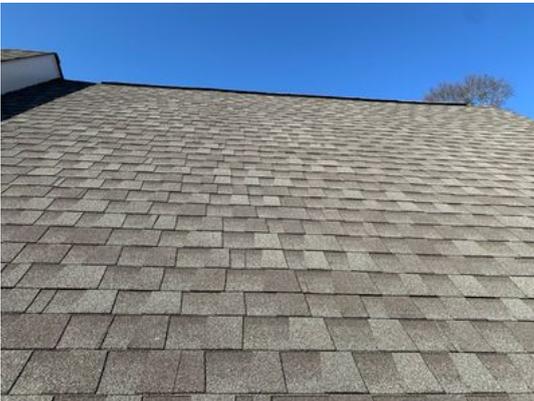
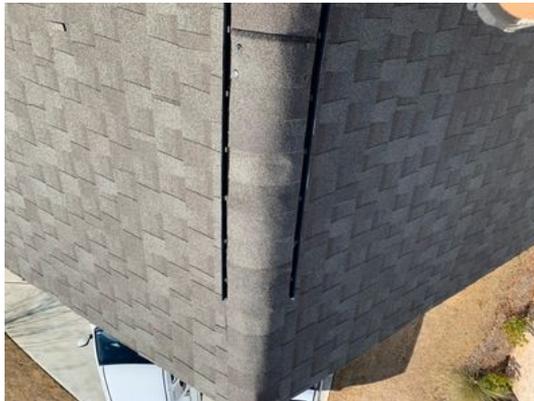
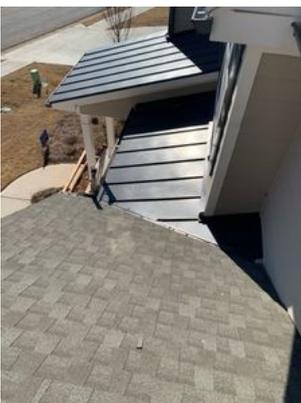
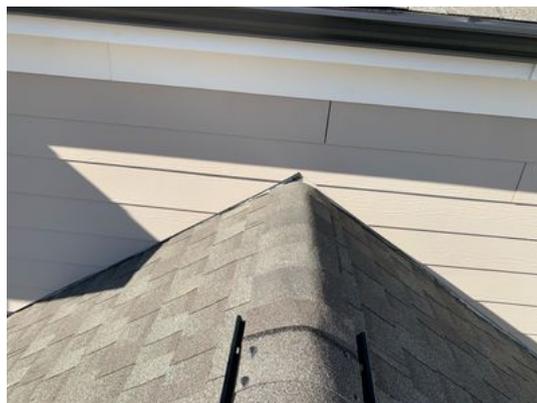
Comment 17
Information

The roof is at architectural fiberglass shingles with a small portion at the entry being metal. The shingles were generally in good condition at the time of the inspection and the roof was properly ventilated.

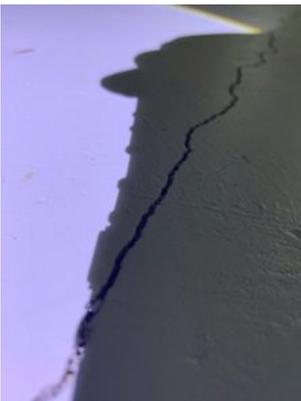
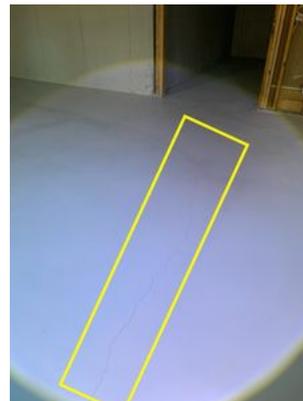
There were minor fractures in the foundation slab. At the time of the inspection both vertical and horizontal displacement was minimal.

Such cracks in newly formed slabs are called shrinkage cracks.

Most shrinkage cracks are of the inconsequential variety usually less than a 16th of an inch wide.

These cracks are often caused by the hardening or curing process.

Most settling and shrinkage cracks appear in the first 5 to 7 years.

There were NO other corresponding cracks in the basement wall at the time of the inspection.

I would recommend keeping an eye on these cracks to see if there's any more shifting overtime beyond a 16th of an inch wide.

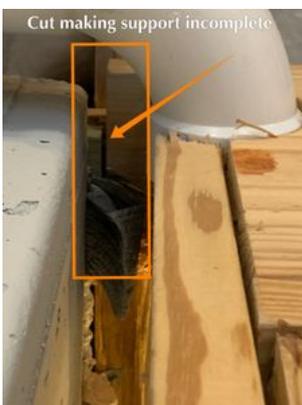
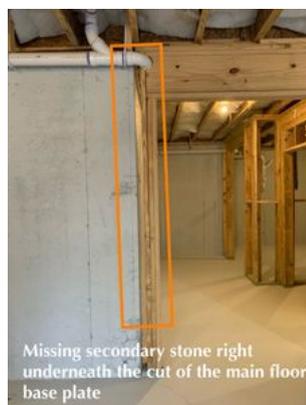
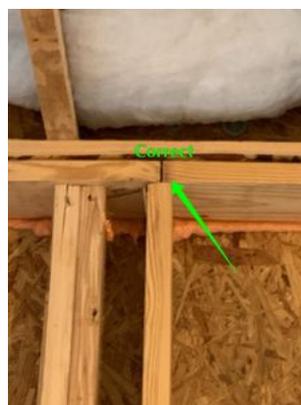
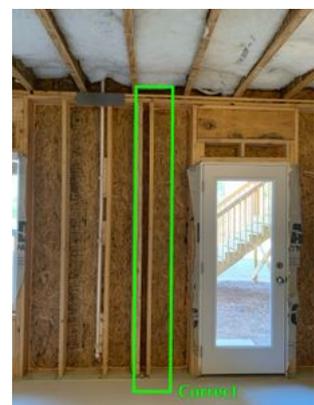
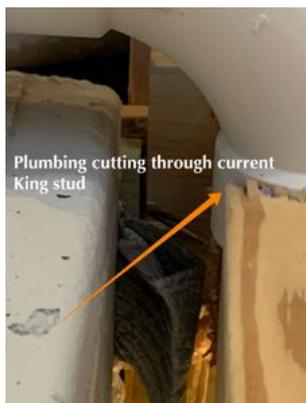
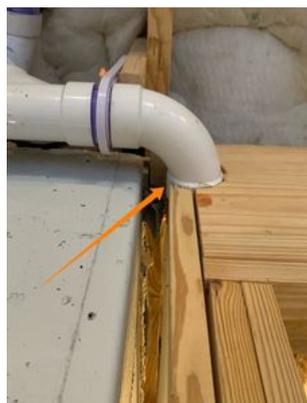
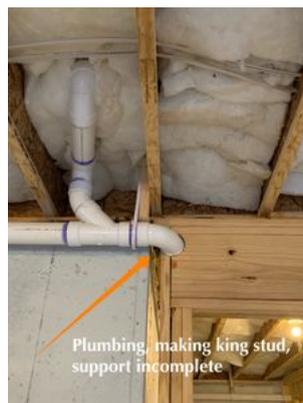
There is a loadbearing area that is missing the proper load bearing support.

The other issue is that the loadbearing support beam that is directly l the cut between the bottom plate board and the interior load bearing base is missing. Directly on the other side, the correlating cut has been properly supported as is shown in these pictures.

The resulting issue would simply be something along the lines of potential settling in this area, but considering how well, these flooring structures are designed in order to minimize or even eliminate settling so that the main floor stays level for a very long time there is no reason that this issue should not be repaired in order to ensure there is no settling from this location.

This needs to be repaired.

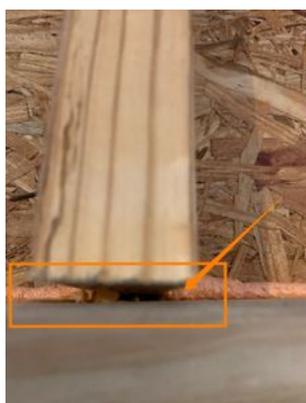
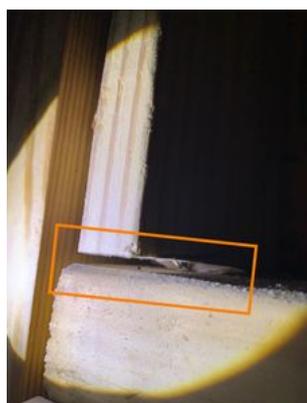
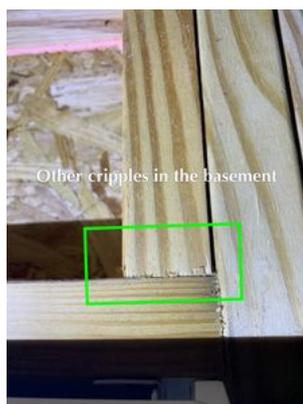
Comment 22

The top cripples are not making any contact with the top sill in this window. ALL other instances in the basement have the cripple making good contact with the top sill.

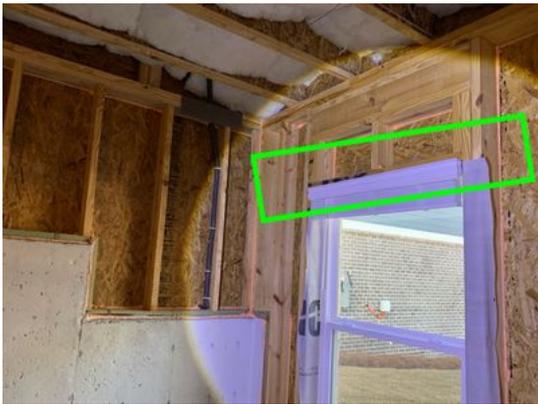
Comment 23
Safety Concern

You need protective metal plates (nail plates or stud guards) in new builds where pipes, wires, or conduits run through wood studs. The general rule is to ALWAYS have them but the specific rule is when they are within 1¼ inches of the stud's edge, to prevent punctures from drywall screws and nails. This is standard building code requirements.

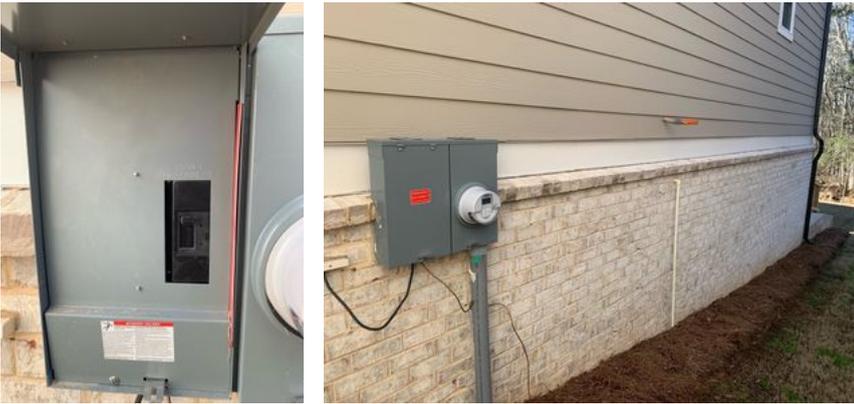
Comment 25 Information

The electrical meter and service are on the right side of the structure

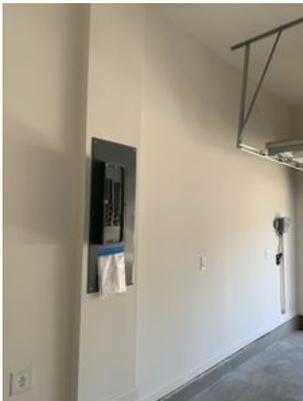
**Comment 26
Information**

The service panel is located in the garage

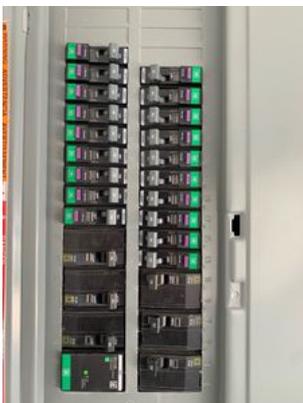
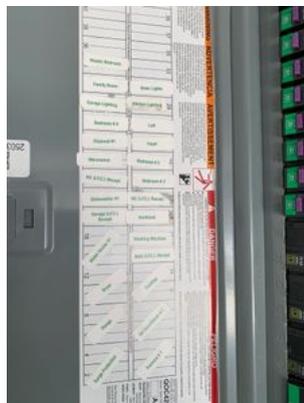
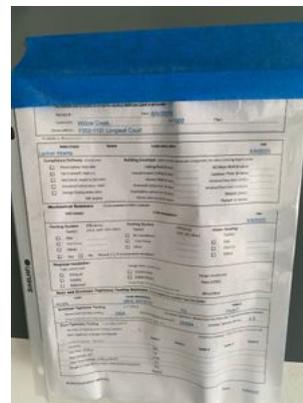
The breaker appeared to be properly labeled and passed by the county, but due to the inconsistency of the wiring I was not able to verify the actual safety and functioning of all the breakers. Once the wiring is properly repaired, then would recommend having the breaker system retested.

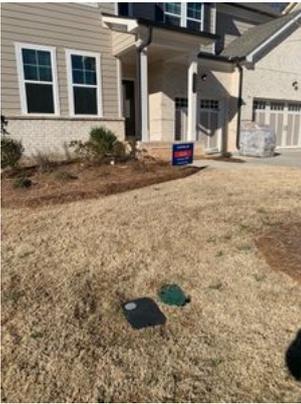
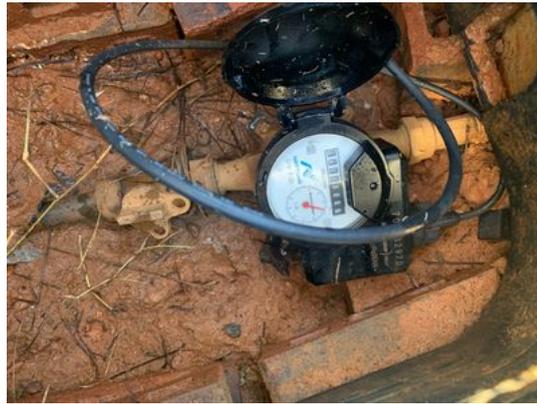
Comment 30 Information

The water meter is located in the front yard.

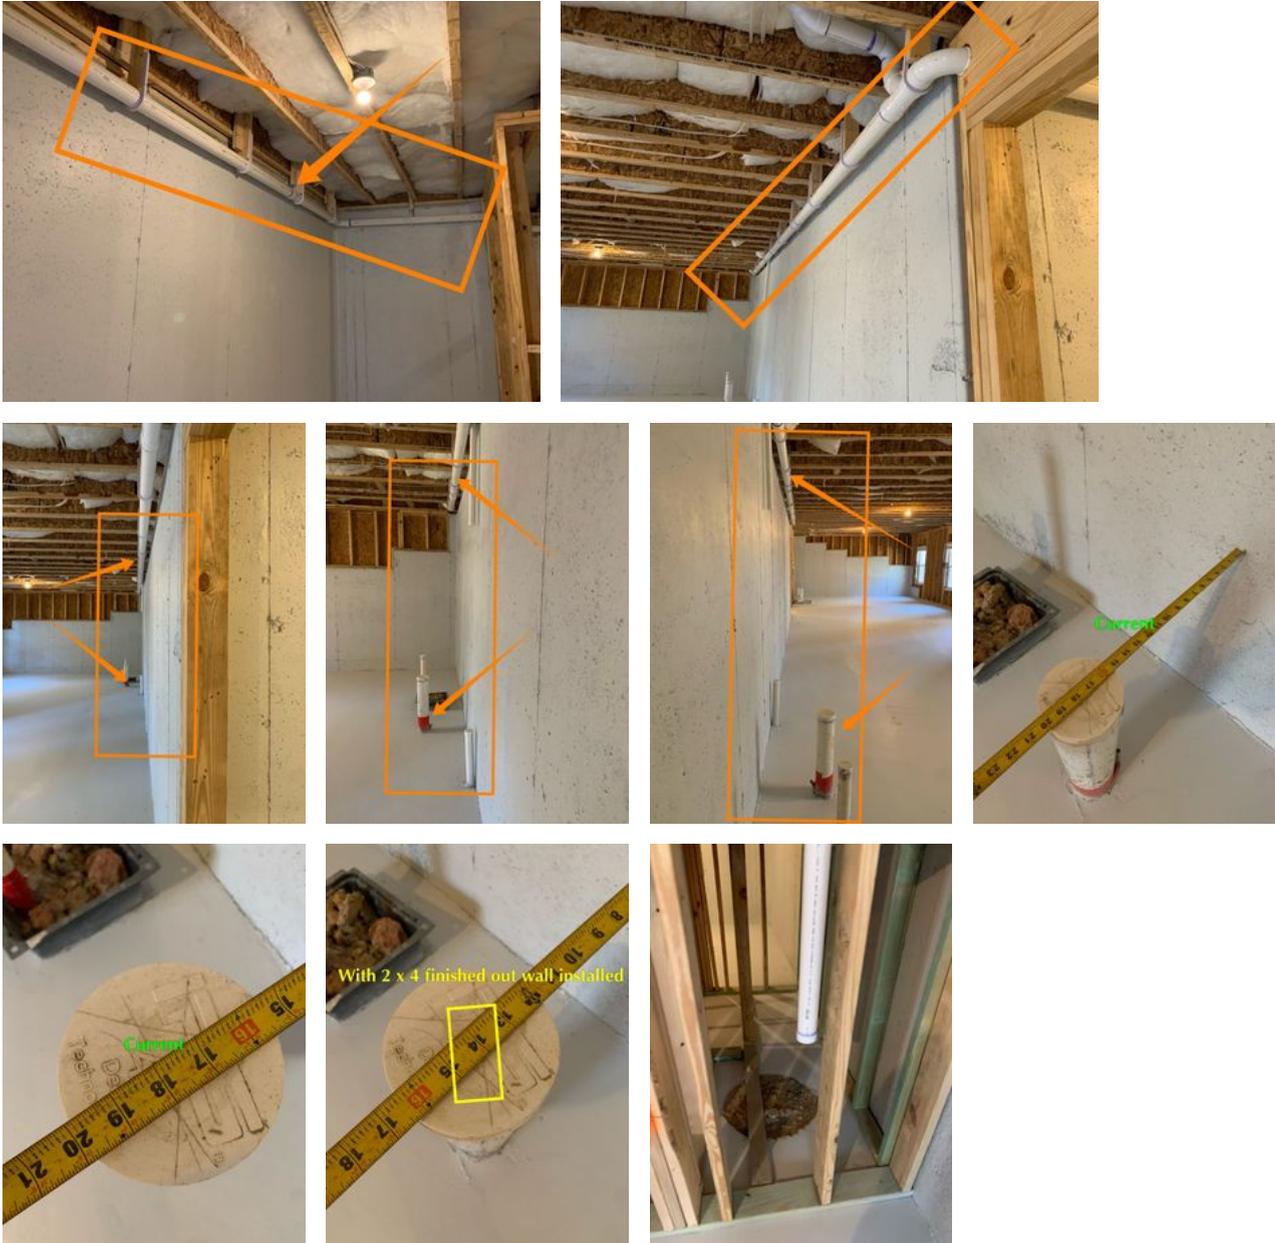
The main plumbing running exposed under the joists comes out from the wall roughly 5 to 5 1/2 inches. That means in order to frame out a wall to hide the main drain lines properly the space would be reduced for a toilet down to at best 14 inches and at worst 13 to 12 1/2 inches when including a studded wall construction. That does not meet the minimum

requirements space for the toilet install a toilet. That means that either the toilet plumbing and the shower plumbing in the slab need to be moved or the main drainage plumbing needs to be redone to run up into the floor joist in order to properly accommodate a finished area.

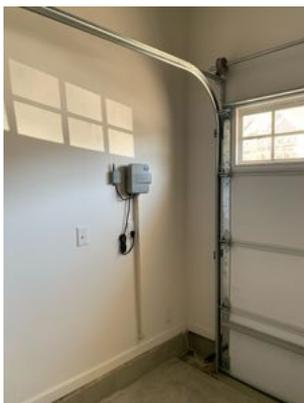
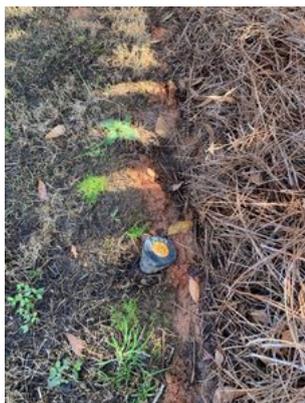
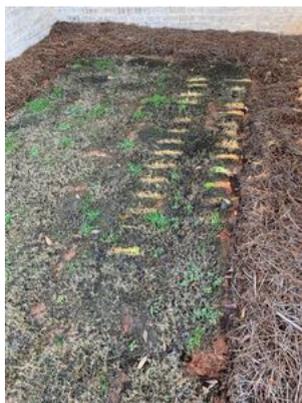
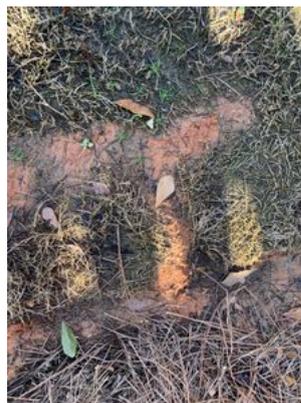
There is an irrigation system set up on the property. Would recommend asking builder about use and maintenance. It did appear that the irrigation system MAY be causing an issue with the moisture level of the backyard. After observing the areas, not much else makes sense to me, but the water meter was also not running at the top of the inspection. So this area may be a combination of issues. Would recommend having the builder double check this before closing.

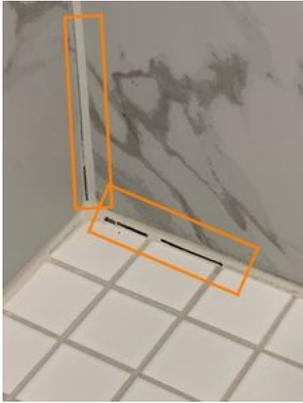
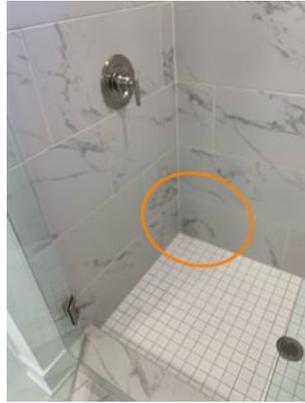
This area needs to have its corners re-grouted or caulked in order to keep water from getting back behind the tile.

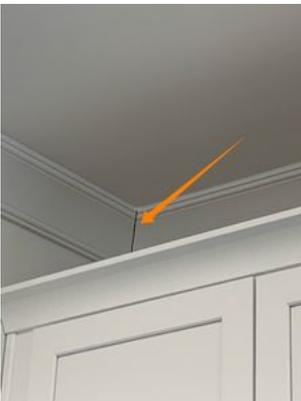
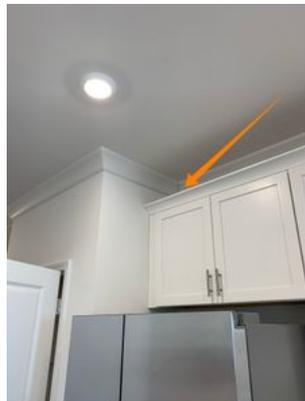
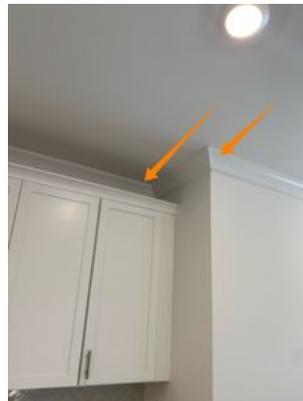
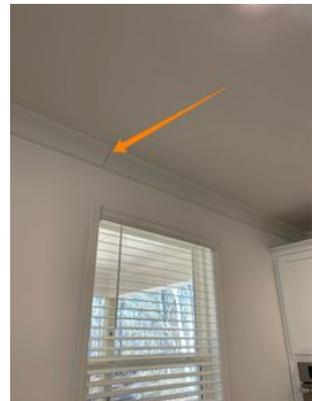
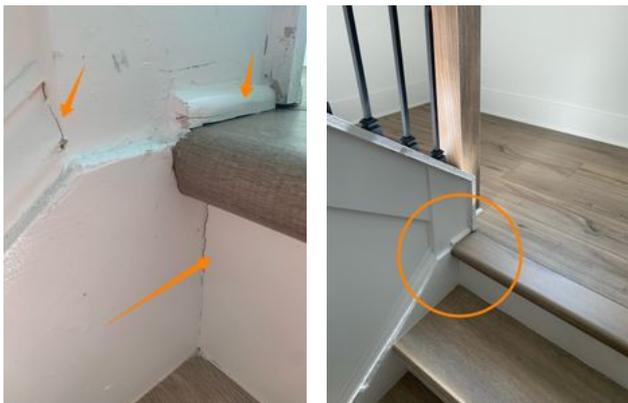
There are multiple areas throughout the house where the trim needs caulking and repainting. These are just a couple of examples of the areas and types of repairs that may be needed. I would make sure to point out these and others to the builder on the final walk-through and ask them to sweep the entire interior. There is one area in the garage around the electrical panel where the drywall needs to be repaired.

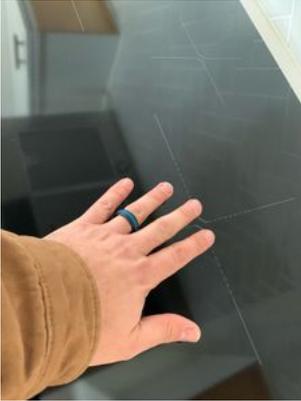
The range was an inductive unit. This means it needs a specific metal in order to interact and heat. You can put your hand on it and it will not heat. It is a protective measure. It appeared to be functioning properly at the time of the inspection, but would want to verify that with some inductive pans.

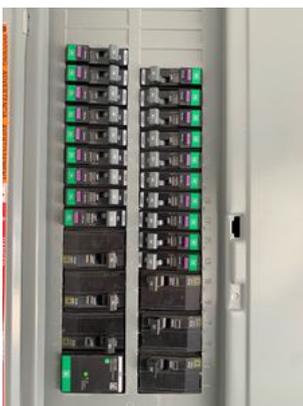
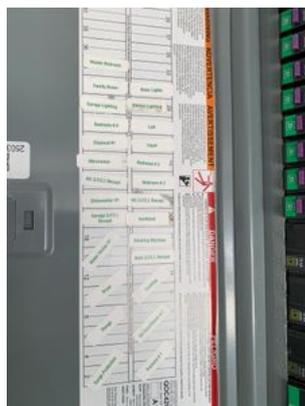
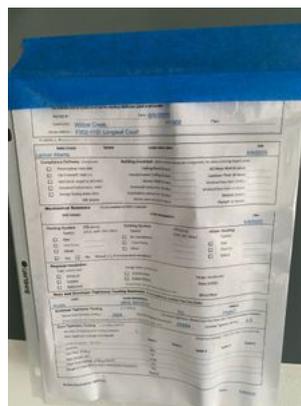
There were multiple loose wires in the service panel. This may be the issues with the bathrooms and other circuits, but that cannot be verified until the electrician repairs these areas and provides proper proof of testing the circuits in question.

The breaker appeared to be properly labeled and passed by the county, but due to the inconsistency of the wiring I was not able to verify the actual safety and functioning of all the breakers. Once the wiring is properly repaired, then would recommend having the breaker system retested.

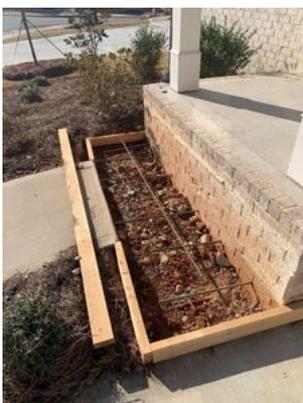
The front step looks to have been removed. It would appear that was previously removed because it was not level. Would make sure to keep track of the new steps to ensure that they remain level and do not need replacement in the future.

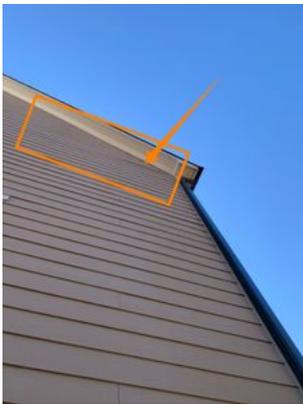
There were a couple places where the hardy type plank was either not properly secured or not sitting flat.

I was not able to get a depiction of the separation of the siding along the back right corner of the structure. The last picture was the most clear depiction I was able to capture at the time of the inspection.

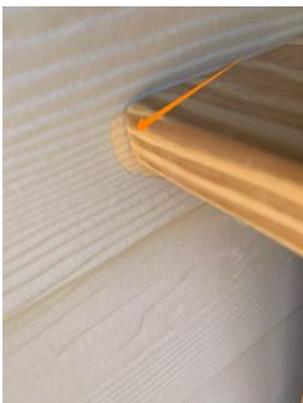
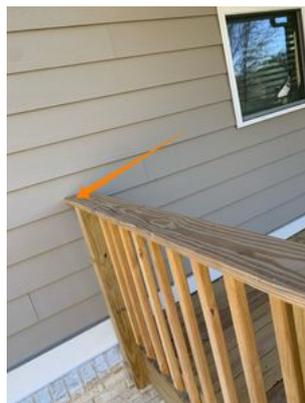
There's a small area of siding that is missing paint around the railing.

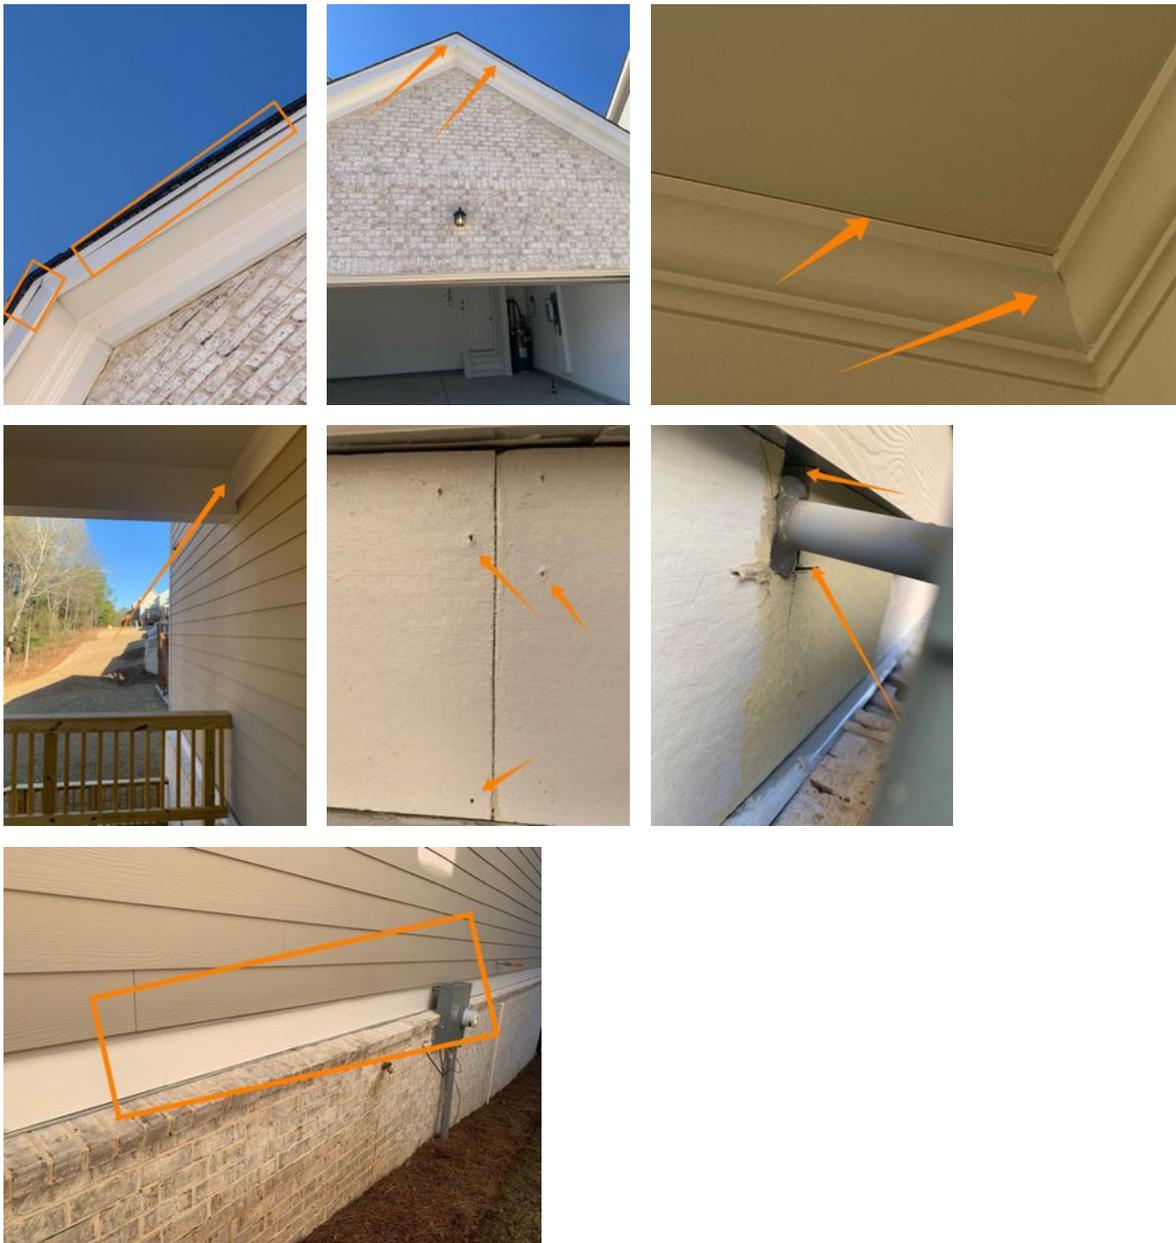
The indicated drip edge is not properly secured.

The indicated trim work along the back porch needs to be properly caulked and repainted.

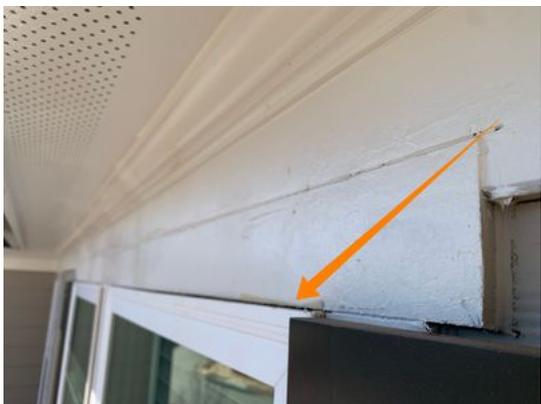
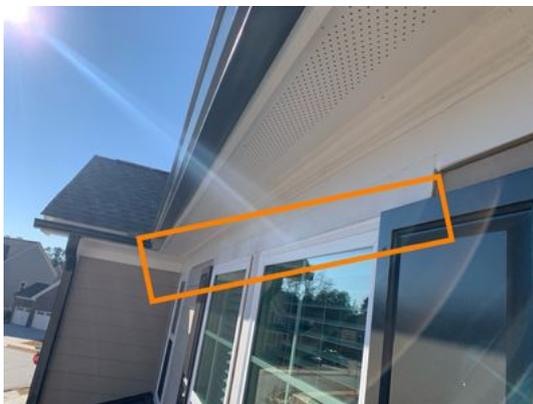
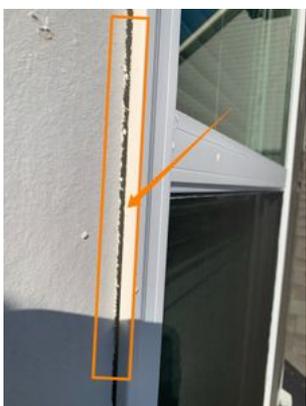
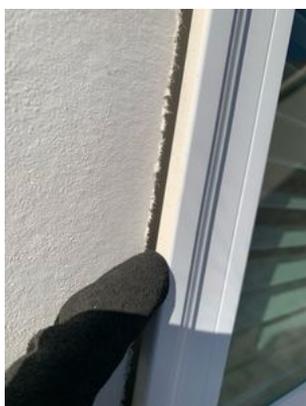
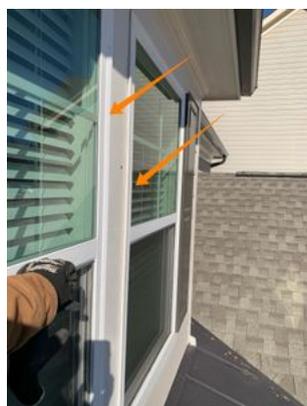
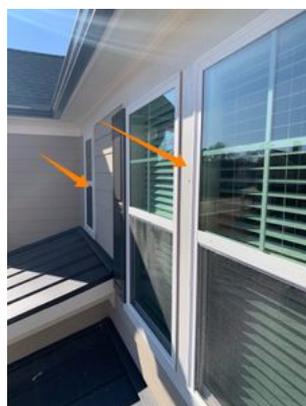
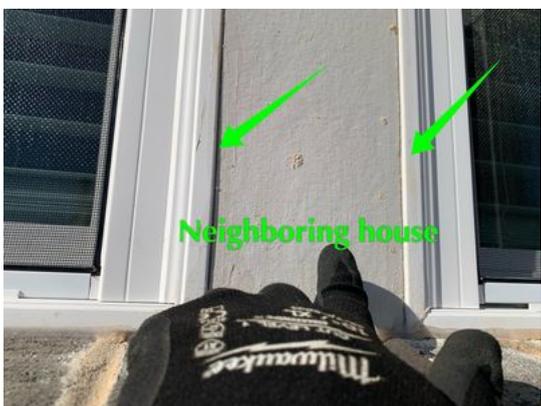
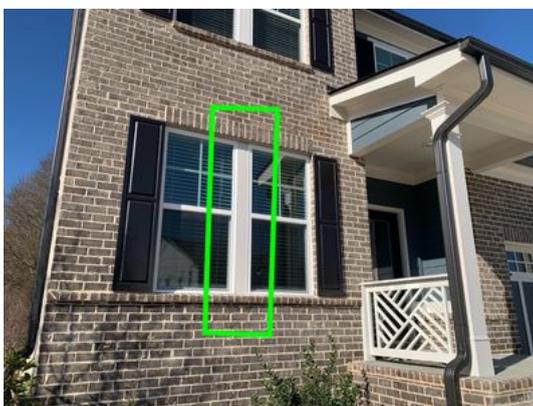
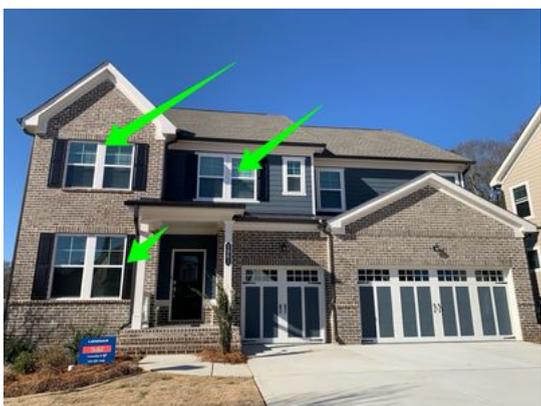
Neighboring homes have these areas properly attended to.

These pictures are for reference to the areas and types of repairs that may be needed. They are not exhaustive. It was pretty much every exterior window trim that needed to be addressed. Would recommend having the contractor sweep the entire exterior.

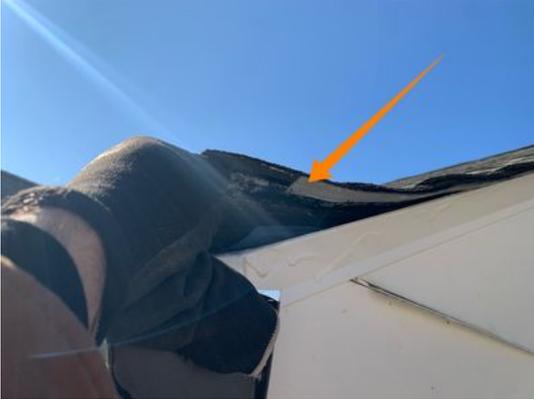
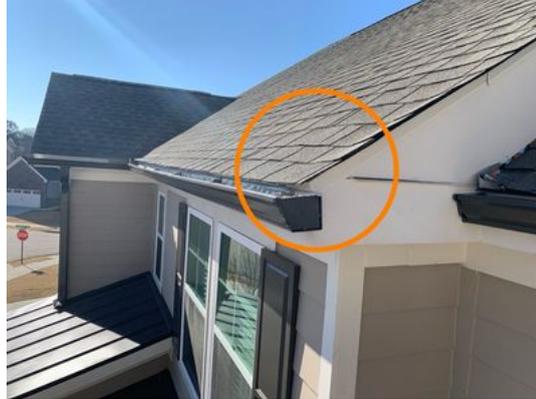
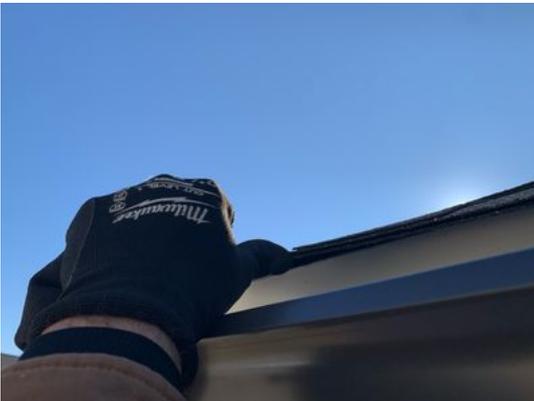
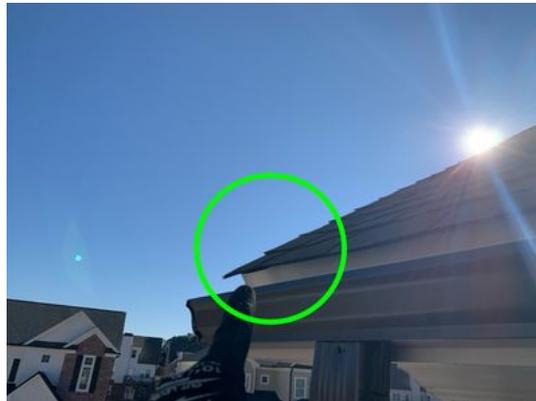
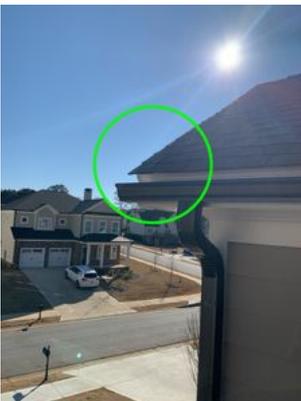
Roofing

The indicated corner of the roof has shingles that are not properly secured to the decking. The last set of pictures indicates how shingles should be properly adhered so that wind does not come along and damage them.

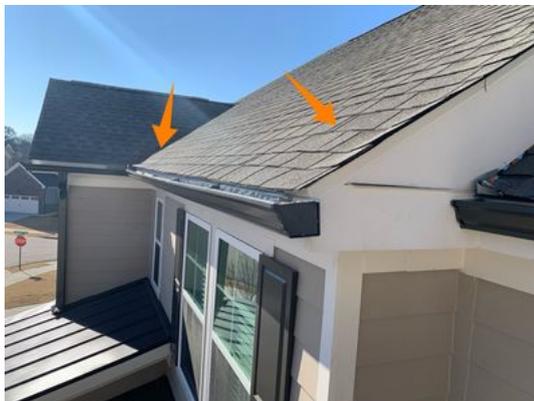
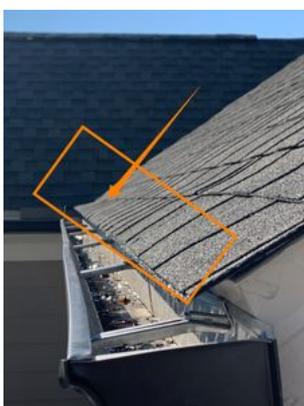
Roofing

There are two areas where there is some improper sloping and dipping in the roof line. These areas will wear out quicker than the rest of the shingles. Would recommend having the roofer come out and assess for repairs.

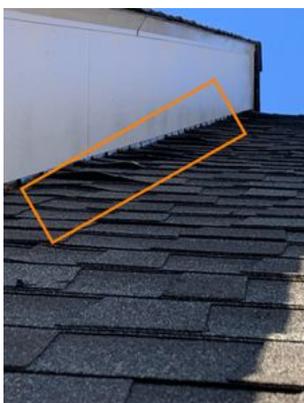
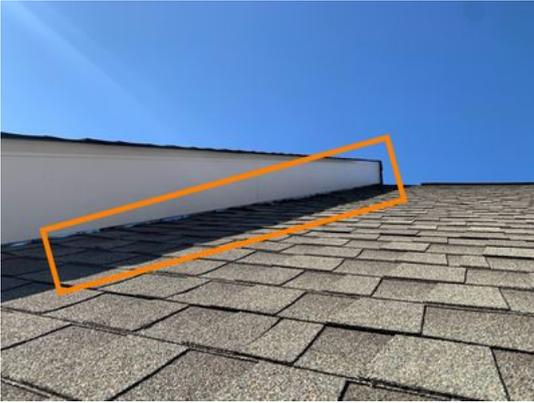
Roofing

There were quite a few shingles along this side of the house are not laying flat. This may be due to nail pops or improper installation. Would recommend having the roofer come out to assess and repair.

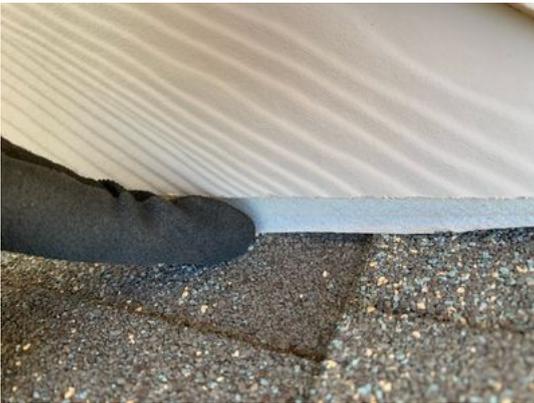
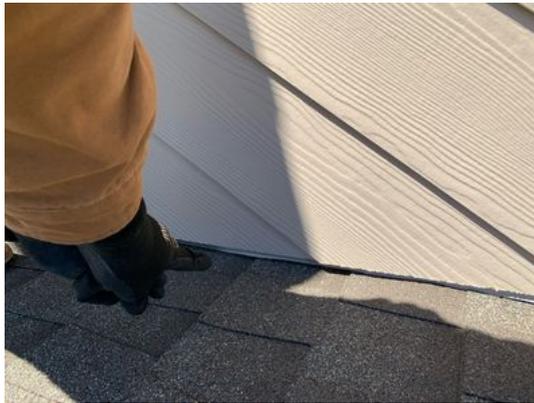
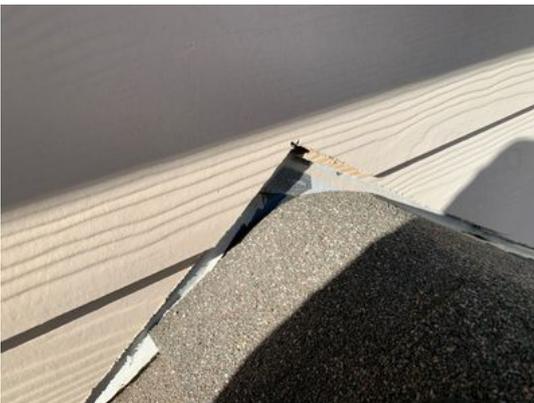
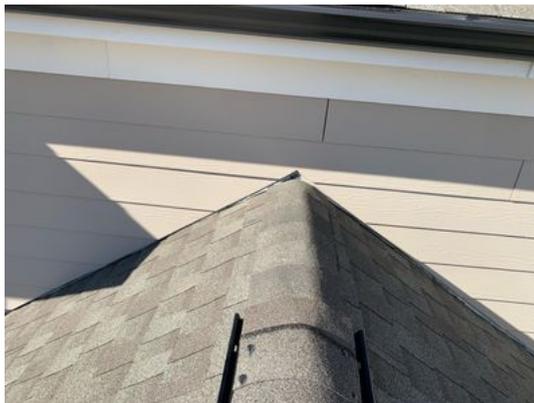
Roofing

There is some house wrap that is exposed along the bottom of the siding in these areas. Simply running a razor blade along the bottom of the siding should clean up this area.

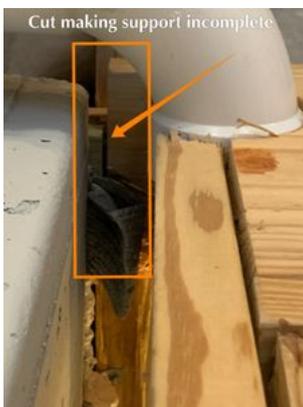
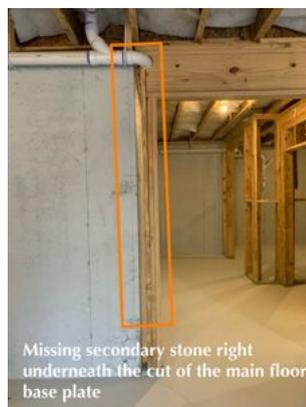
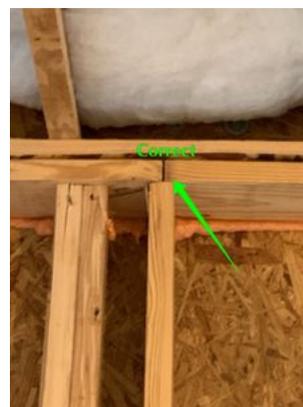
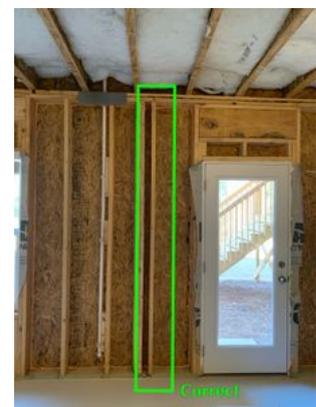
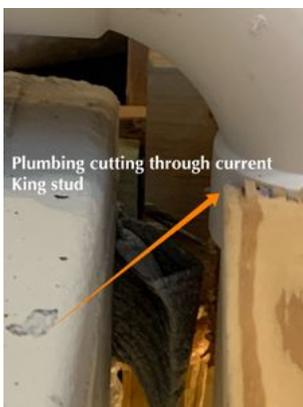
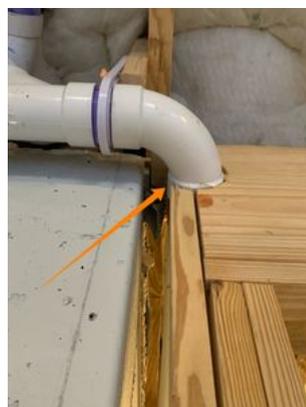
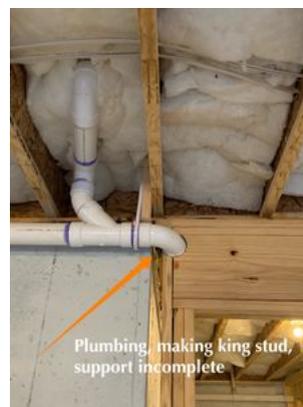
Structure

There is a loadbearing area that is missing the proper load bearing support.

The other issue is that the loadbearing support beam that is directly | the cut between the bottom plate board and the interior load bearing base is missing. Directly on the other side, the correlating cut has been properly supported as is shown in these pictures.

The resulting issue would simply be something along the lines of potential settling in this area, but considering how well, these flooring structures are designed in order to minimize or even eliminate settling so that the main floor stays level for a very long time there is no reason that this issue should not be repaired in order to ensure there is no settling from this location.

This needs to be repaired.

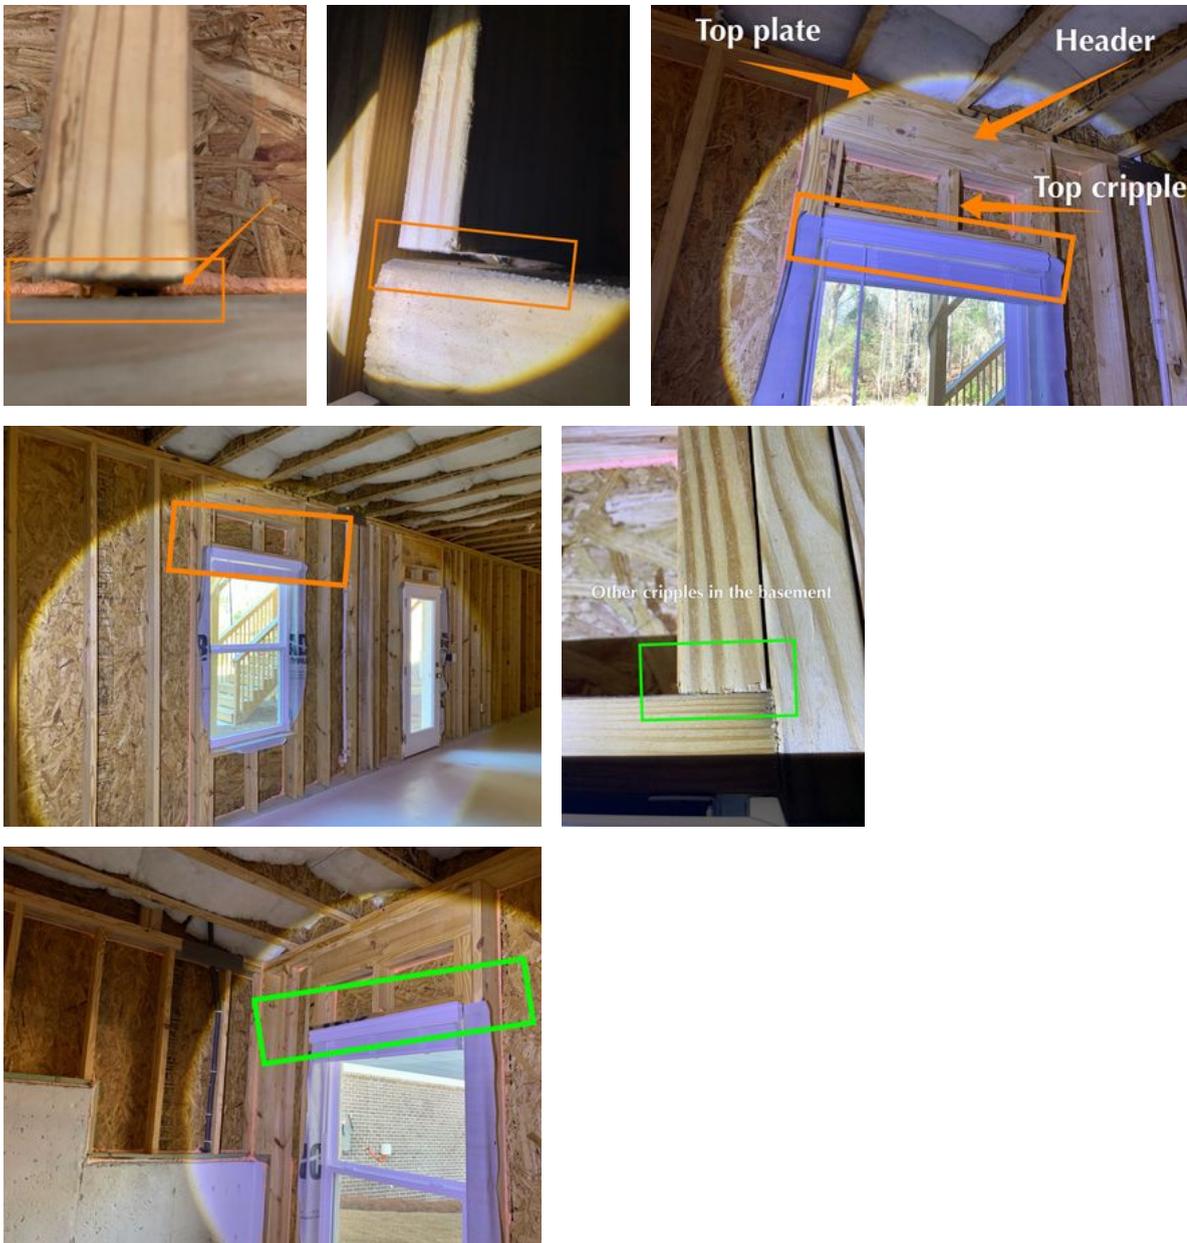
Structure

The top cripples are not making any contact with the top sill in this window. ALL other instances in the basement have the cripple making good contact with the top sill.
