Residential Solutions
7062545330

Home Inspection Report

Inspected By: Christopher Cooke
Inspected On Sat, Feb 7, 2026 at 9:00 AM

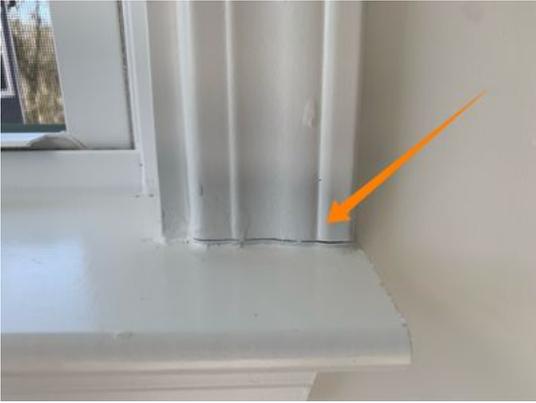
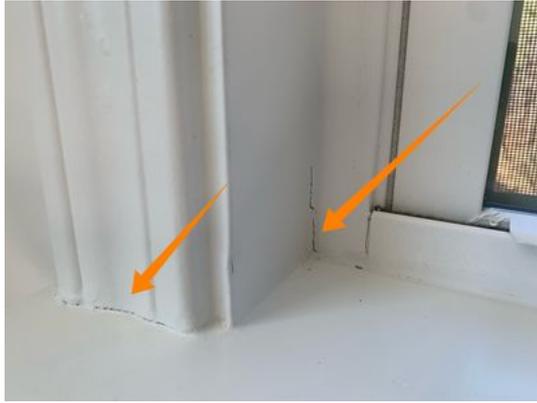
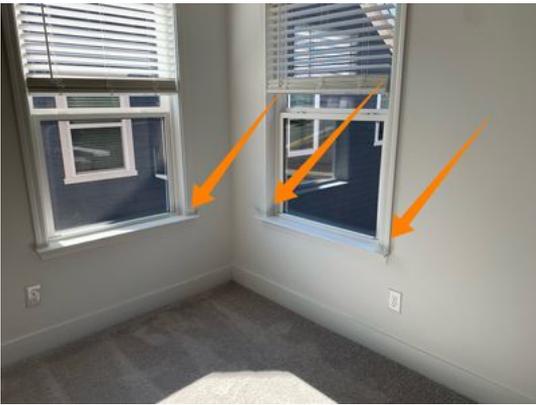
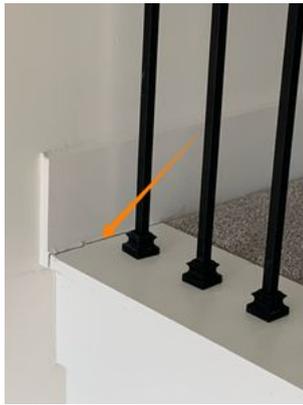
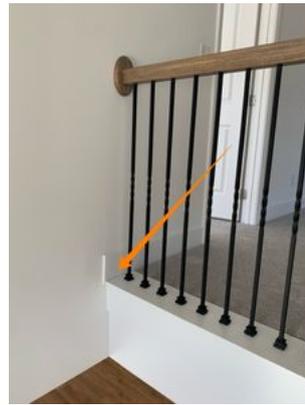
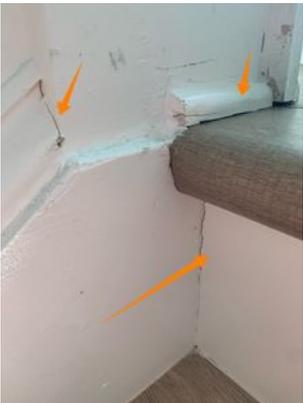
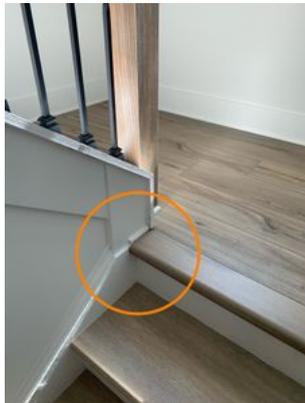
There are multiple areas throughout the house where the trim needs caulking and repainting. These are just a couple of examples of the areas and types of repairs that may be needed. I would make sure to point out these and others to the builder on the final walk-through and ask them to sweep the entire interior. There is one area in the garage around the electrical panel where the drywall needs to be repaired.

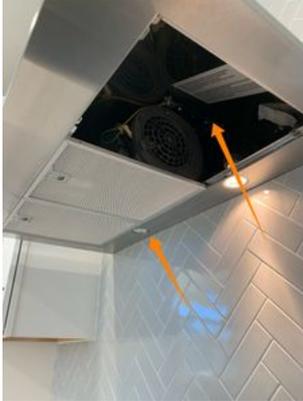
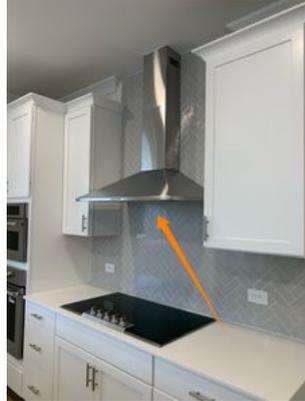
Kitchen: Appliances: Range Hood

One of the lights was not working on the range hood and one of the protective panels was missing as well.
