Residential Solutions
7067673336

Home Inspection Report Sample

Inspected By: Christopher Cooke
Inspected On Sun, Jan 11, 2026 at 8:00 AM

Church

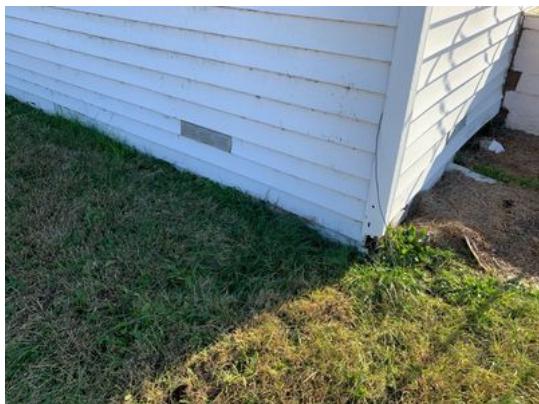
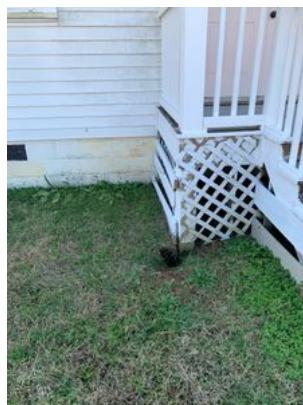
The grading slopes toward the structure and will not shed water away properly. This is a common cause of wet crawl spaces and leaking basements. Suggest adding fill dirt at low areas to prevent water from sitting next to home.

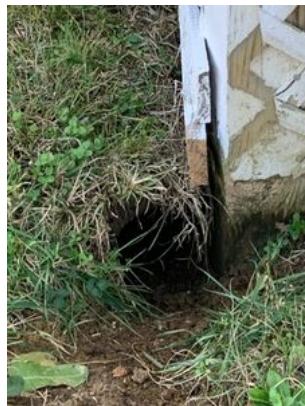
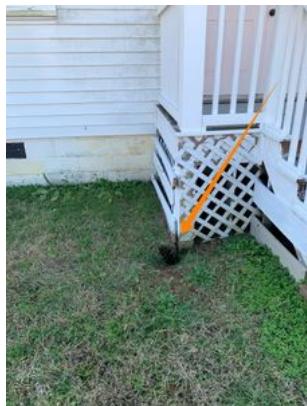
There appears to be a burrow in this area. Would recommend having the critter removed and the hole filled.

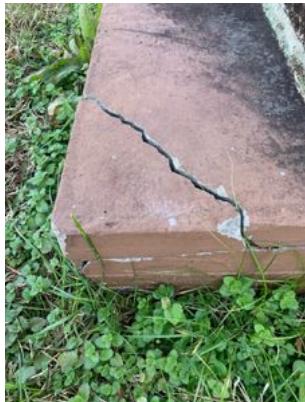
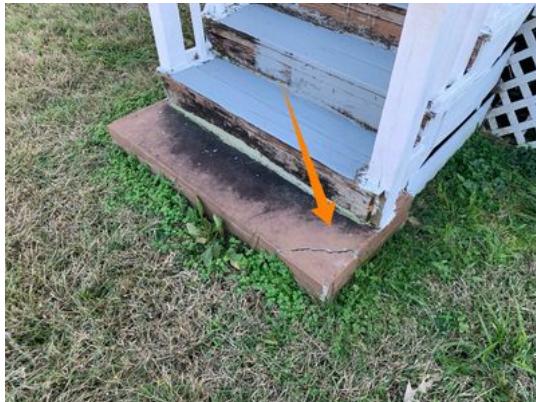
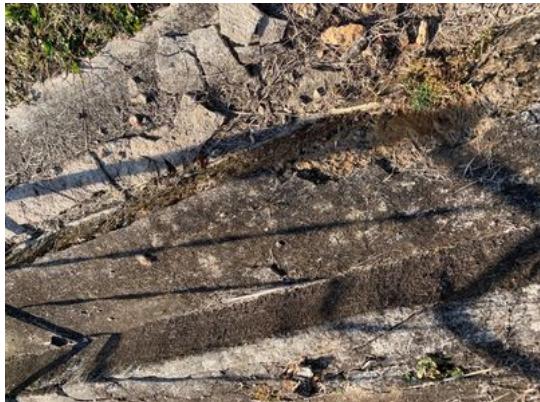
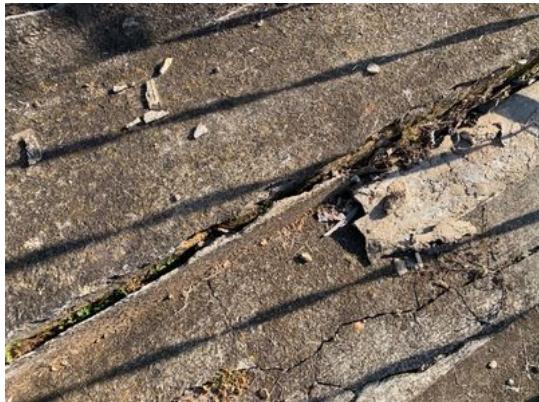
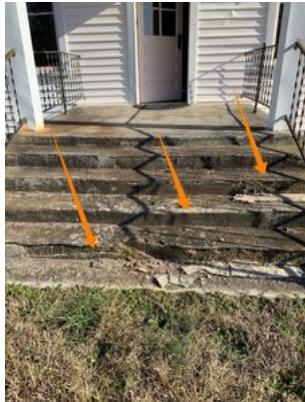
The concrete is broken and broken up along the steps/stoop area in multiple places.

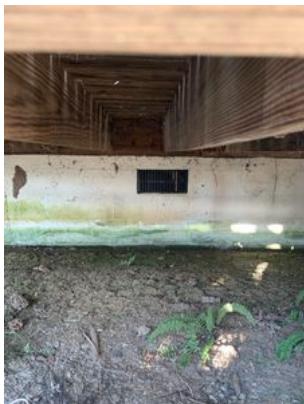
The structure of the deck appeared to be in good condition, but I was not able to access directly underneath in order to verify that there were bolts or lags every 18 to 24 inches connecting the deck to the structure.

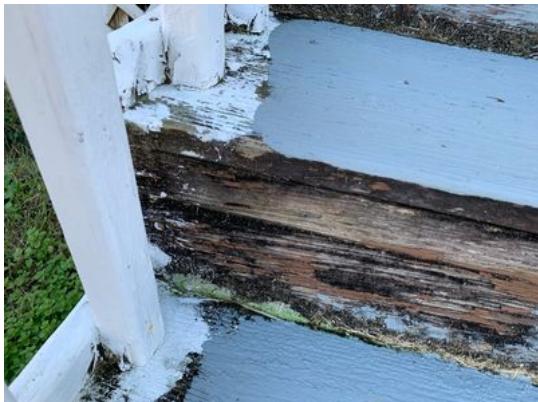
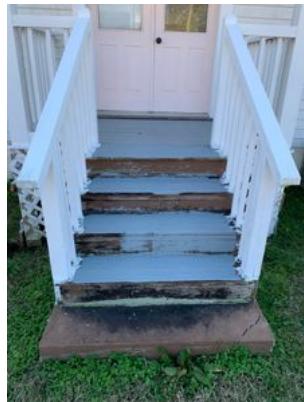
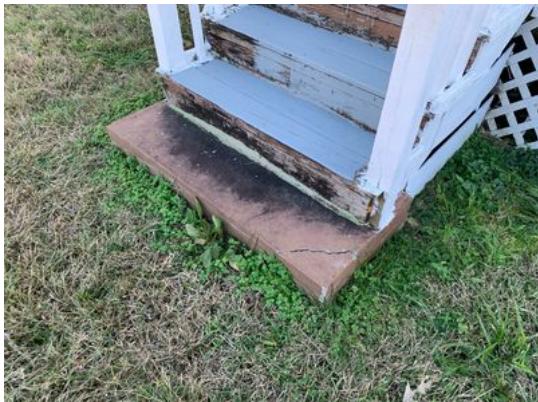
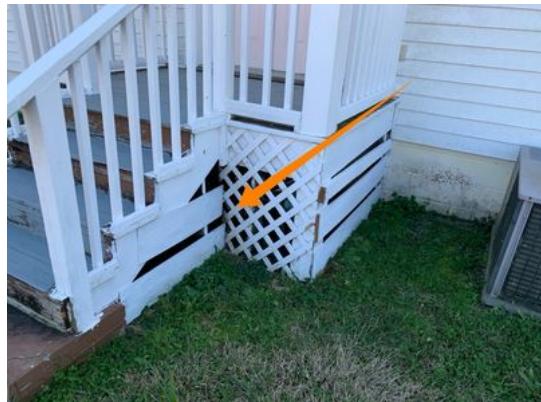
There are several areas where the wood may need to be repaired or replaced on the back deck. Would recommend pressure washing and reseal the back deck after these repairs are made.

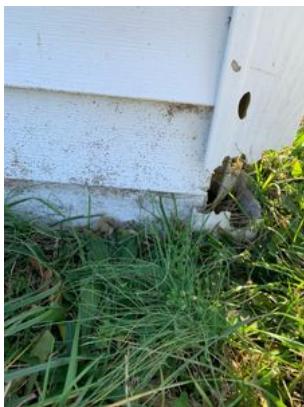
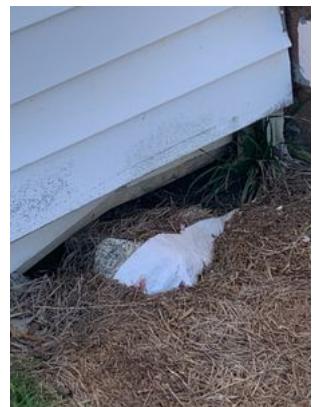
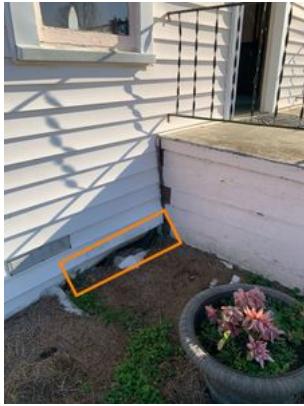
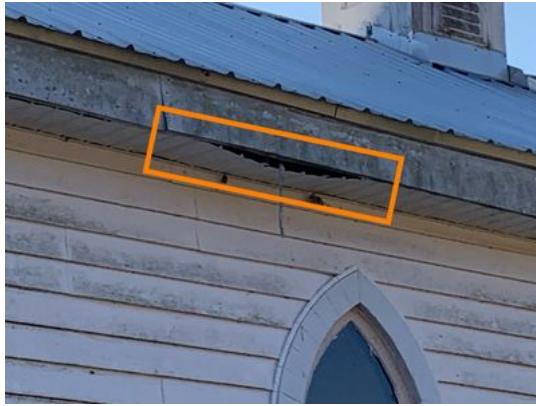
There are several places where the vinyl siding or trim has been damaged. Would recommend having all penetration sealed in order to prevent pest or moisture from affecting the interior of the structure.

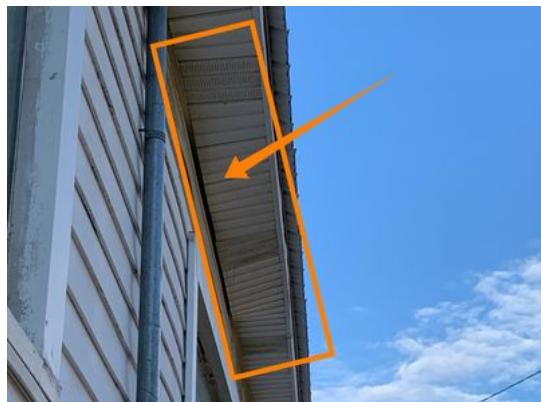
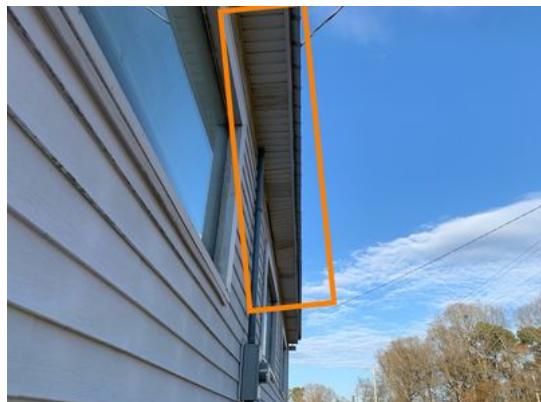
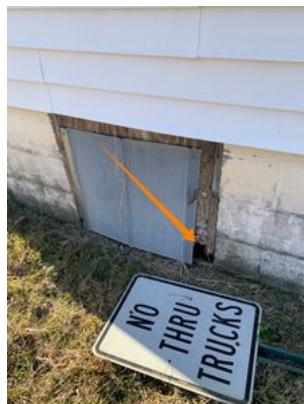
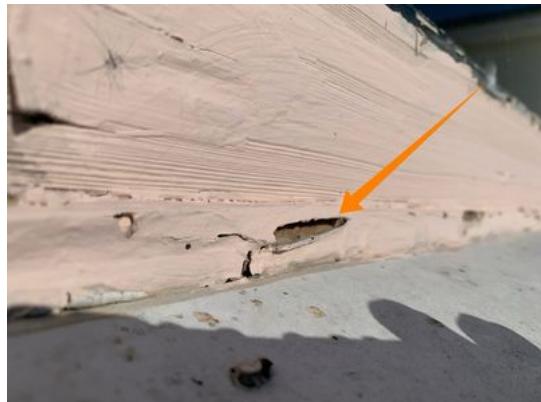
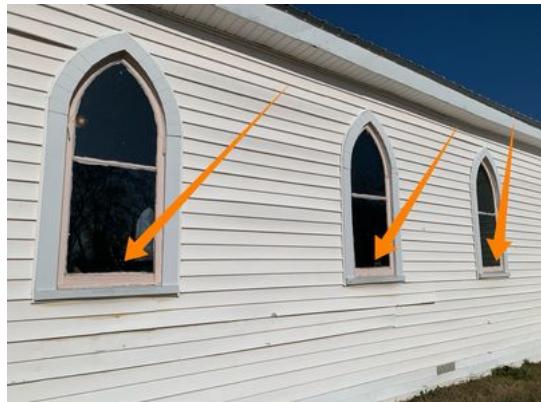
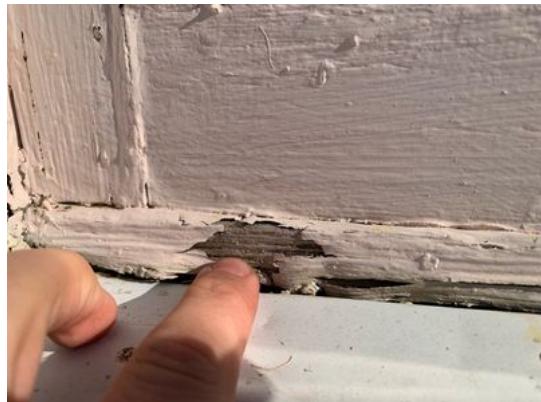
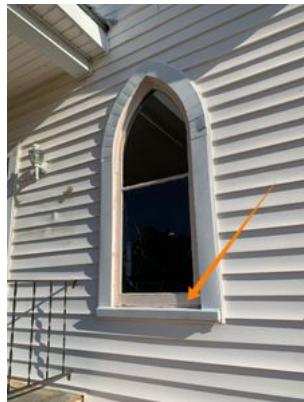
There are places along the entire exterior where the trim need to be repaired, caulked and repainted.

These pictures are for reference to the areas and types of repairs that may be needed. They are not exhaustive. Make sure to have your contractor sweep the entire exterior.

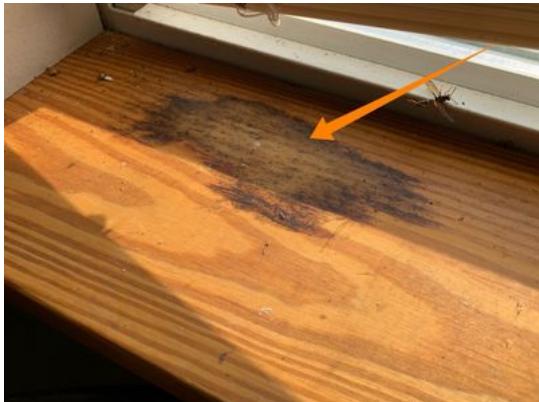
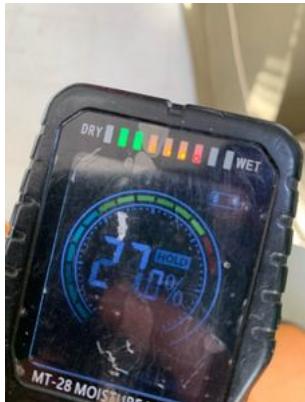
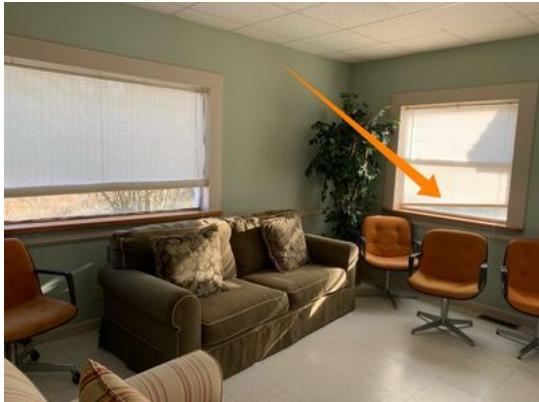
Repair or Replacement Needed

There are water stains on the interior sill of this window. These things registered with high moisture at the time of the inspection and applying a current leak. Would recommend having this area repaired by a contractor.

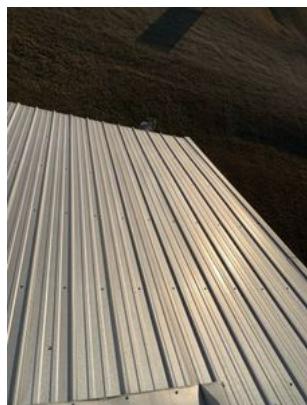
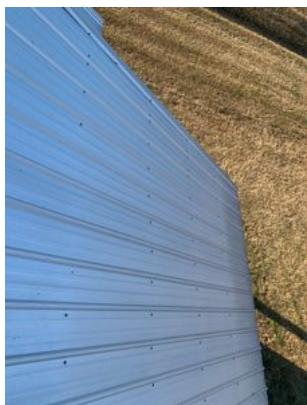
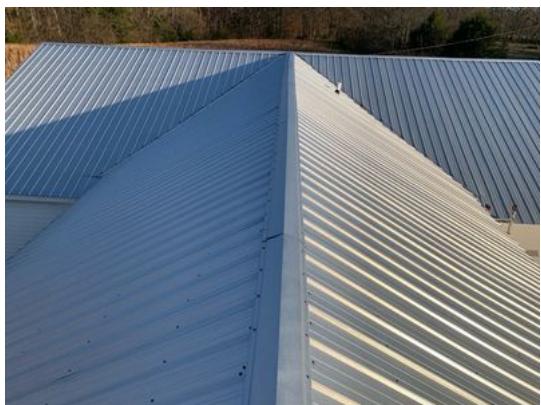
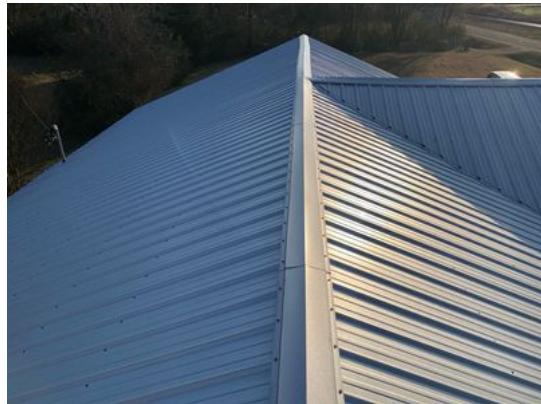
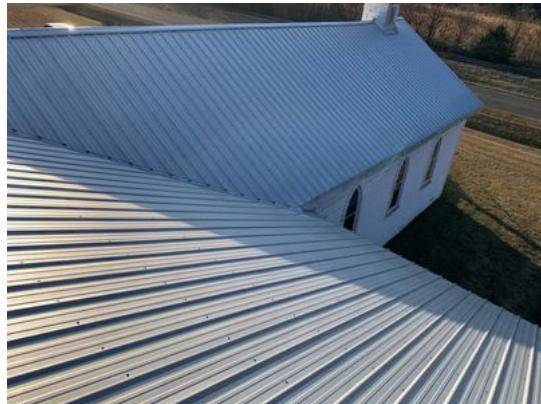
The roofing is a metal interlocking sheet system. The fasteners were tight, and the metal sheets were properly secured at the time of the inspection.

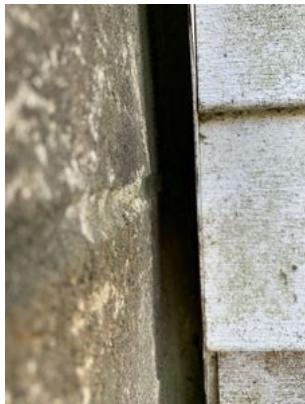
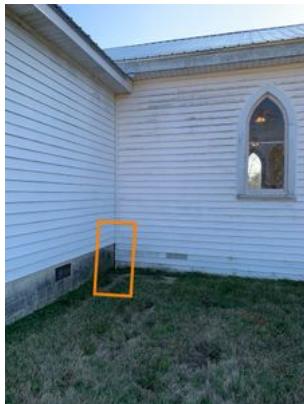
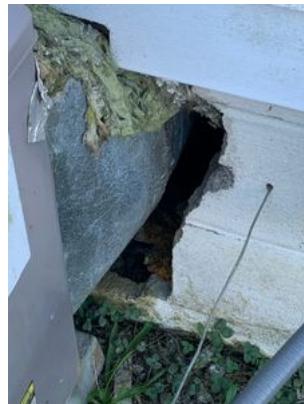
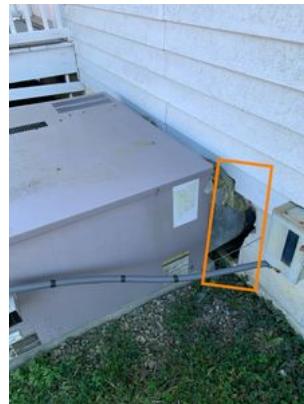
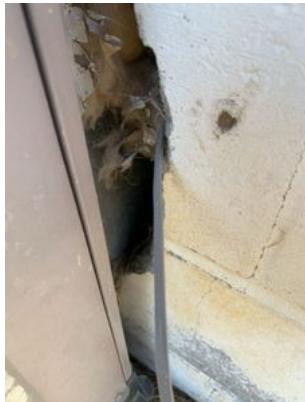
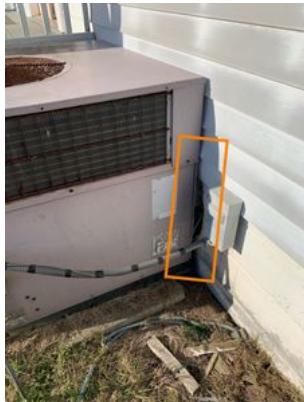
Repair or Replacement Needed

There are some gaps around the exterior structure that would recommend having filled in order to prevent pest or critters from entering.

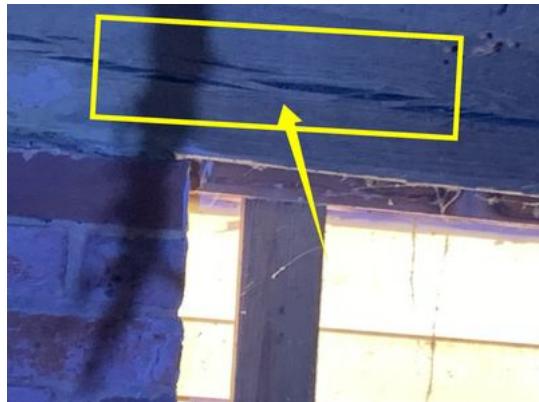
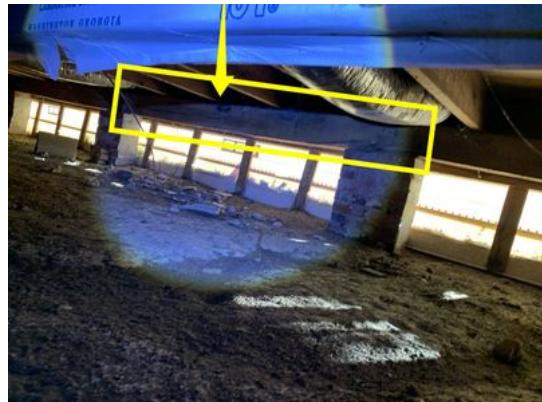
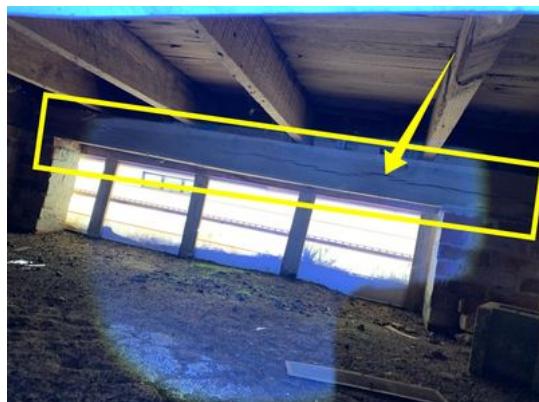
Comment 14

Monitor Condition

There is some slight bowing in this beam and also some stress fractures.

There were no signs of undue stress on the floor joists in these areas and no major signs on the interior of the structure of settling. This implies that it may be an older issue and possibly a previous issue rather than current. The stress fractures are fairly consistent through the beam, but at no point does it look to have undermined the integrity of the beam. This is something to keep an eye on as further cracking could result in need of repair.

For more information or further assessment would recommend contacting a Structural engineer.

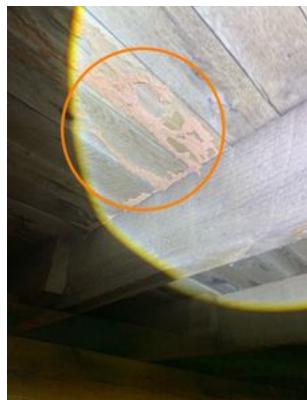
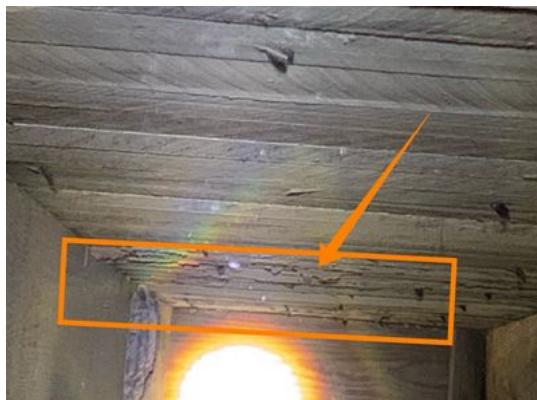
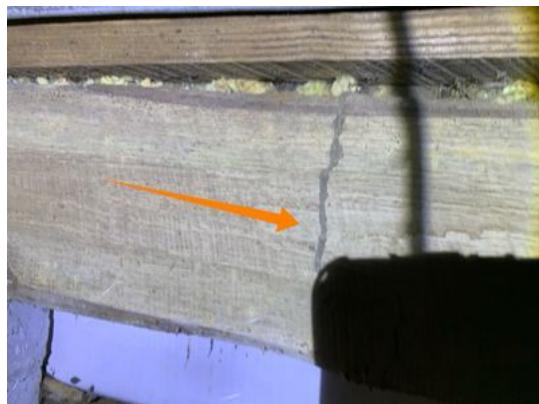
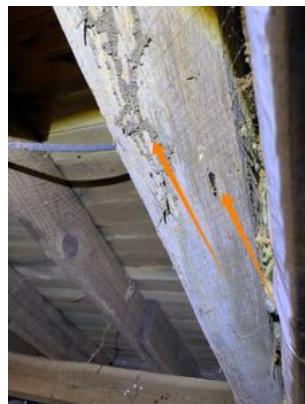
Comment 15

Repair or Replacement Needed

There are signs of termite activity throughout the old sanctuary. I was not able to determine whether they were current lead active in each of the areas. The damage that I was able to assess at the time of the inspection was not to the point where repairs would be needed.

Would highly recommend having a pest specialist come out and assess to see if any of these are current and what treatment options would look like as well, as if there is any deeper damage in some of these areas.

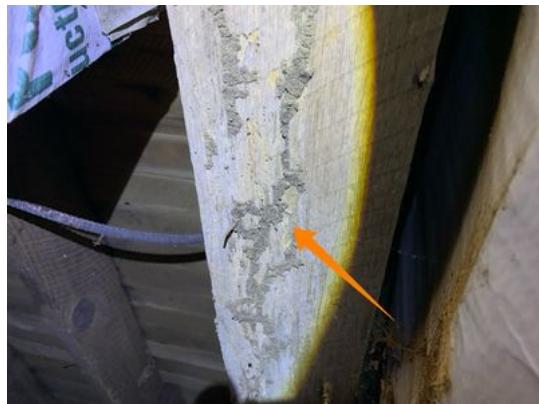
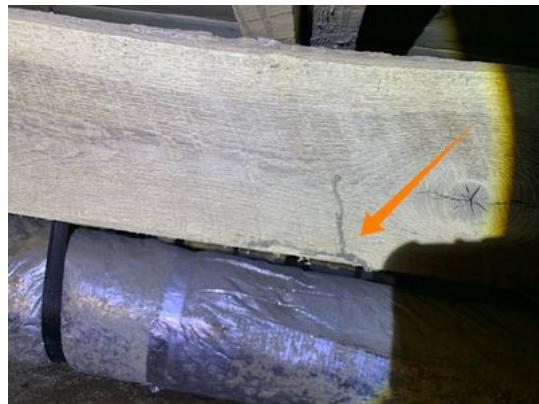
Comment 16

Repair or Replacement Needed

There are a couple areas where it would appear. There is moisture, making it to the skirt board of the structure. Would highly recommend having these areas repair/replaced in order to prevent any further moisture damage.

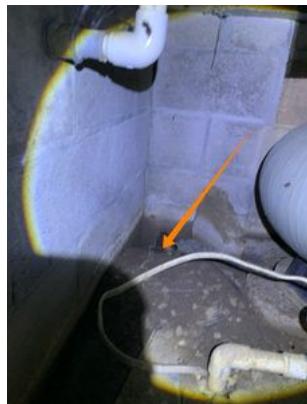
Comment 17

At the entrance to the crawlspace, there appears to be a burrow or some sort of large hole off to the left-hand side in the corner. Would recommend having this filled as it runs underneath the footer.

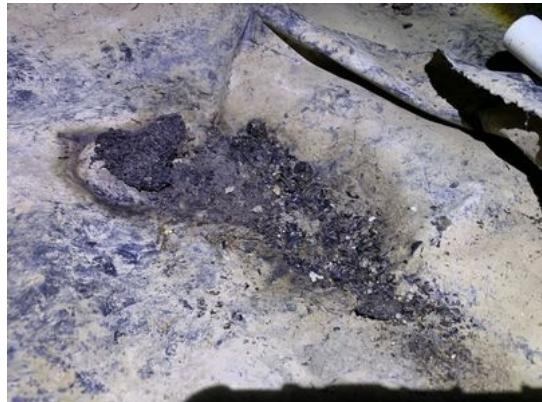
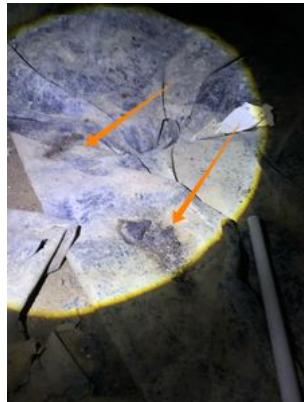
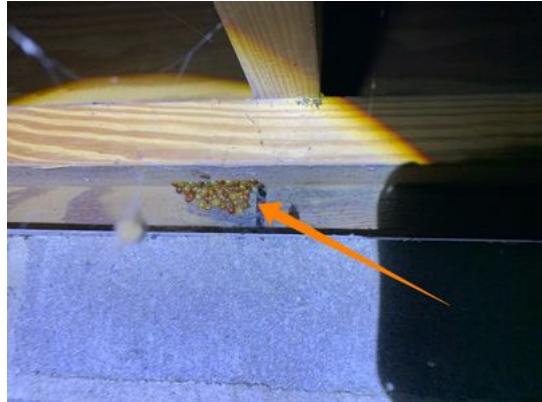
Comment 18

There are some signs of pest activity in the crawlspace. Would recommend having a pest specialist come out and assess for treatment.

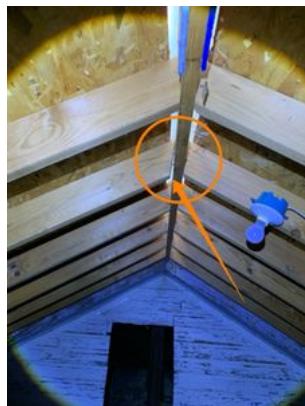
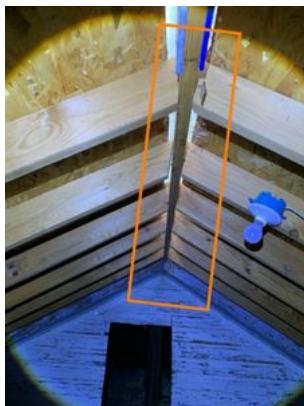
There was one section of the roofing where there are no collar ties. Would highly recommend having color ties installed in this area in order to prevent any further pulling away of the rafters from the spine.

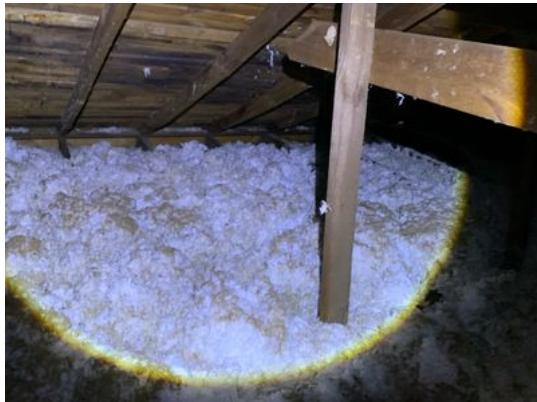
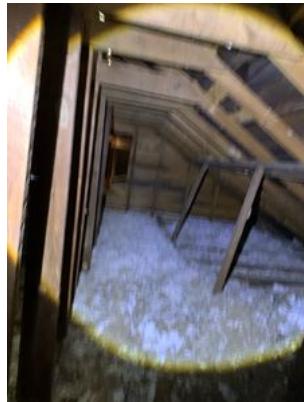
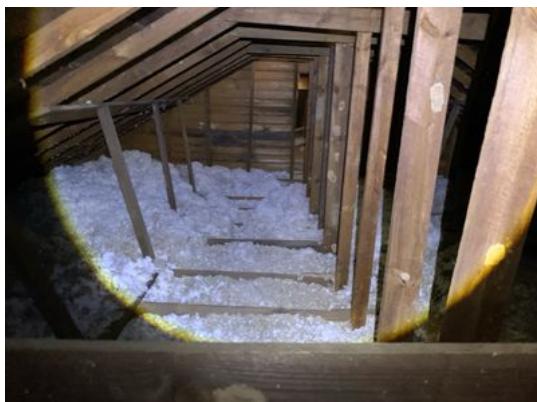
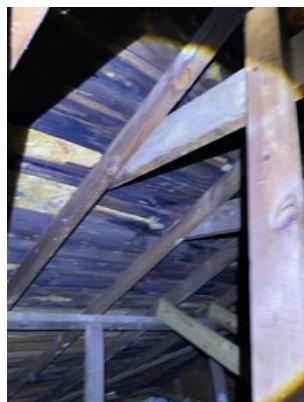
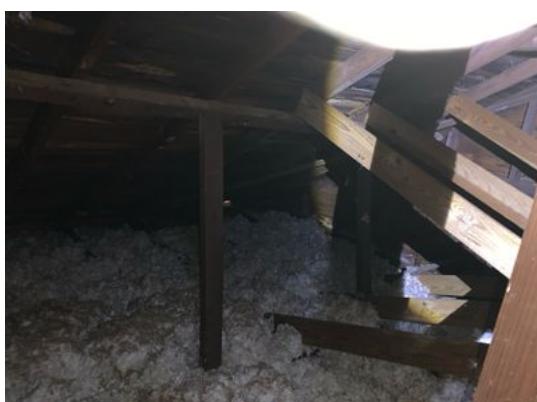
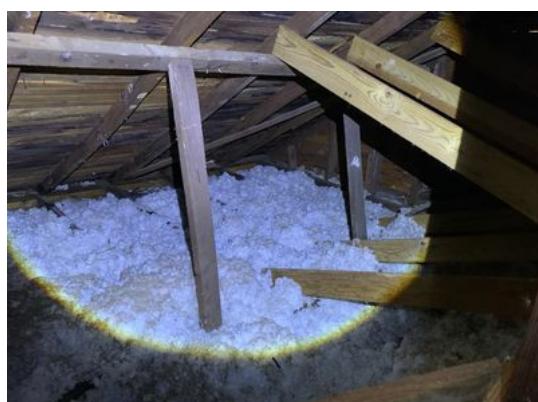
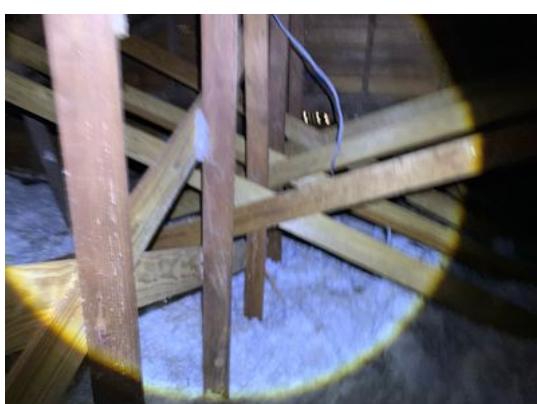
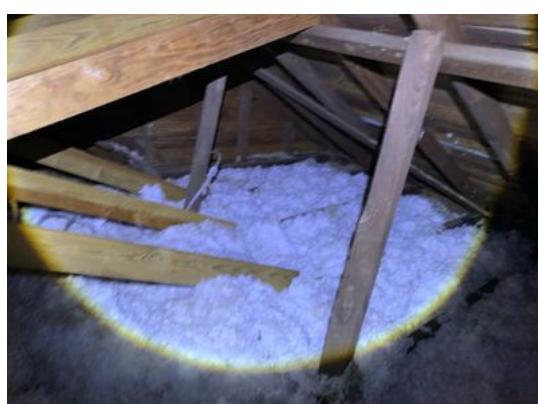
Comment 20
Information

The insulation was in good condition and a proper depth for efficiently insulating the house.

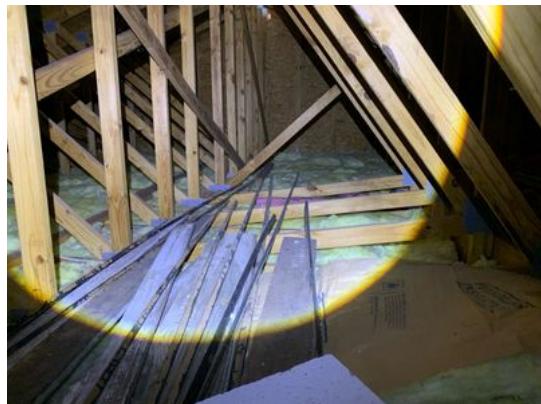
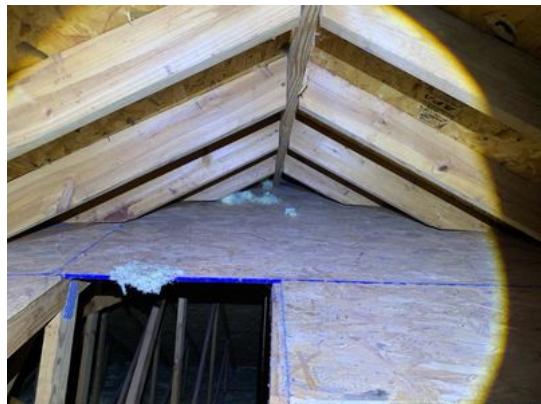
Comment 21

There's a minor bowing in the roof along the right side of the sanctuary. This looks to be an older issue as the older beams have some slight bowing in them as well, but no signs of any unused stress or cracks. There is also some additional support that has been added to the structure in this general area. Would recommend asking owners for more information about these repairs.

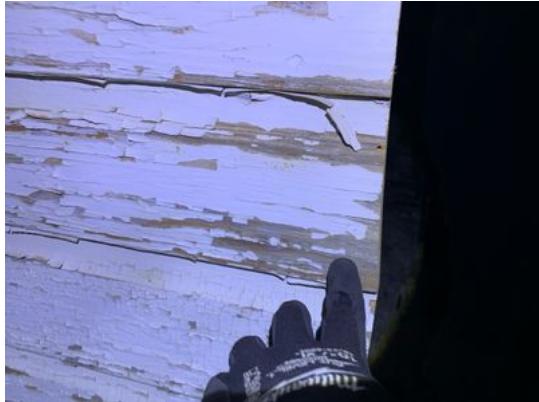
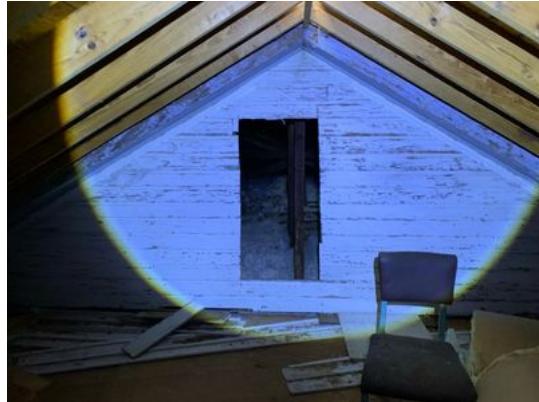
This area of the building where there is old exposed siding. It would look as though there is some lead-based paint in this area. Would recommend caution when interacting with this substance.

Painting over the material with latex, technically encapsulate it, but any sanding of these areas could result in hazard.

If there's any further concern would recommend having some environmental testing done.

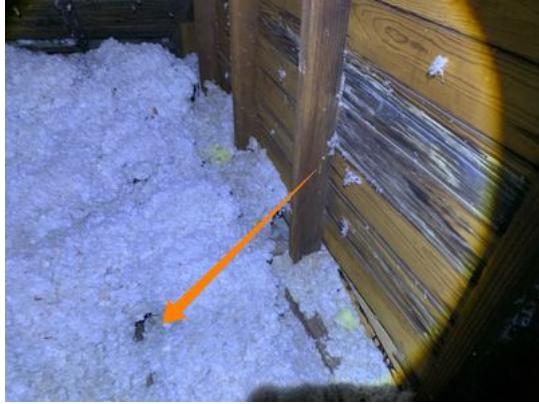
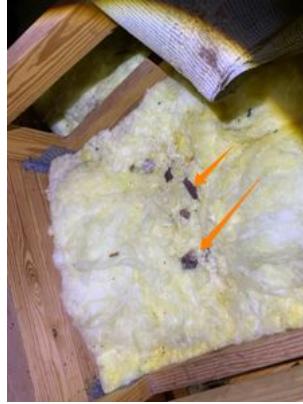
Comment 23

There are some signs of rodent activity in the attic space at the time of the inspection.

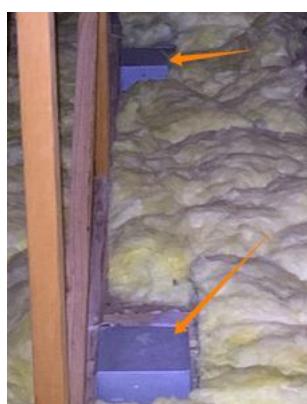
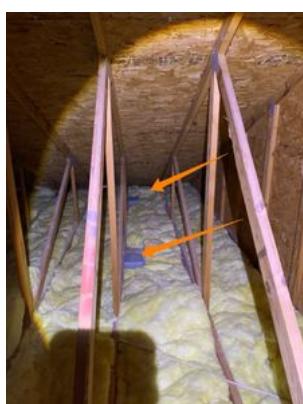
Comment 24

The bathroom vents vent directly into the attic space. It would be best for these to vent to the exterior of the structure.

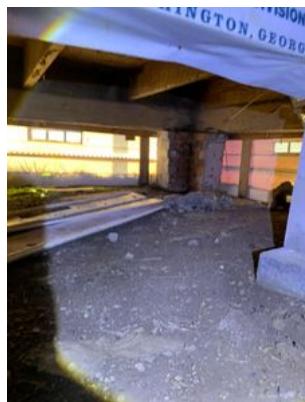
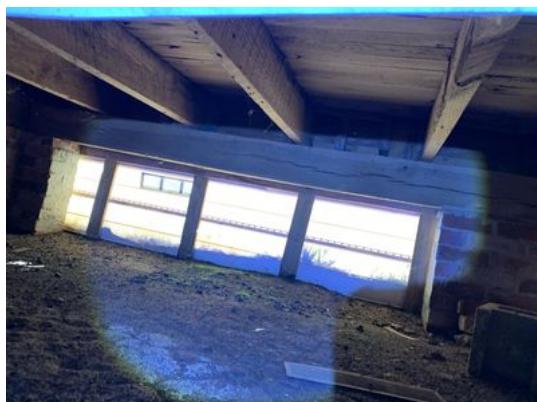
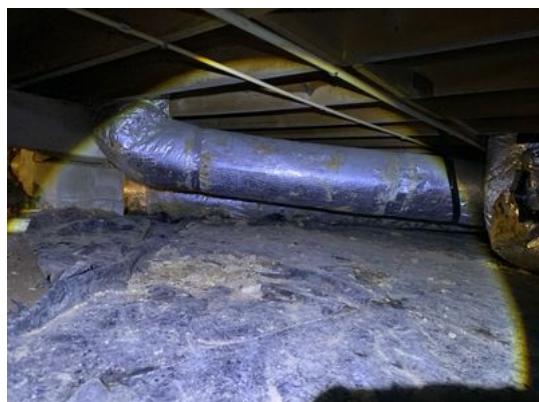
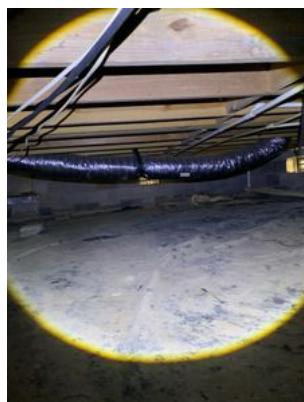
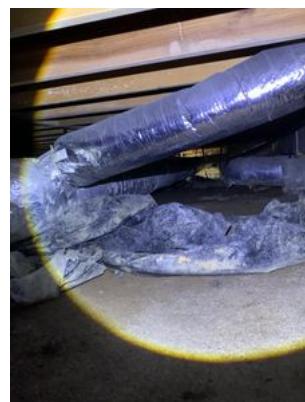
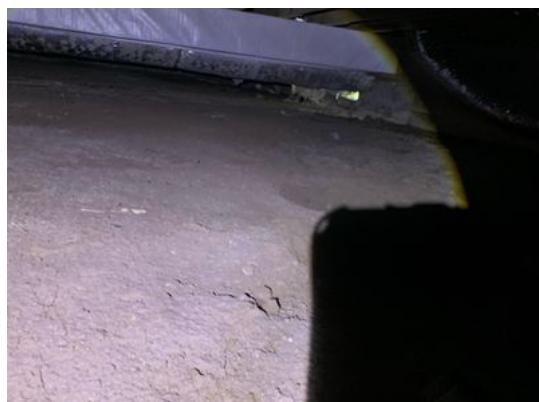
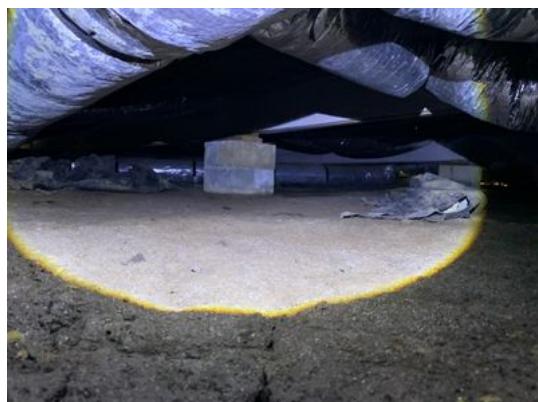
There is a poor barrier installed in the crawlspace. A minimum of 90% of the grounds in the crawlspace should be covered in order to control, moisture buildup in the crawlspace and prevent mold, mildew and fungal growth.

We had high moisture readings in the crawlspace, as well as fungal growth in multiple areas.

Most moisture issues can be dealt with proper ventilation and a vapor barrier. Would highly recommend having a vapor barrier installed.

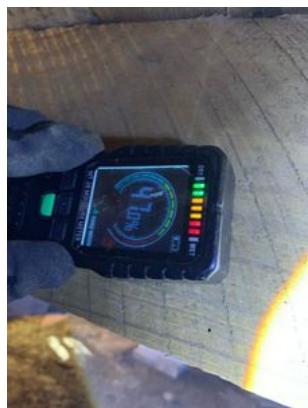
There were high moisture readings in the crawlspace at the time of the inspection.

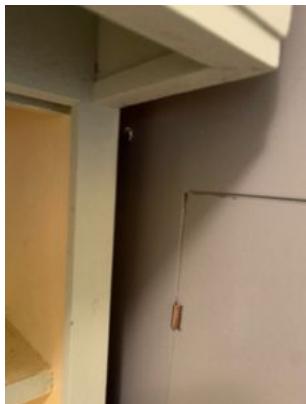
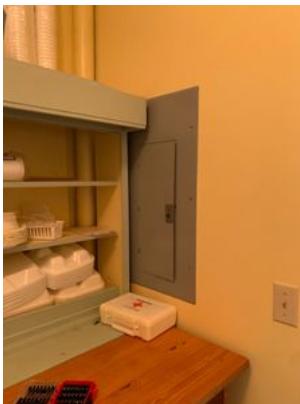
I was not able to access the interior of the panel at the time of the inspection.

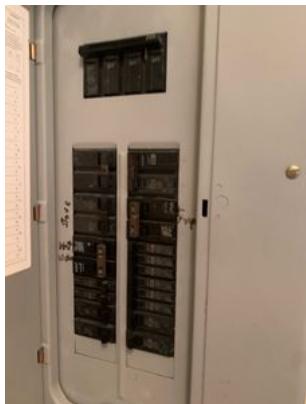
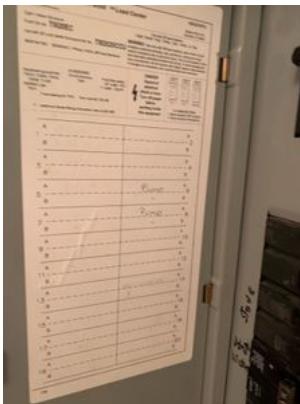
The breakers were not properly labeled and but were in good working order at the time of the inspection.

It will be best to have all the circuits labeled in order to know what portions of the structure are connected with each specific circuit.

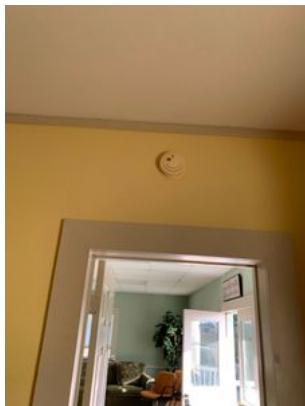
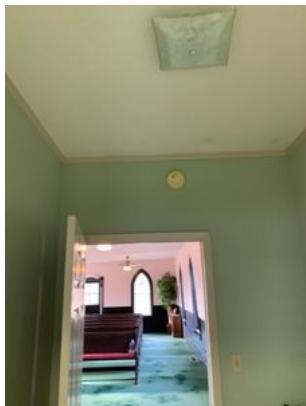
There were no functioning fire alarms at the time of the inspection. Current code for fire alarms is to have a fire alarm within each sleeping area and within 6 feet of the exterior of any individual sleeping area.

It would be best to have AT LEAST a fire alarm within 6 feet of any sleeping area.

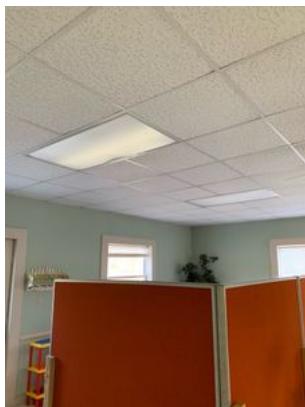
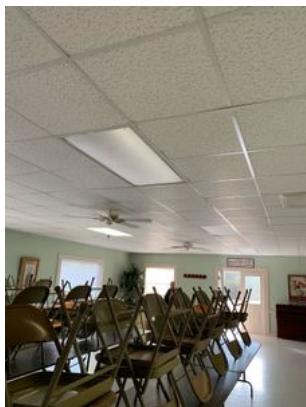
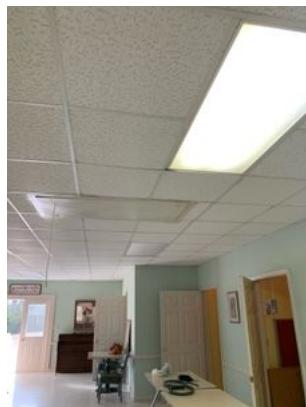
Comment 33

There were several lights that were not fully coming on at the time of the inspection. This can be either due to the bulb or the ballast, which would imply that the ballast would need to be changed.

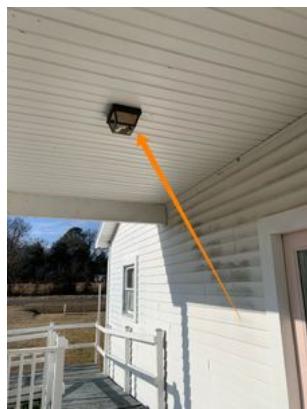
Comment 34

This light did not come on at the time of the inspection. Most likely just needs a new bulb, but we would recommend having the owners verify the functionality of the fixture before closing.

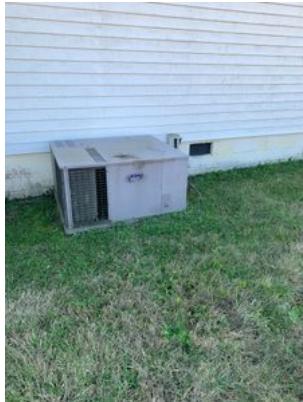
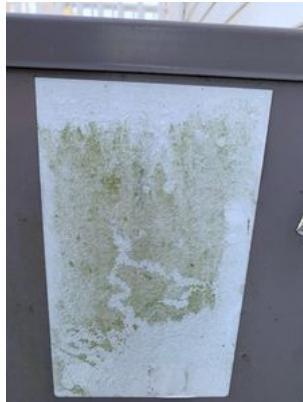
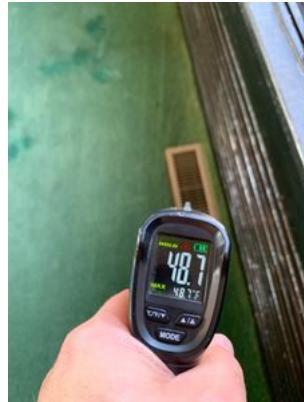
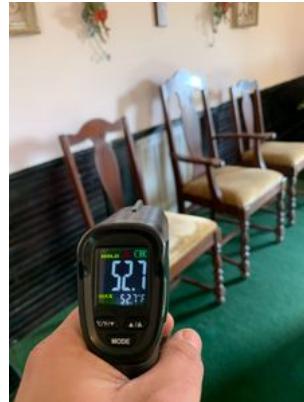
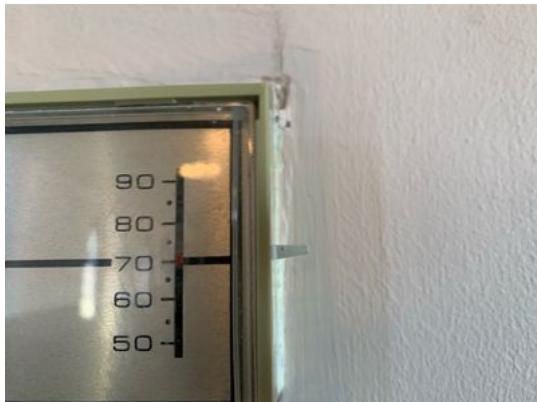
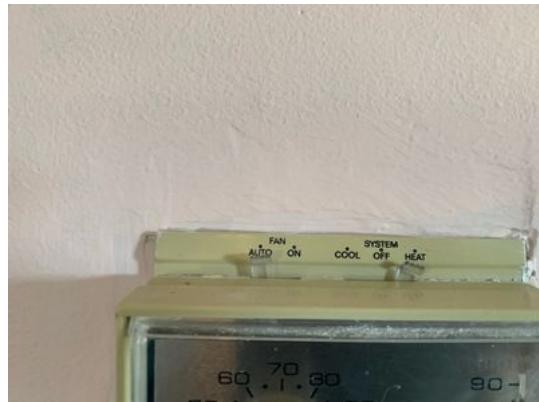
Comment 36

The AC unit for the sanctuary area was not functioning at the time of the inspection. The ID plate was not legible at the time of the inspection either. I was unable to get cold or hot air from the unit. It is an AC/furnace combo. Would recommend having a licensed HVAC specialist come out and assess.

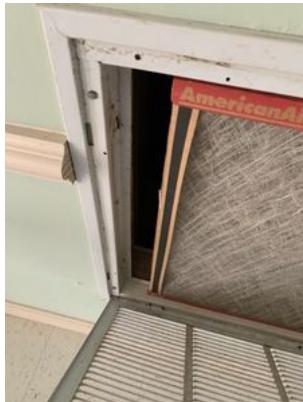
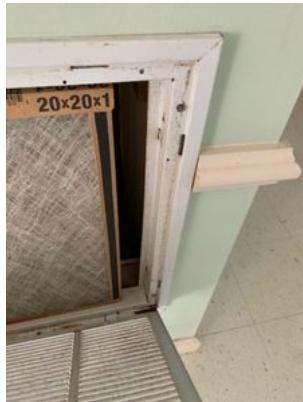
Comment 37

The current return does not have a properly sized filter.

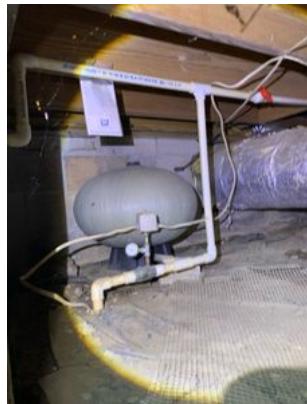
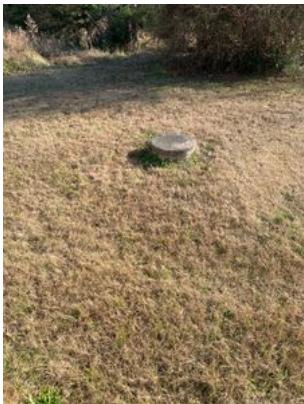
Water services supplied by a well pump. Would recommend asking the owners for more information about the well.

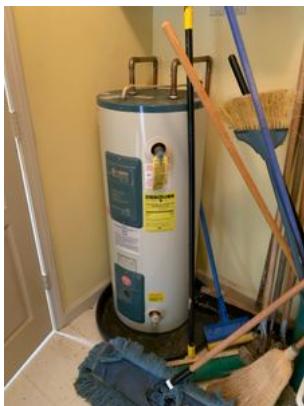
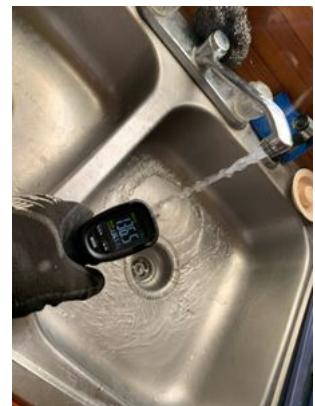
The water heater is a 50 gallon electric unit manufactured in 1999. There was no electrical shut off easily accessible and no expansion tank installed. The unit was functioning properly at the time of the inspection.

***Note : the typical lifespan on a water heater is 8 to 10 years. Would recommend budgeting for replacement.

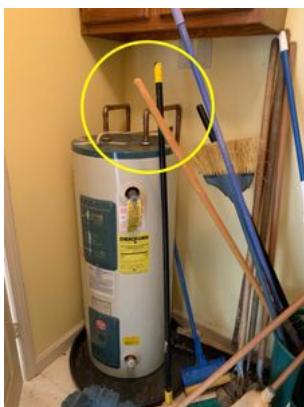
No expansion tank or expansion valve was present on the water heater. Since 2012 expansion tanks/valves have been required if there is a check valve, pressure regulator, or backflow preventer installed on the main supply line, regardless of the type of water heater. As these elements create a “closed loop system” and it would be best if a thermal expansion tank was installed. The thermal expansion tank prevents the relief valve on the water heater from blowing off all the time.

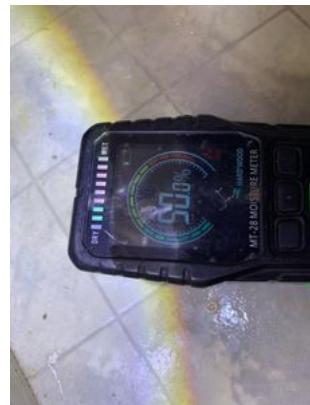
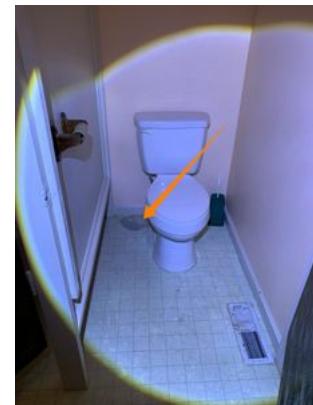
There it appears to be an active water leak in the women's bathroom around this toilet area. I was not able to access this area from the crawlspace at the time of the inspection due to the HVAC ductwork runs. Would highly recommend having this area assessed and repair repaired.

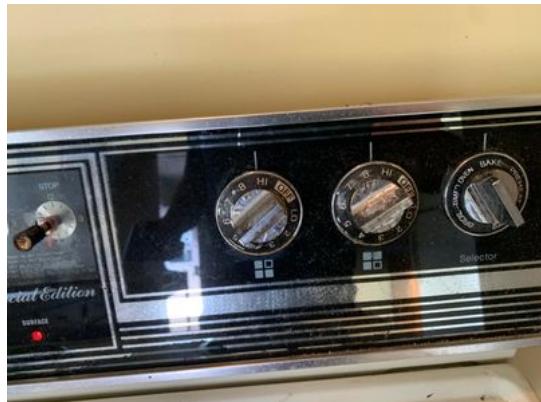
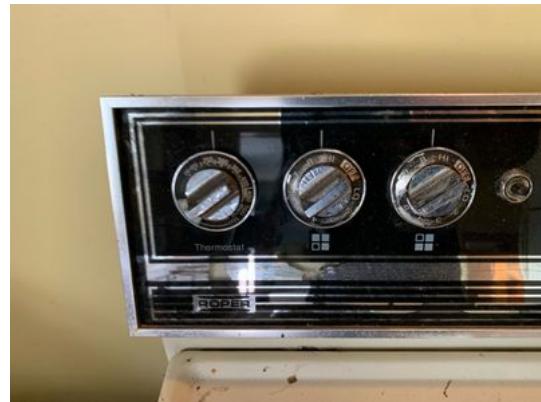
Two of the burners are not functional on the stove at the time of the inspection.

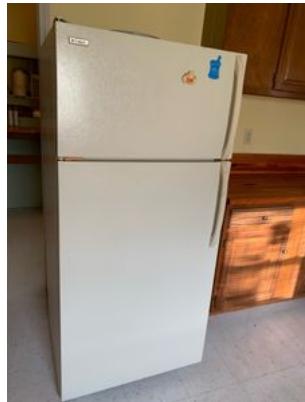
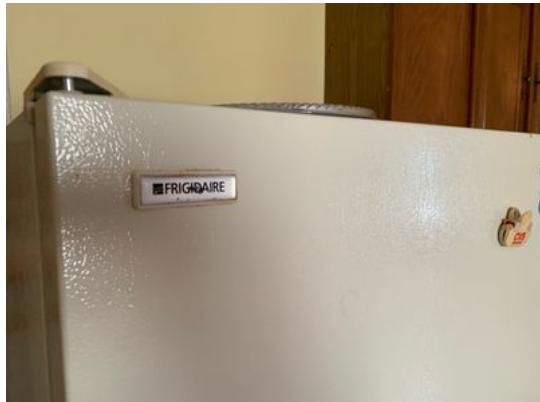
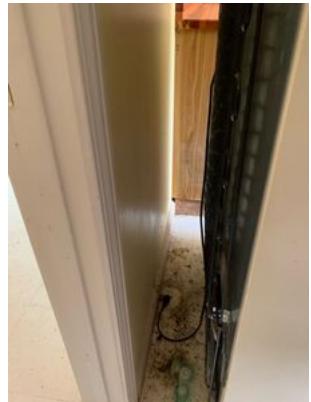
The refrigerator had been unplugged for some time and there was food on the interior. Would highly recommend having cleaned and tested if intending on getting any further use out of the unit.

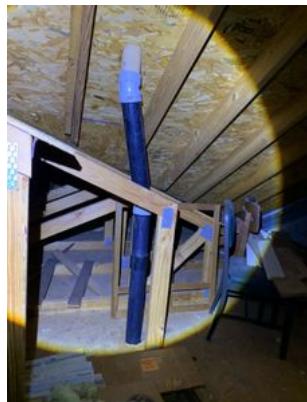
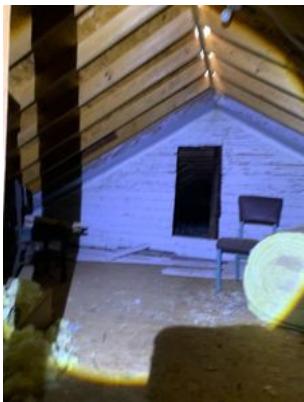
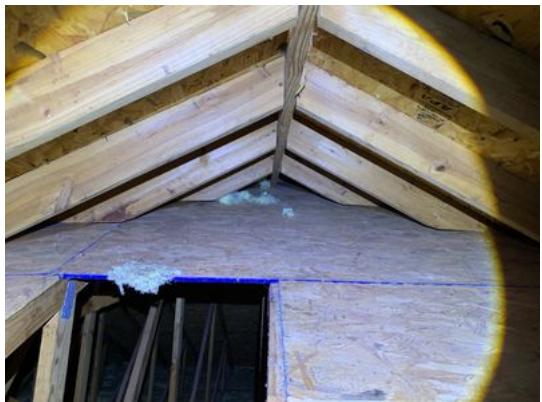
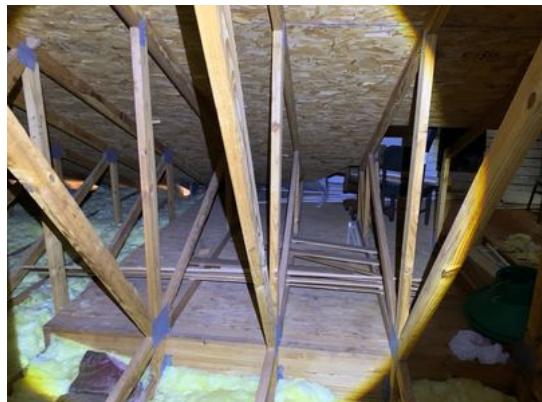
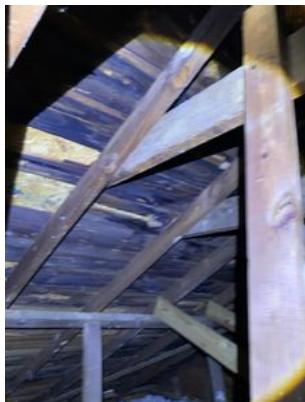
There were signs of leaks throughout the structure at the time of the inspection. All of these areas registered with no moisture, and there were no signs of any active leaks in the attic space around those areas. In fact, the roof looks to be new within the last five years, implying that any of these areas were likely due to the previous roof.

Would recommend asking owners for more information.

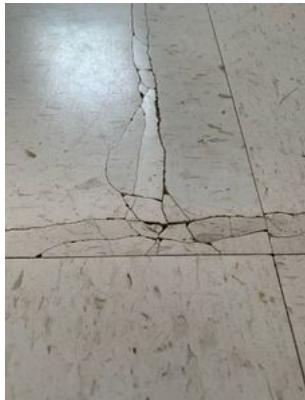
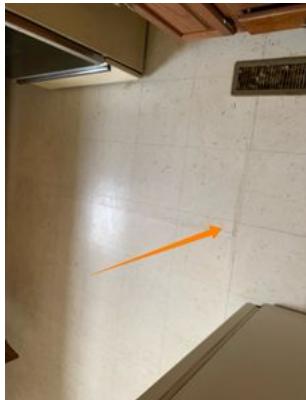
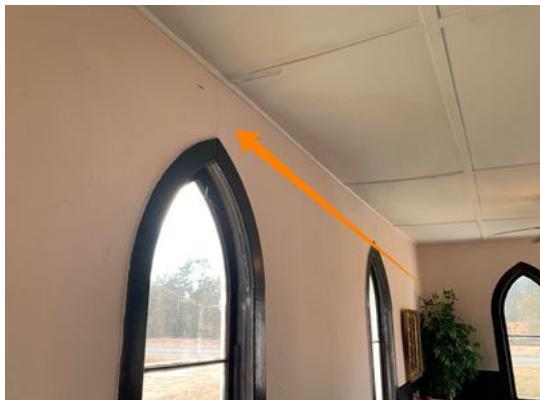
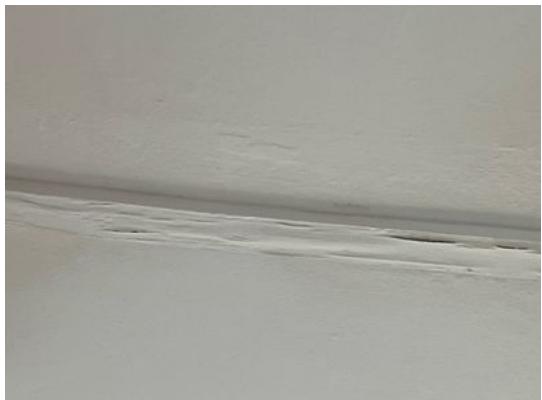
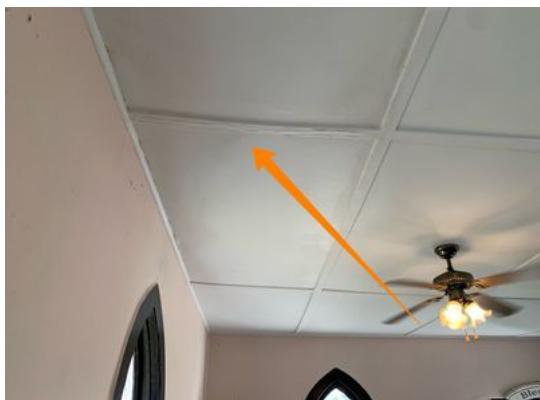
Comment 50

There are a couple areas where the drywall or the flooring has been damaged.

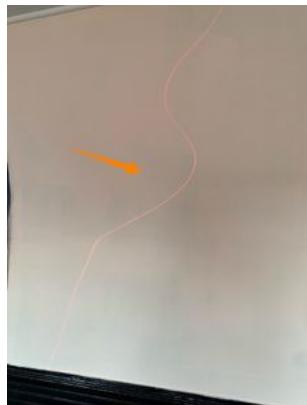
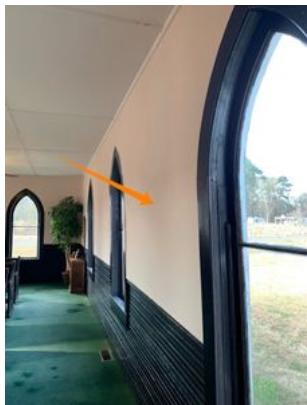
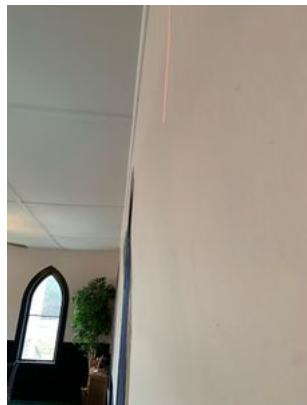
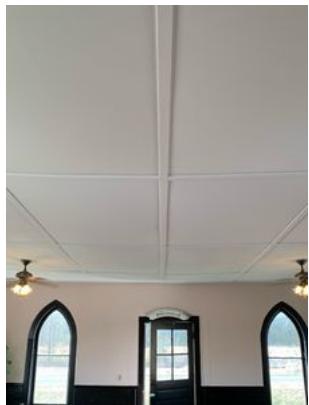
Comment 51

There are two areas where the ceiling or the wall is bowing. On the left side of the sanctuary the wall is bulging out a good deal as can be seen in the picture with the laser level. This area was firm at the time of the inspection, and there was no signs of any bowing or undue stress on the structure either in the crawlspace, the exterior or the attic of the structure at the time of the inspection. If there are further concerns or for more information, would recommend having a specialist come out and assess the specific area.

There's also bowing in the ceiling of the sanctuary. This looks to be the result of insulation laying directly on top of the drywall and the drywall not having proper support. It looks like the drywall of the ceiling has only been nailed along the edge of the sheet into the studs rather than 4 to 6 times along each stud in order stop to keep it flat against the ceiling.

For more information or further concerns, we recommend asking owner for more information first before having a specialist come out and assess.
