Residential Solutions
7067673336

Home Inspection Report Sample

Inspected By: Christopher Cooke
Inspected On Sun, Jan 11, 2026 at 8:00 AM

Church

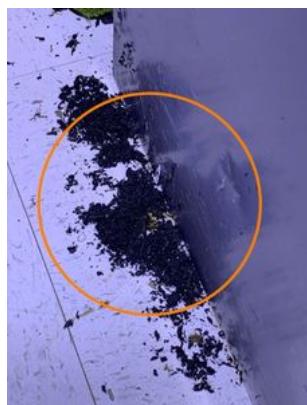
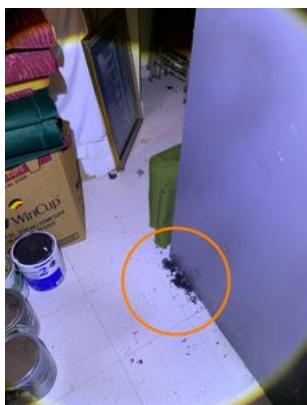
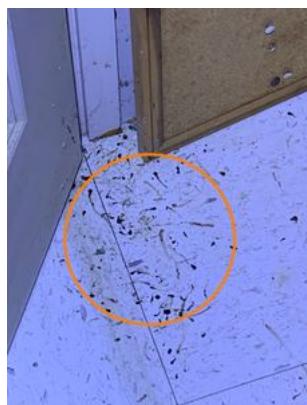
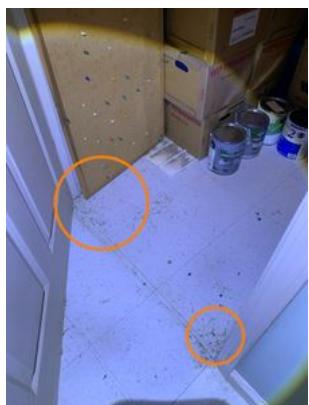
There were potential signs of pest activity on the interior of the structure. Would highly recommend having a pest specialist come out and assess

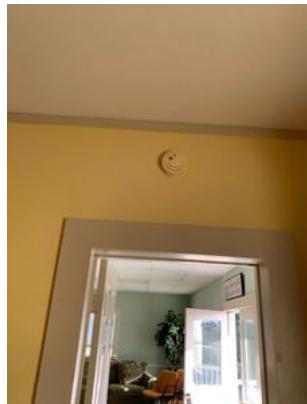
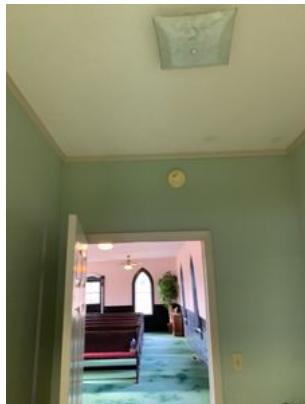
There were no functioning fire alarms at the time of the inspection. Current code for fire alarms is to have a fire alarm within each sleeping area and within 6 feet of the exterior of any individual sleeping area.

It would be best to have AT LEAST a fire alarm within 6 feet of any sleeping area.

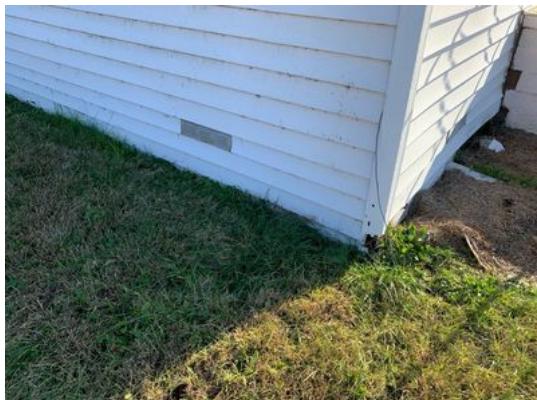
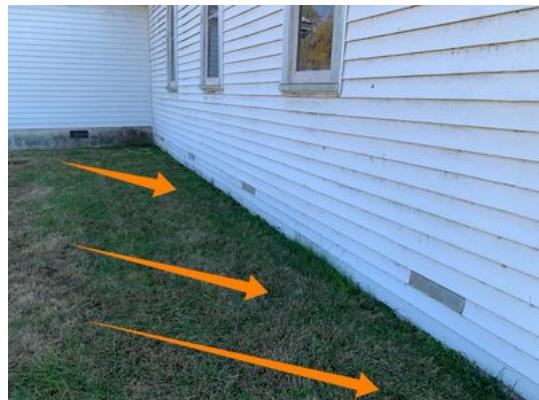
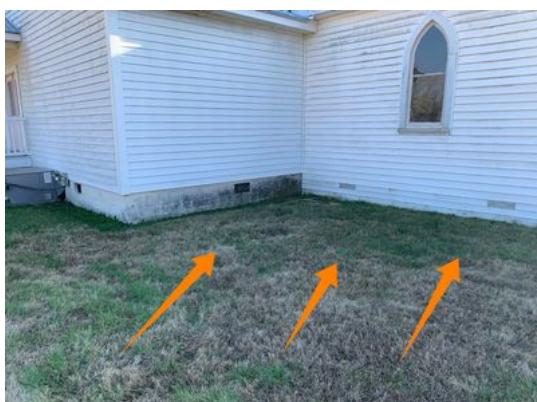
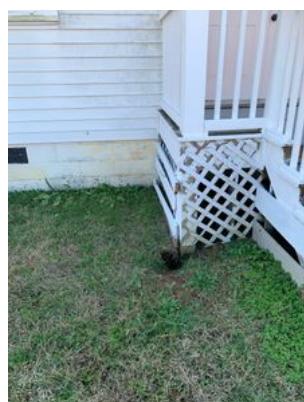
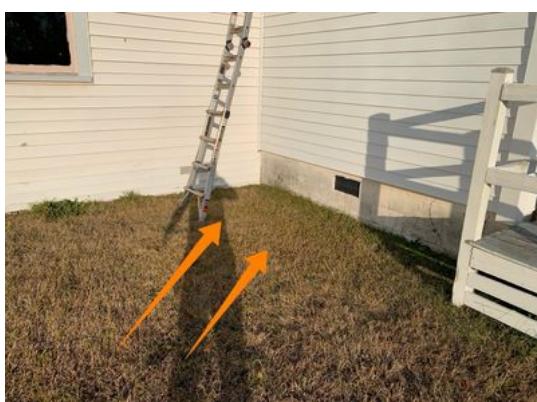
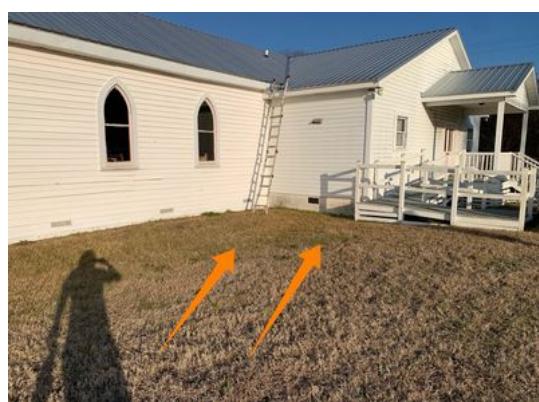
Site: Site Grading

The grading slopes toward the structure and will not shed water away properly. This is a common cause of wet crawl spaces and leaking basements. Suggest adding fill dirt at low areas to prevent water from sitting next to home.

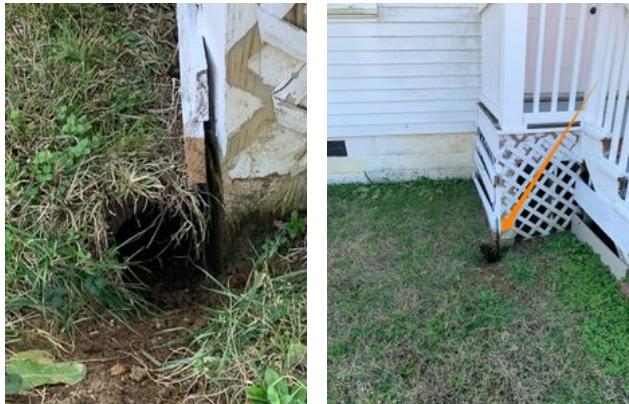
Site: Site Grading

There appears to be a burrow in this area. Would recommend having the critter removed and the hole filled.

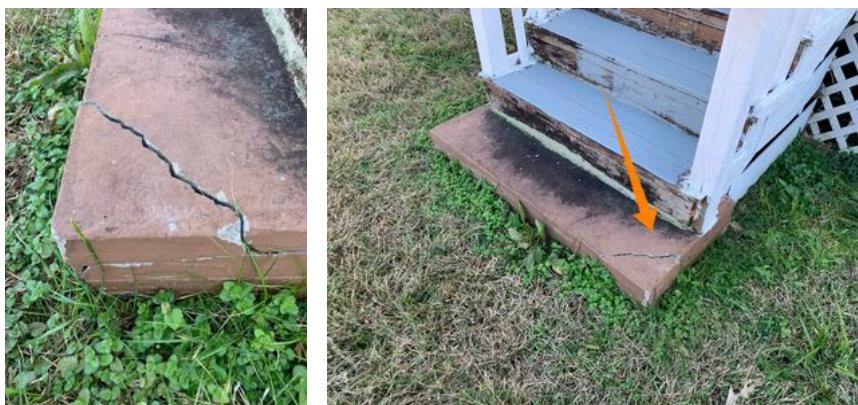
Site: Steps/Stoops

The concrete is broken and broken up along the steps/stoop area in multiple places.

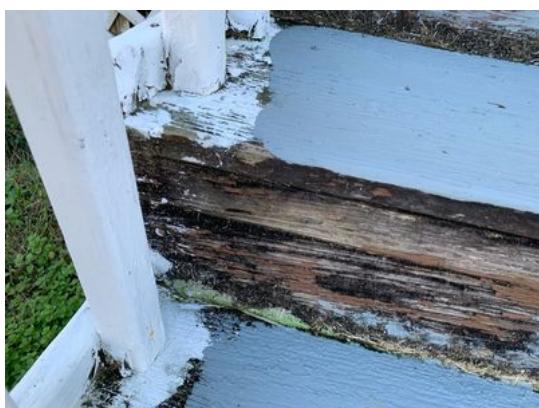
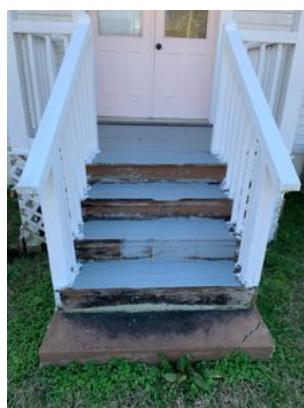
Site: Patios/Decks

There are several areas where the wood may need to be repaired or replaced on the back deck. Would recommend pressure washing and reseal the back deck after these repairs are made.

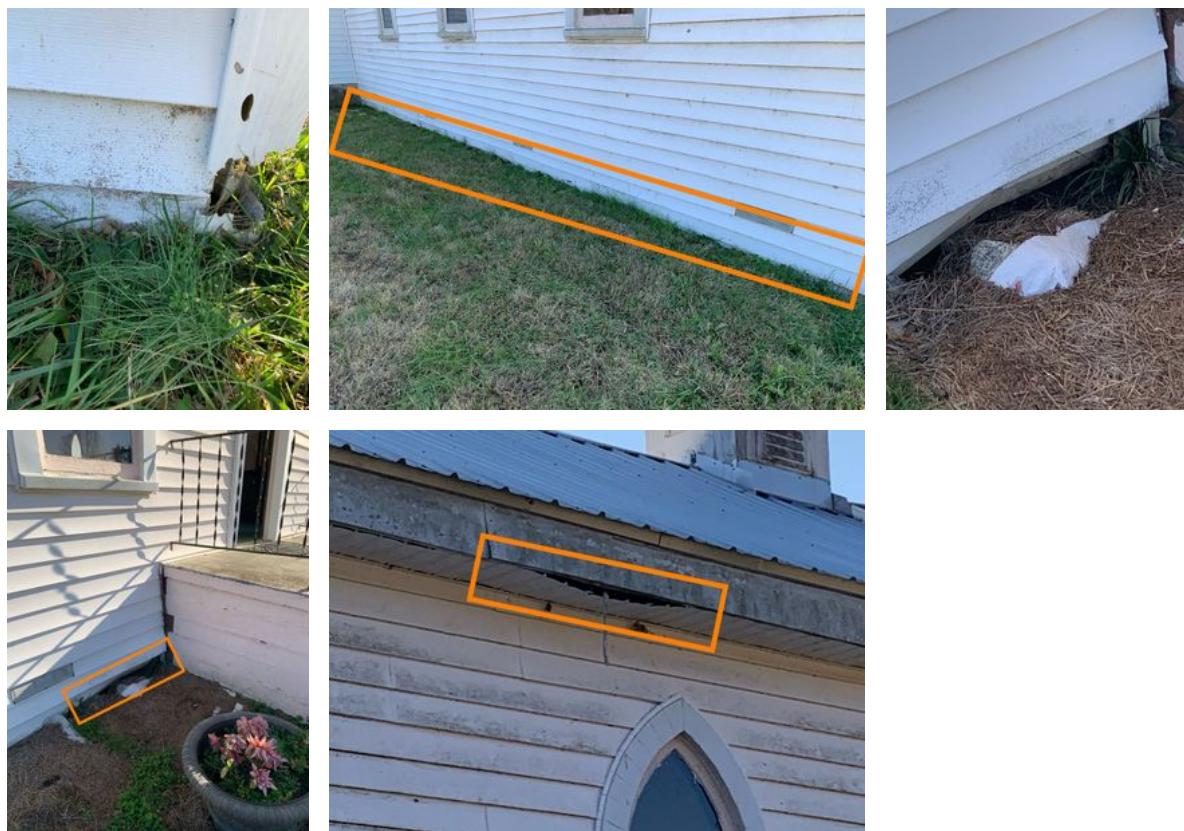
Exterior: Exterior Covering

There are several places where the vinyl siding or trim has been damaged. Would recommend having all penetration sealed in order to prevent pest or moisture from affecting the interior of the structure.

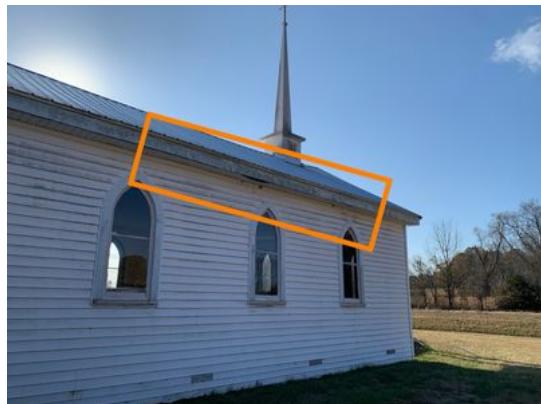
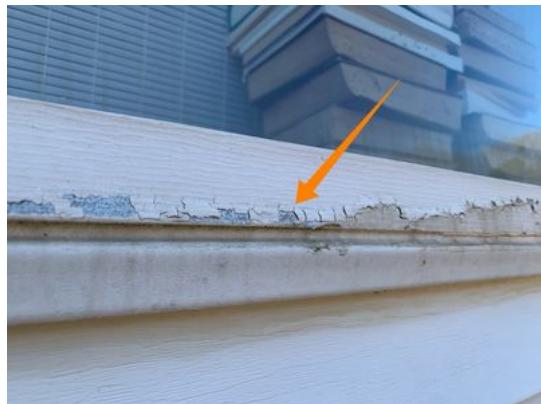
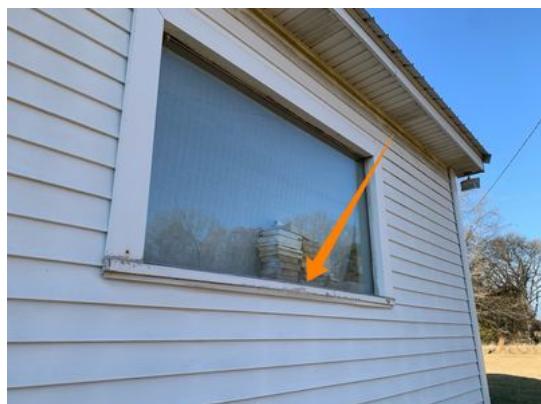
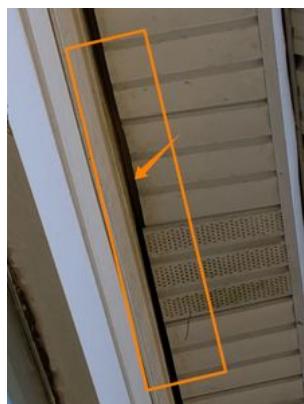
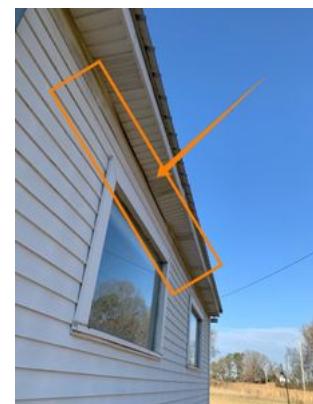
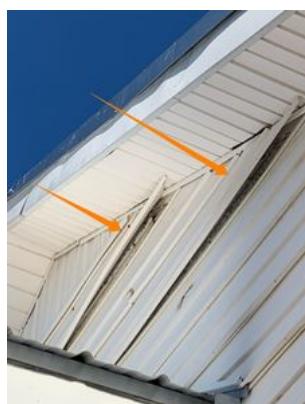
Exterior: Exterior Trim Material

There are places along the entire exterior where the trim need to be repaired, caulked and repainted.

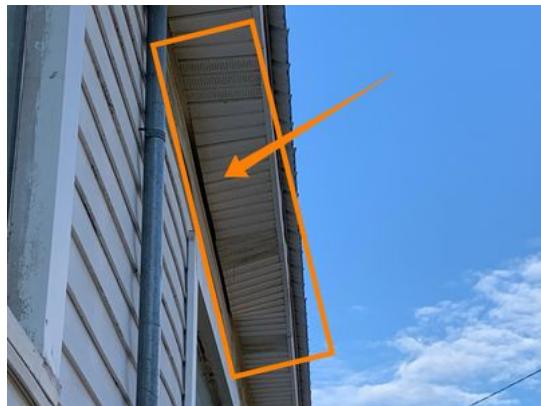
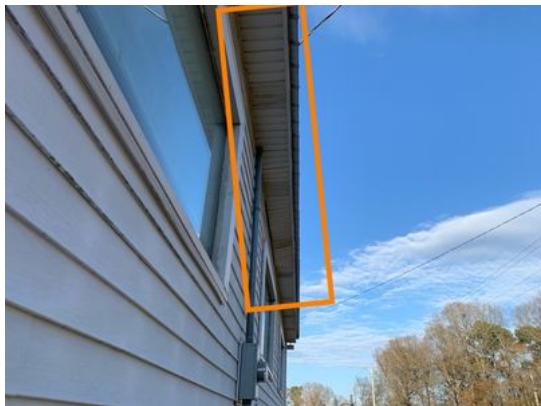
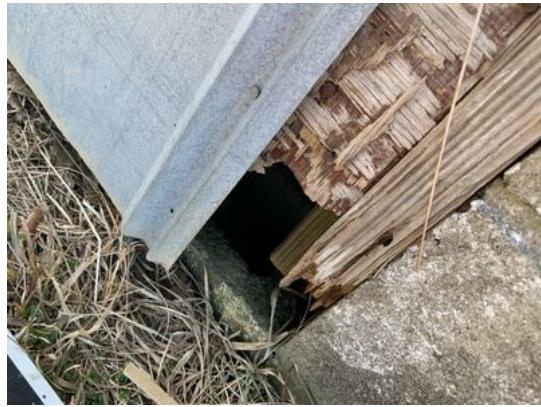
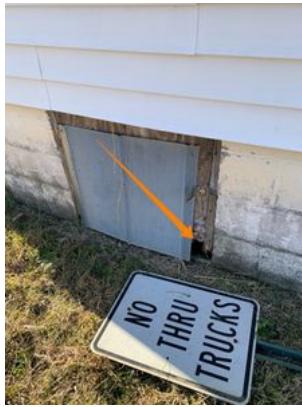
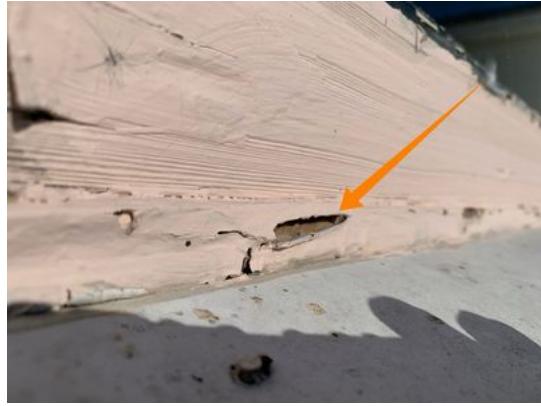
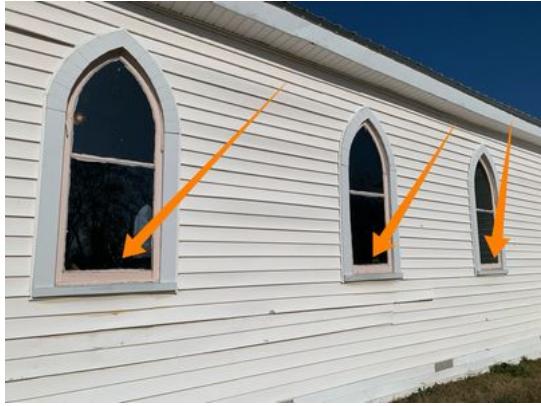
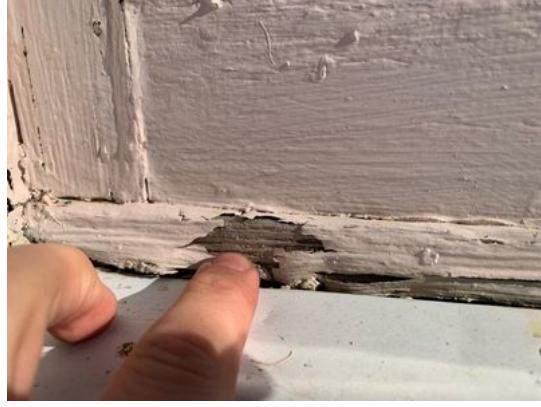
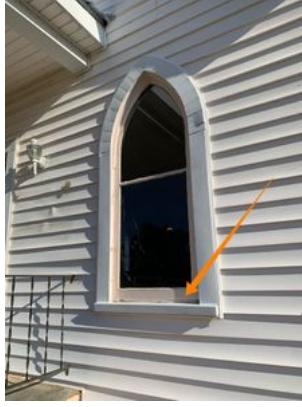
These pictures are for reference to the areas and types of repairs that may be needed. They are not exhaustive. Make sure to have your contractor sweep the entire exterior.

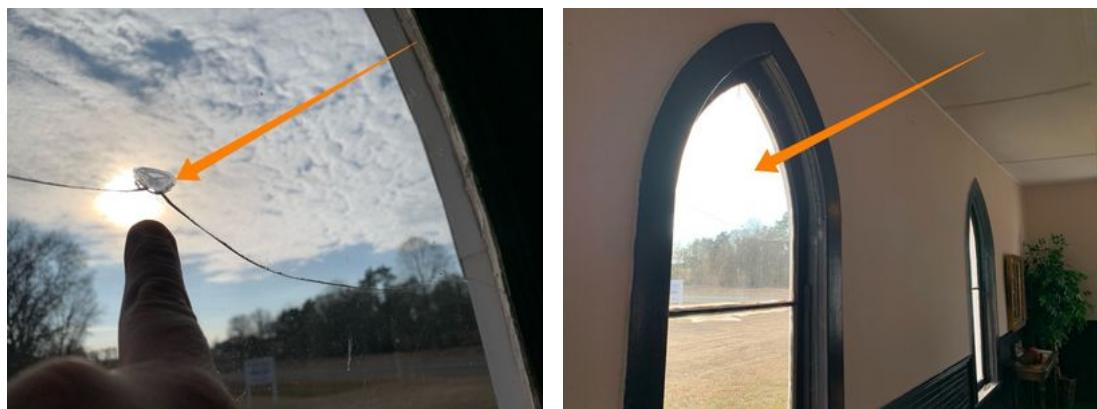
Exterior: Windows

This glass is broken and needs to be repaired by a local window company.

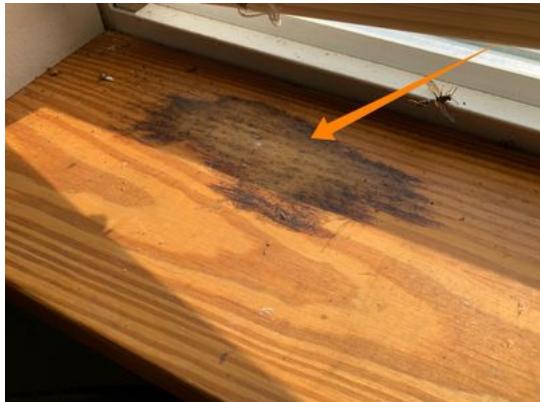
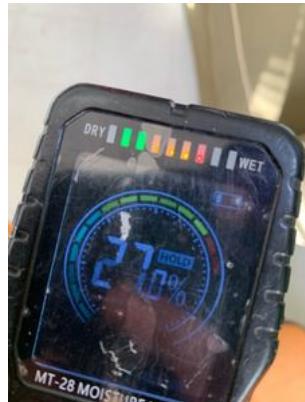
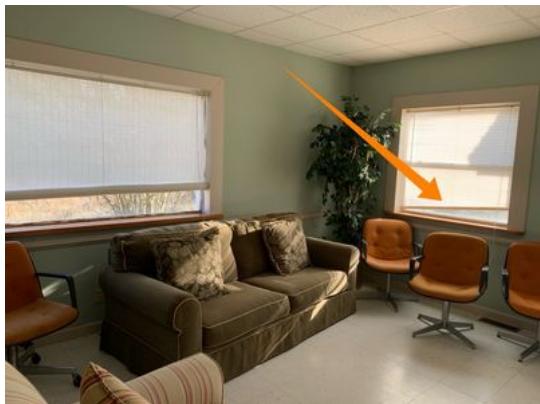
Exterior: Windows

There are water stains on the interior sill of this window. These things registered with high moisture at the time of the inspection and applying a current leak. Would recommend having this area repaired by a contractor.

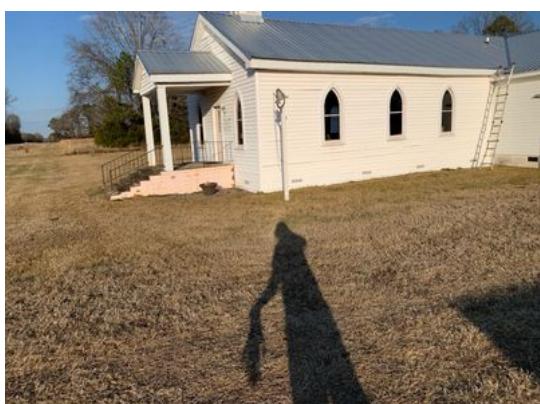
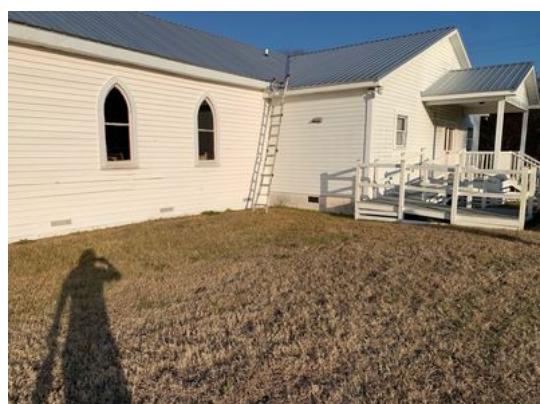
Roofing: Gutters & Downspouts

There are no gutters on the exterior of the structure. Gutters are the first line defense for keeping moisture out of the crawlspace and basement and water away from the structure of the home.

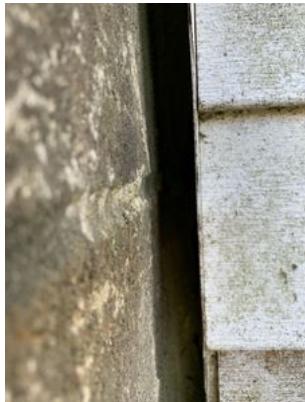
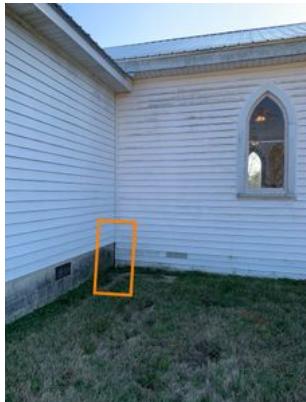
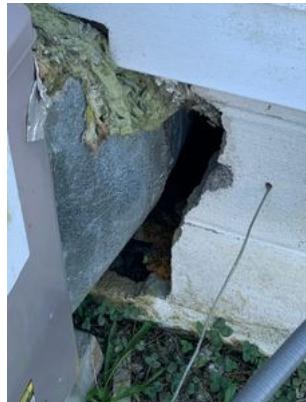
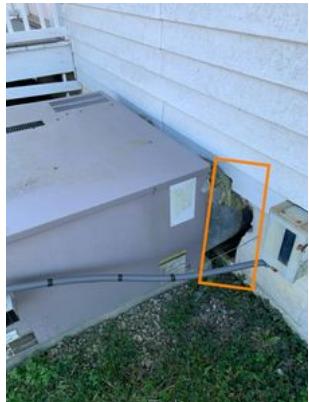
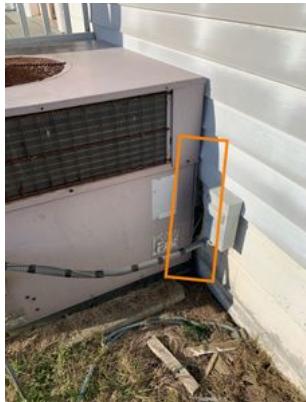
Structure

There are some gaps around the exterior structure that would recommend having filled in order to prevent pest or critters from entering.

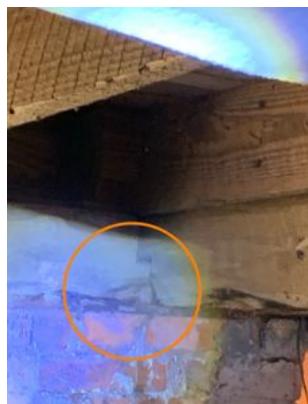
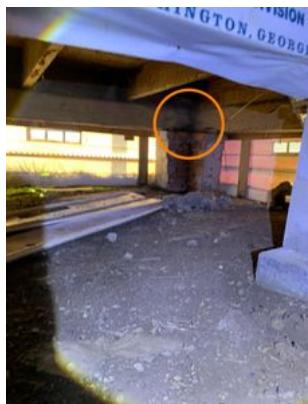
Structure

There are a couple areas where it would appear. There is moisture, making it to the skirt board of the structure. Would highly recommend having these areas repair repaired in order to prevent any further moisture damage.

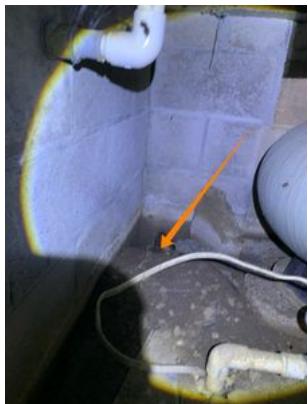
Structure

At the entrance to the crawlspace, there appears to be a burrow or some sort of large hole off to the left-hand side in the corner. Would recommend having this filled as it runs underneath the footer.

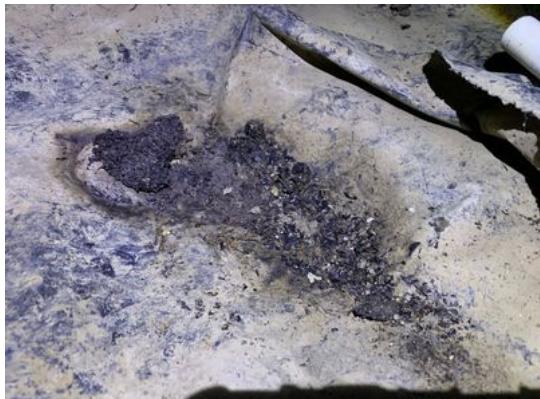
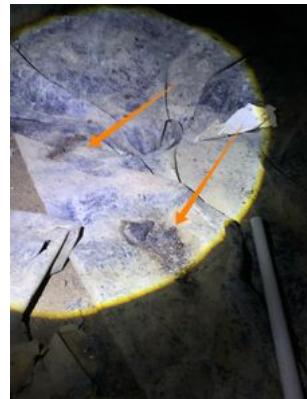
Structure

There are some signs of pest activity in the crawlspace. Would recommend having a pest specialist come out and assess for treatment.

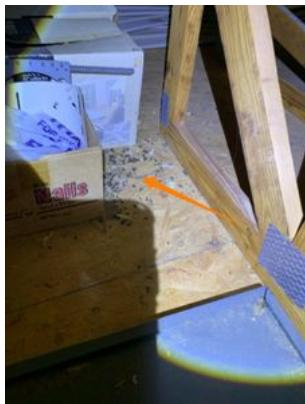
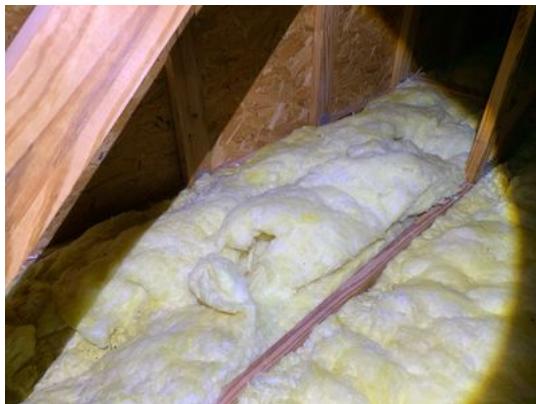
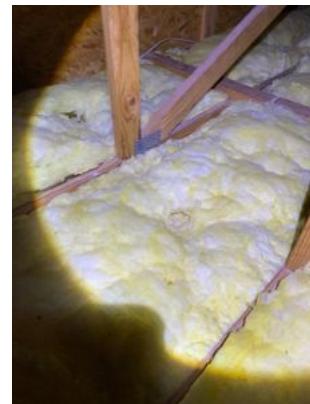
Structure: Attic

There are some signs of rodent activity in the attic space at the time of the inspection.

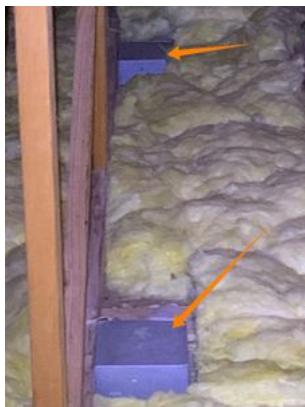
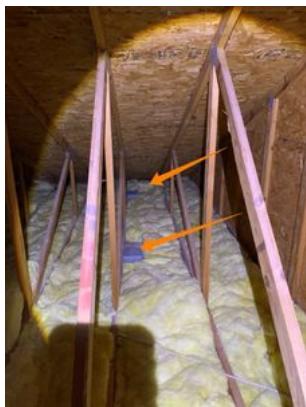
Structure: Attic

The bathroom vents vent directly into the attic space. It would be best for these to vent to the exterior of the structure.

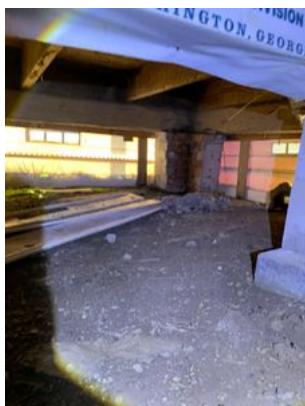
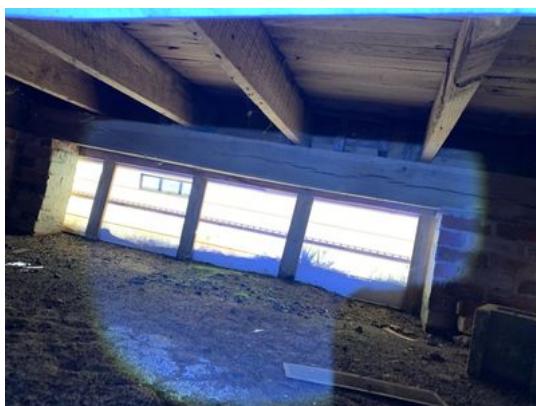
Structure: Crawlspace: Vapor Retarder

There is a poor barrier installed in the crawlspace. A minimum of 90% of the grounds in the crawlspace should be covered in order to control moisture buildup in the crawlspace and prevent mold, mildew and fungal growth.

We had high moisture readings in the crawlspace, as well as fungal growth in multiple areas.

Most moisture issues can be dealt with proper ventilation and a vapor barrier. Would highly recommend having a vapor barrier installed.

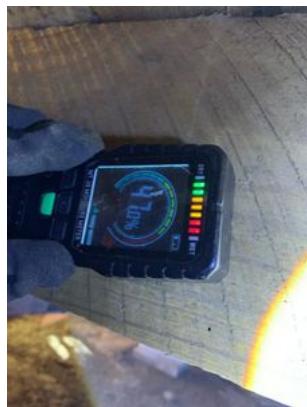
Structure: Crawlspace: Moisture Condition

There were high moisture readings in the crawlspace at the time of the inspection.

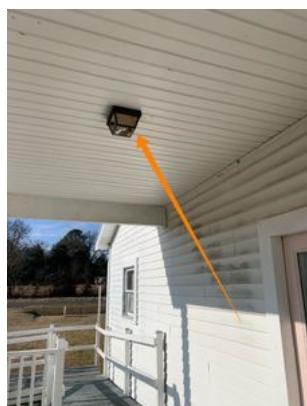
Electrical

This light did not come on at the time of the inspection. Most likely just needs a new bulb, but we would recommend having the owners verify the functionality of the fixture before closing.

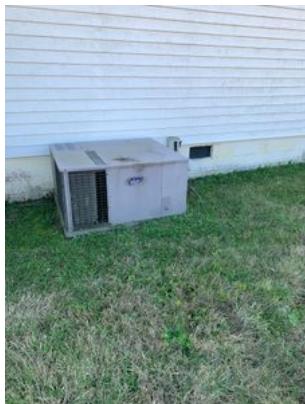
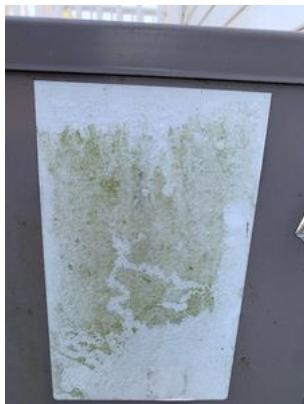
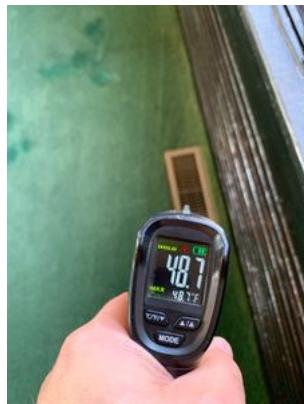
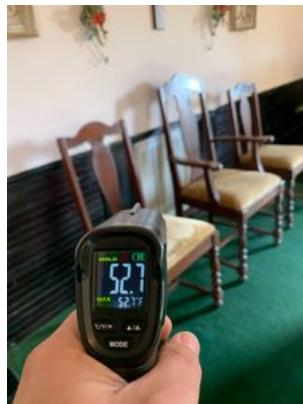
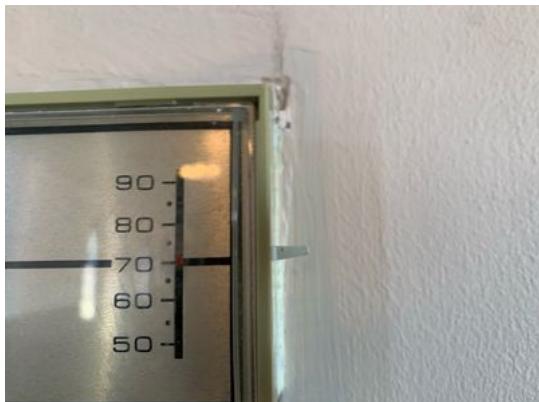
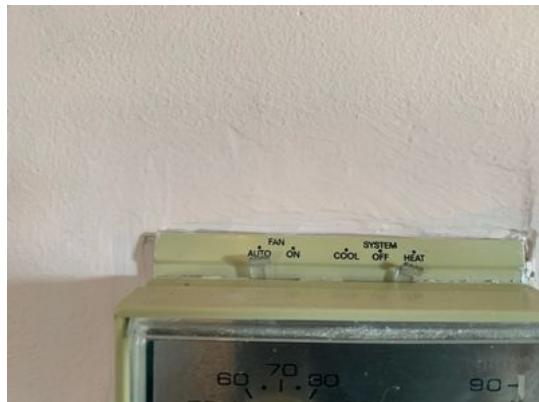
The AC unit for the sanctuary area was not functioning at the time of the inspection. The ID plate was not legible at the time of the inspection either. I was unable to get cold or hot air from the unit. It is an AC/furnace combo. Would recommend having a licensed HVAC specialist come out and assess.

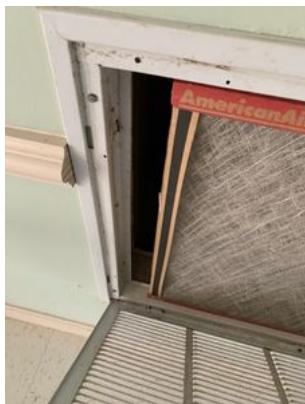
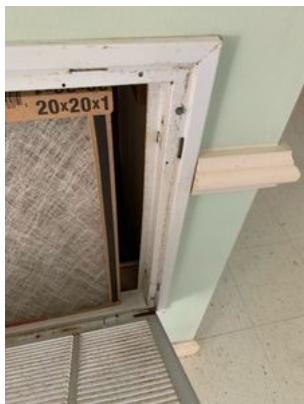
HVAC

The current return does not have a properly sized filter.

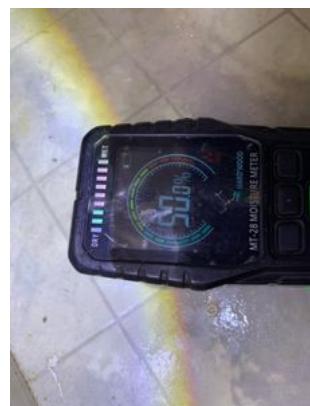
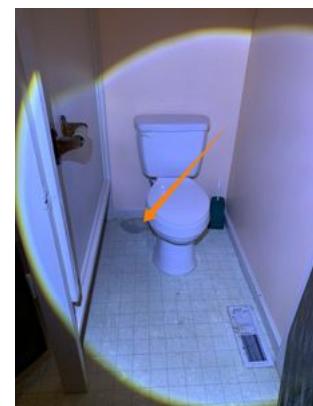
Bathrooms: Half Bath #2

There it appears to be an active water leak in the women's bathroom around this toilet area. I was not able to access this area from the crawlspace at the time of the inspection due to the HVAC ductwork runs. Would highly recommend having this area assessed and repair repaired.

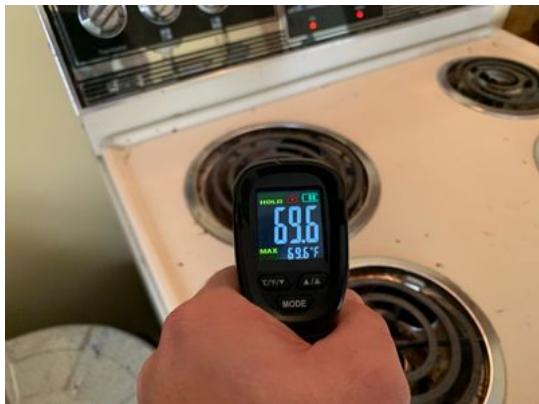
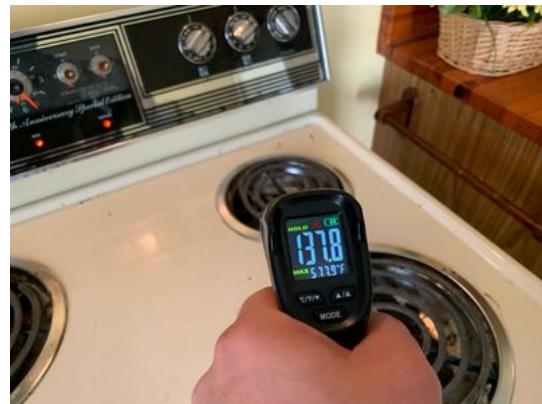
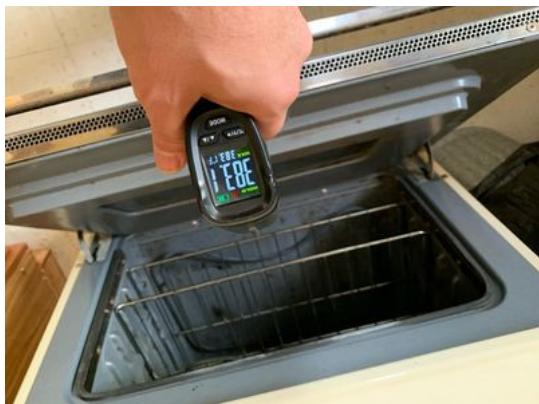
Two of the burners are not functional on the stove at the time of the inspection.

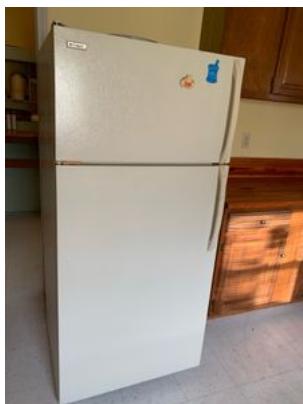
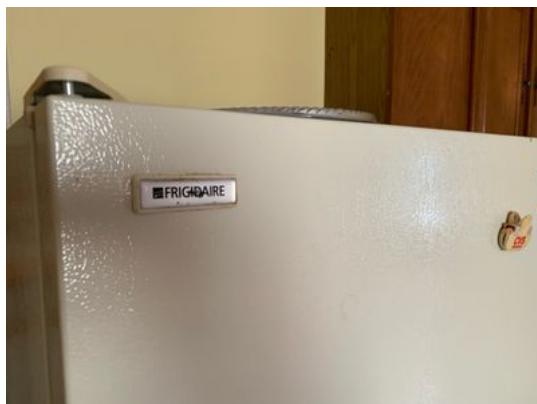
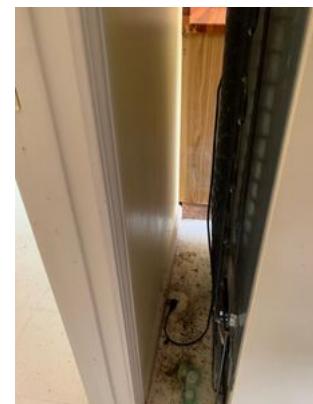
Kitchen: Appliances: Refrigerator

The refrigerator had been unplugged for some time and there was food on the interior. Would highly recommend having cleaned and tested if intending on getting any further use out of the unit.

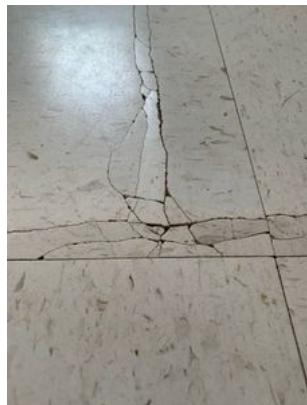
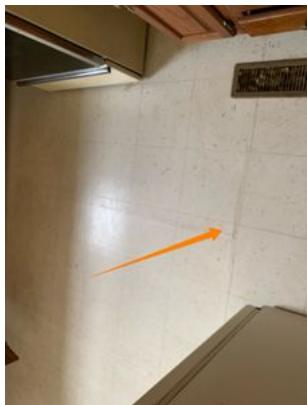
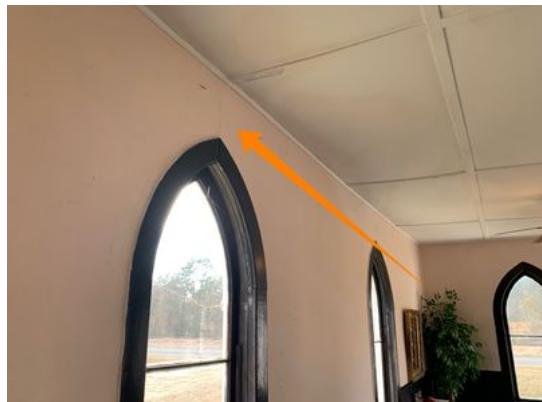
Interior

There are a couple areas where the drywall or the flooring has been damaged.

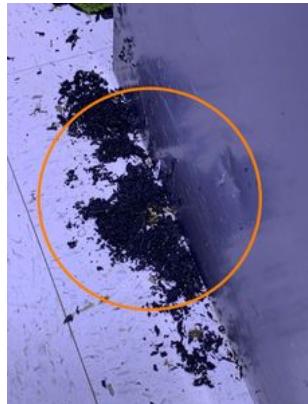
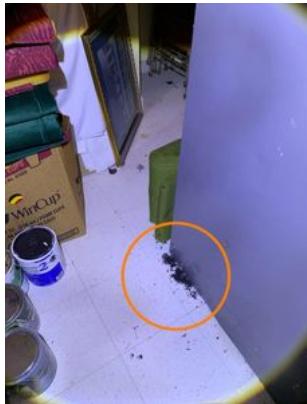
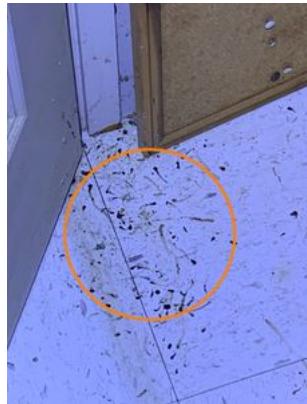
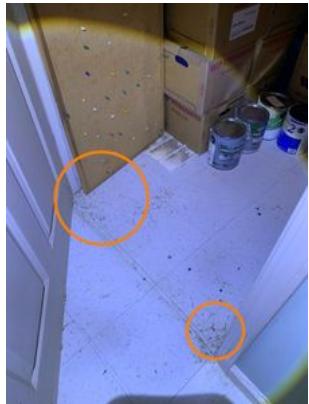
Interior

There were potential signs of pest activity on the interior of the structure. Would highly recommend having a pest specialist come out and assess
