HOME CONDITION AUDIT REPORT (SNAGGING)

Mr. Client Name
Project Name
Project Location

A detailed list of all identified defects within **269, Ixora, Al Barari, Dubai, UNITED KINGDOM** is provided in the Appendix A for reference. Each defect entry includes a description, location and severity level. This comprehensive list serves as a guide to address each issue systematically and ensure the unit meets the required quality standards.

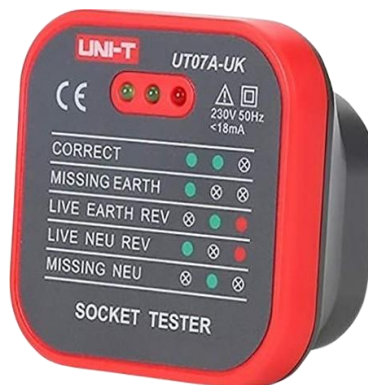
- A thorough visual inspection was conducted, covering both the interior and exterior areas of the property.
- The operational status of essential systems and equipment was visually assessed using specialized tools such as **thermal imaging cameras, moisture meters, hygrometers, socket testers e.t.c.** Some of these tools are displayed below.
