## **Harrison Hot Springs Dike Upgrades**

### **Factual Geotechnical Report**

**Client Name:** Northwest Hydraulic Consultants

**Date:** October 21, 2025

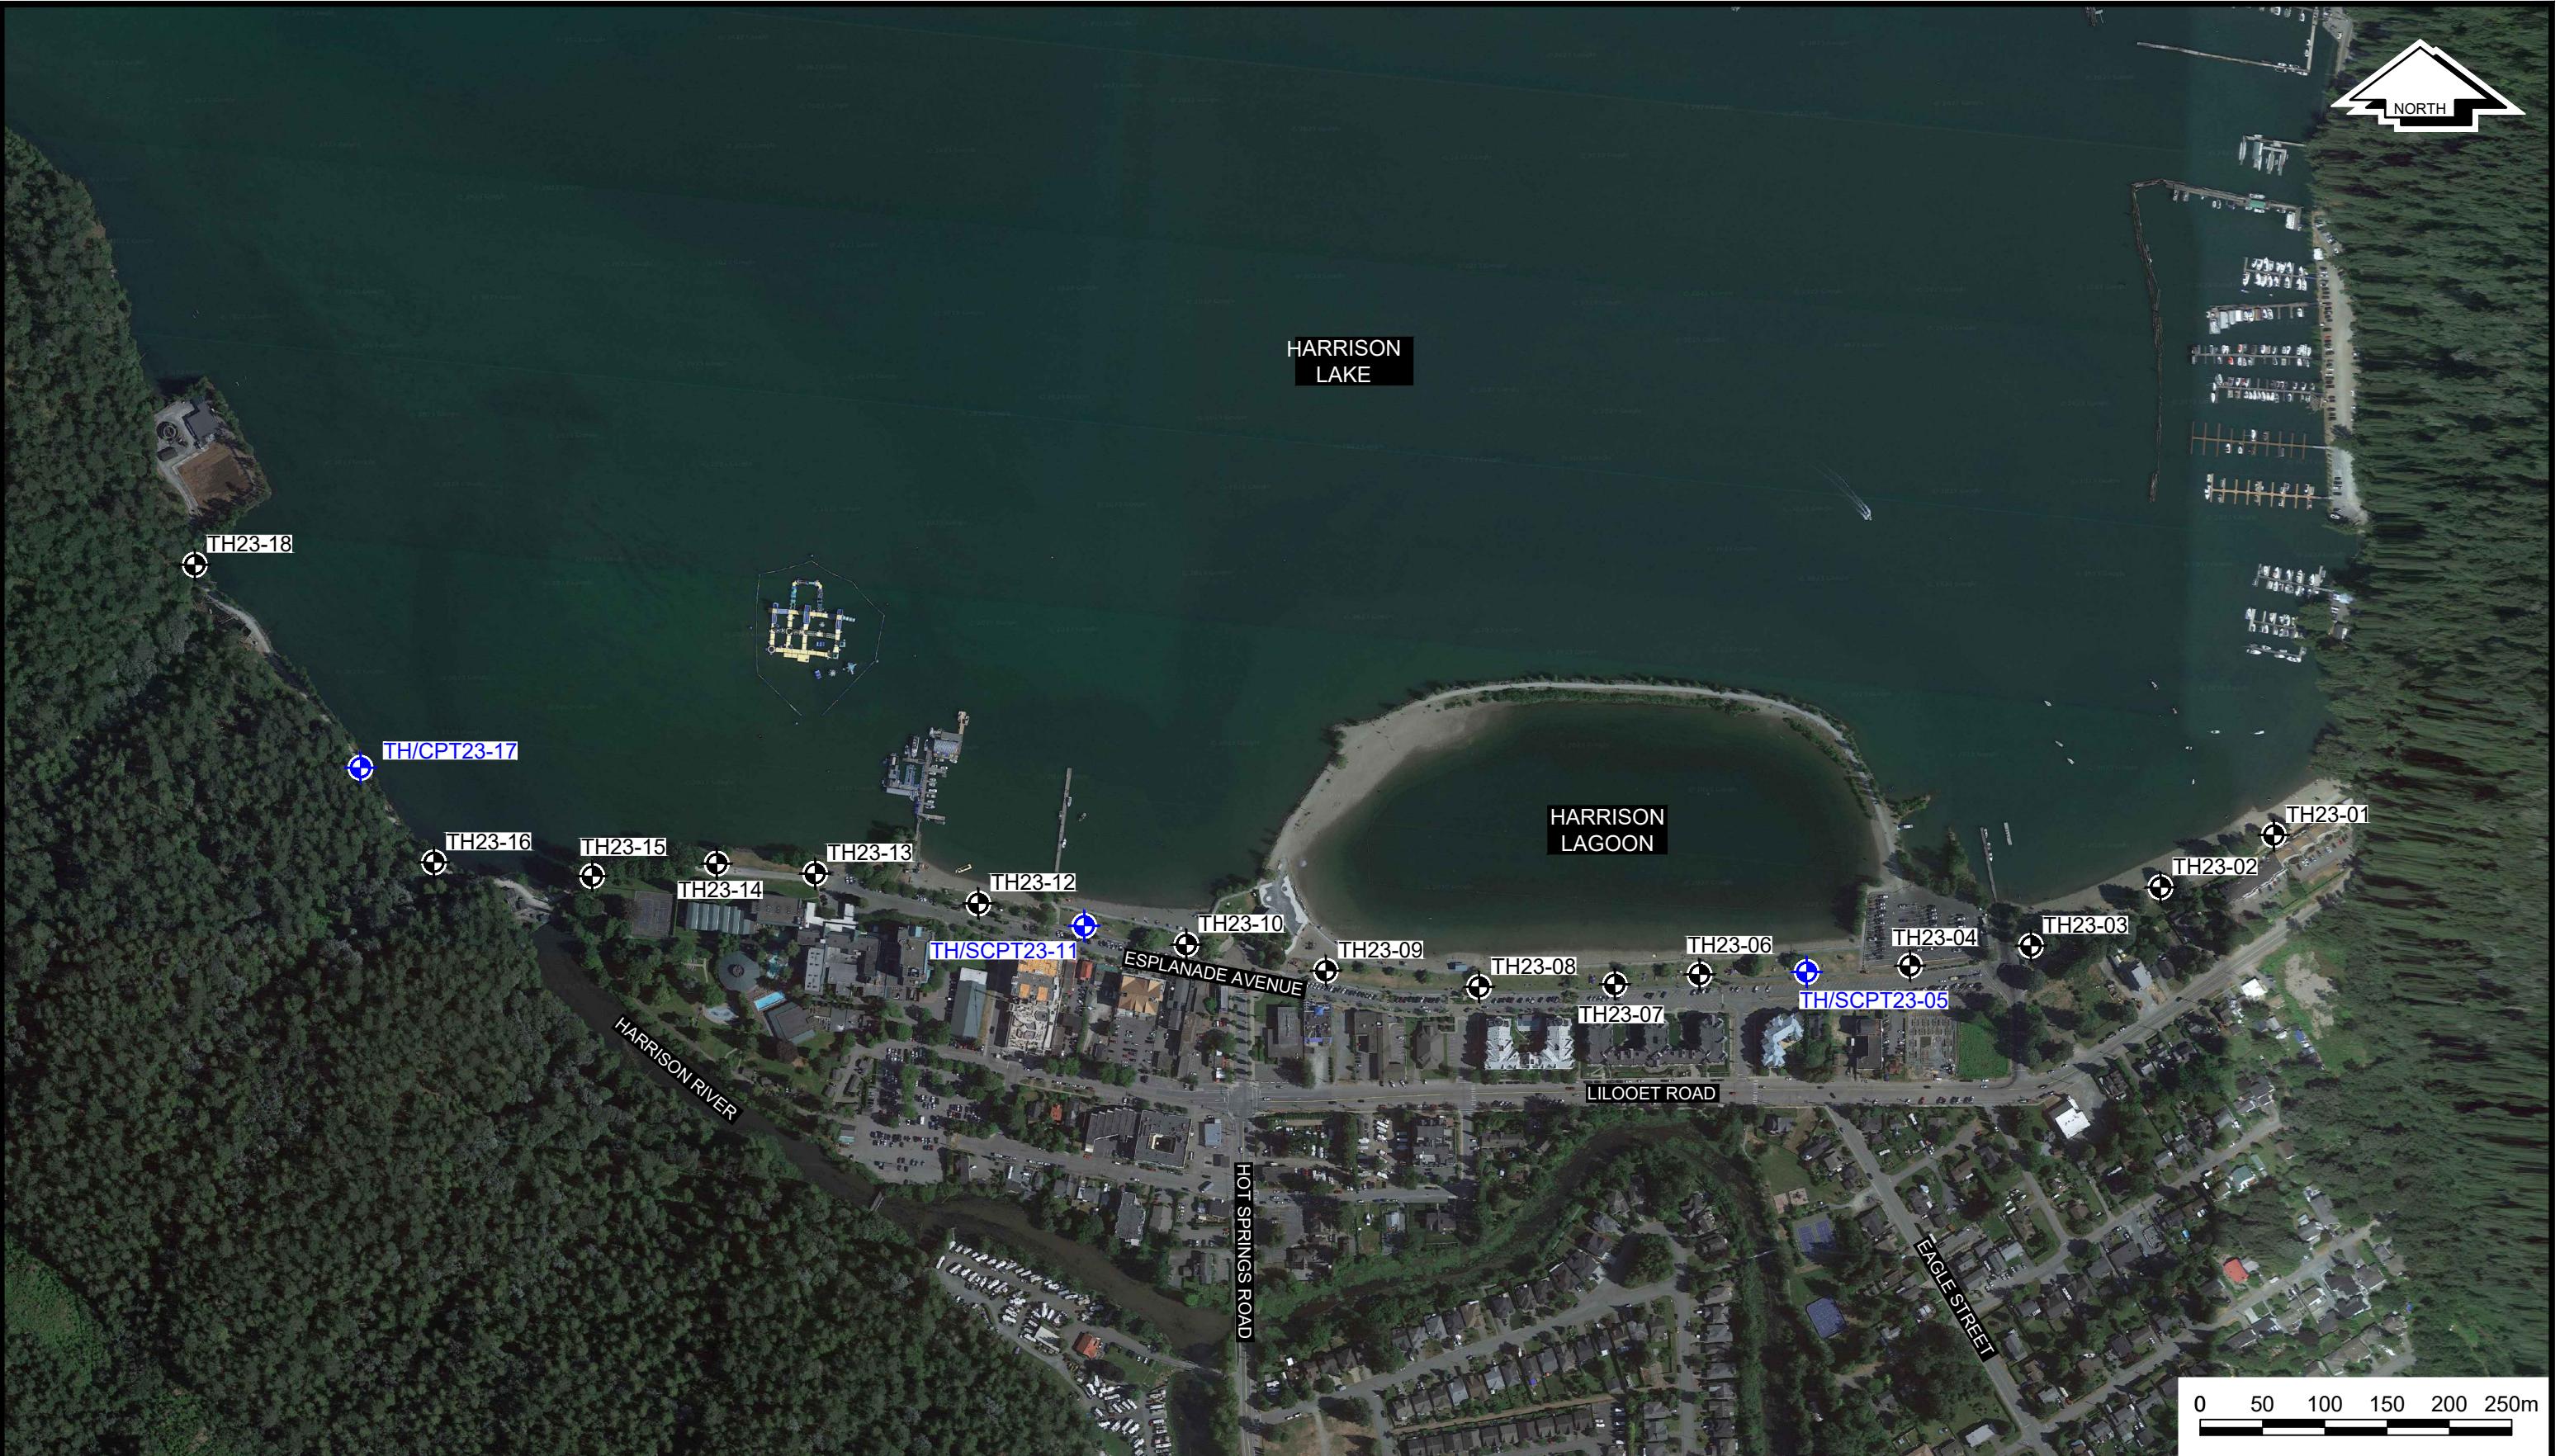
Drawing No. 34701-1

## TEST HOLE LOCATION PLAN

HARRISON LAKE DIKE UPGRADE

**LOCATION:** See DWG. 34701-1  
N 5462005, E 589130 (Est.)

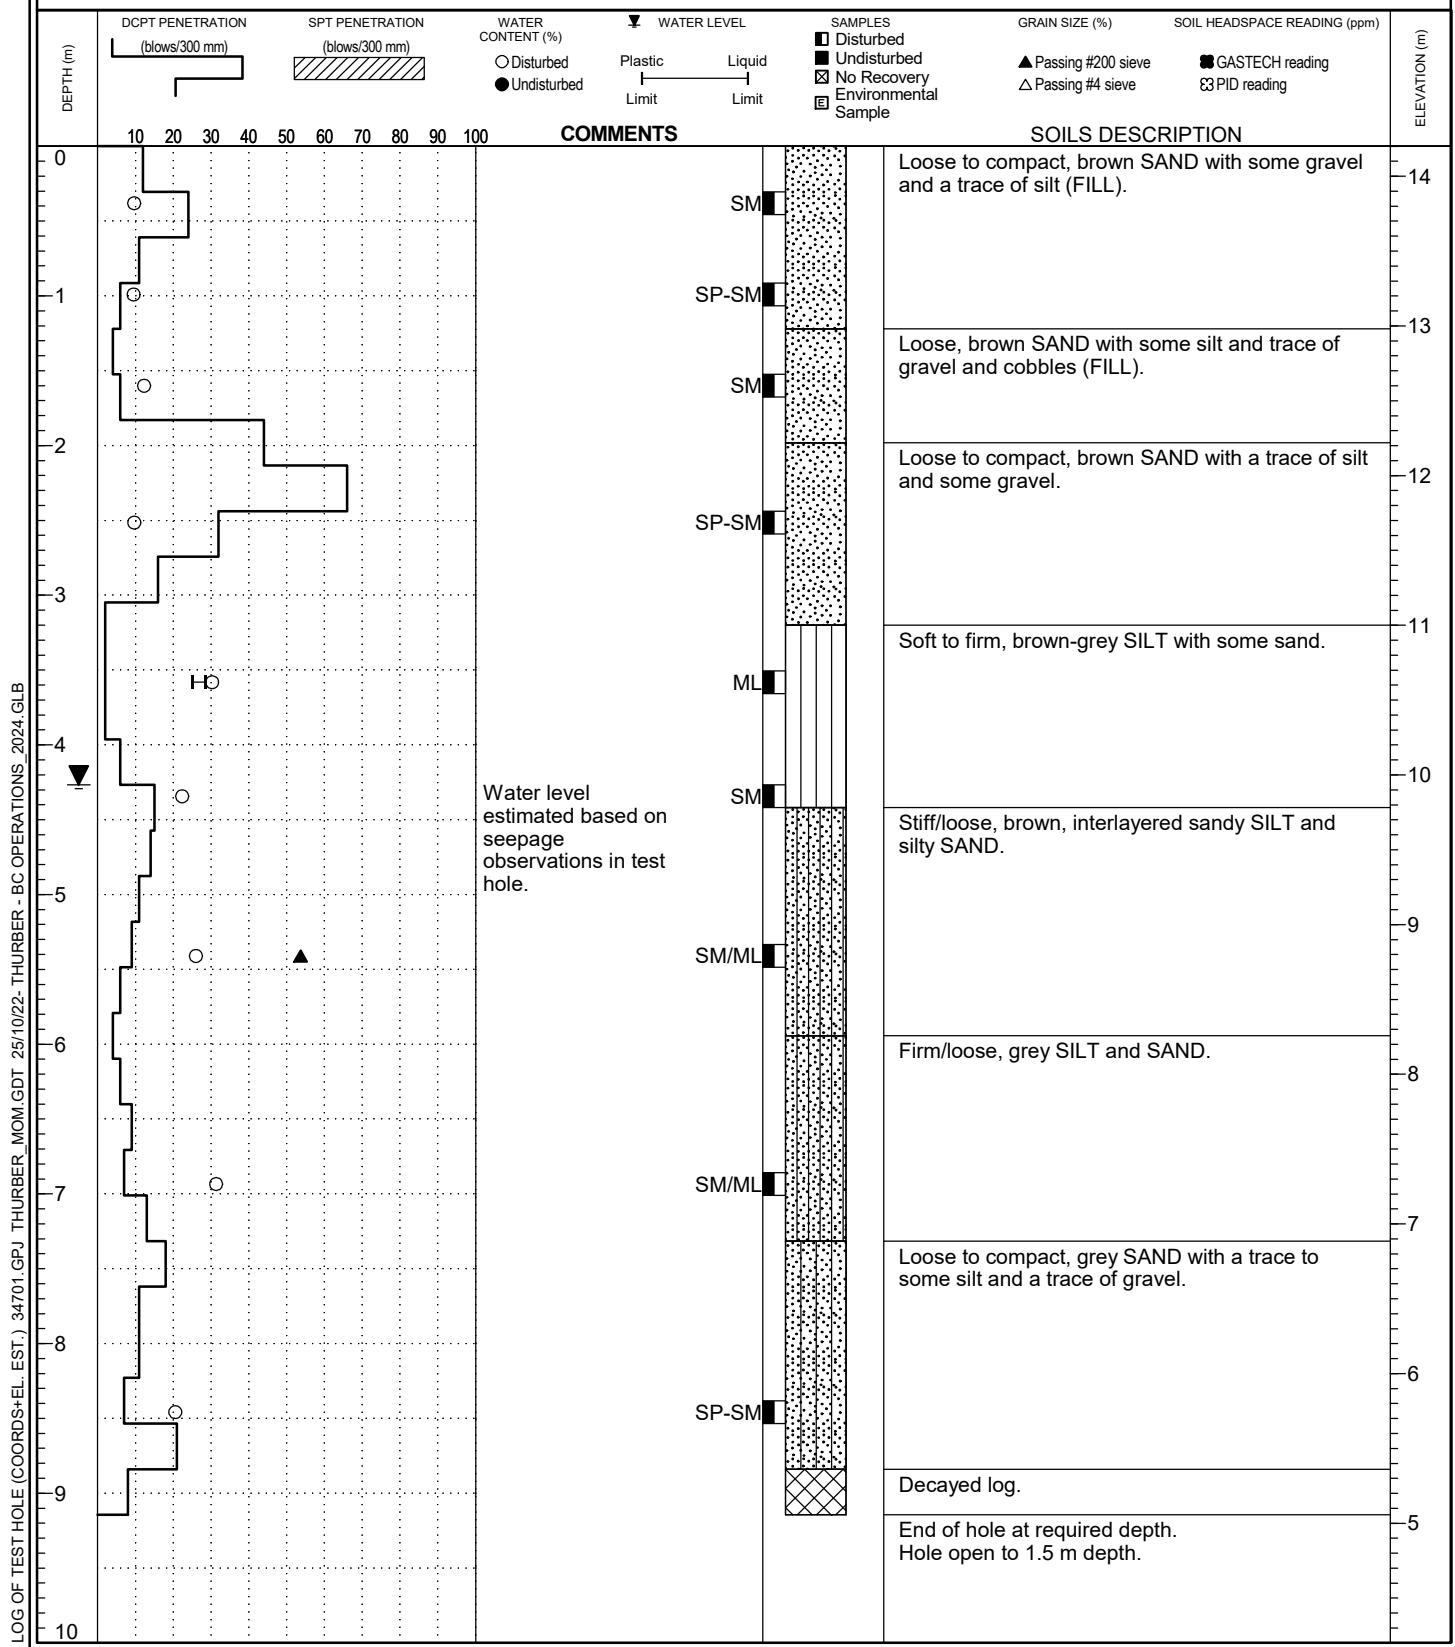
TH23-01

**TOP OF HOLE ELEV:** 14.2 m (Est.)

**METHOD:** Solid Stem Auger/DCPT

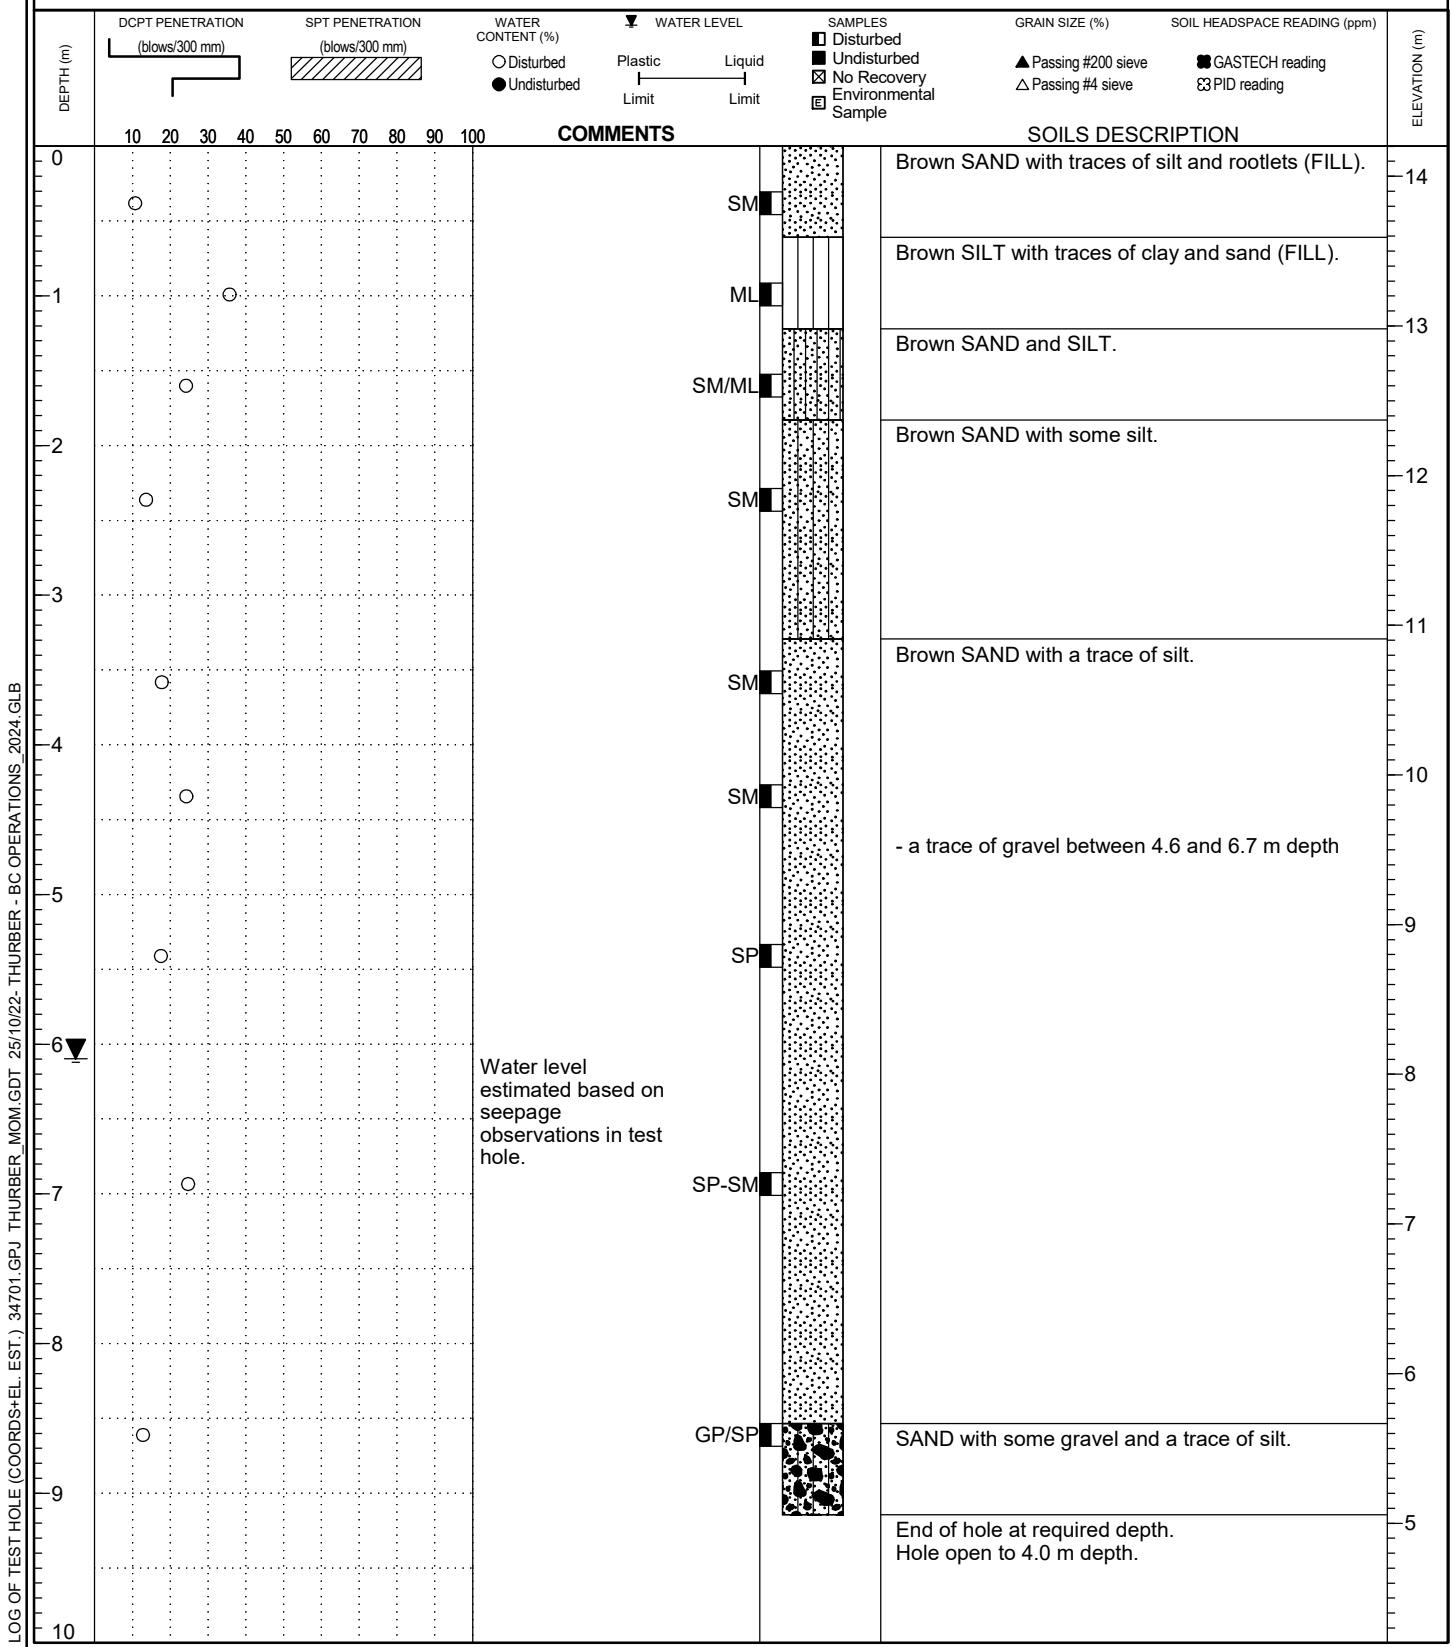
TH23-02

**LOCATION:** See DWG. 34701-1  
N 5461963, E 589039 (Est.)

**TOP OF HOLE ELEV:** 14.2 m (Est.)

**METHOD:** Solid Stem Auger

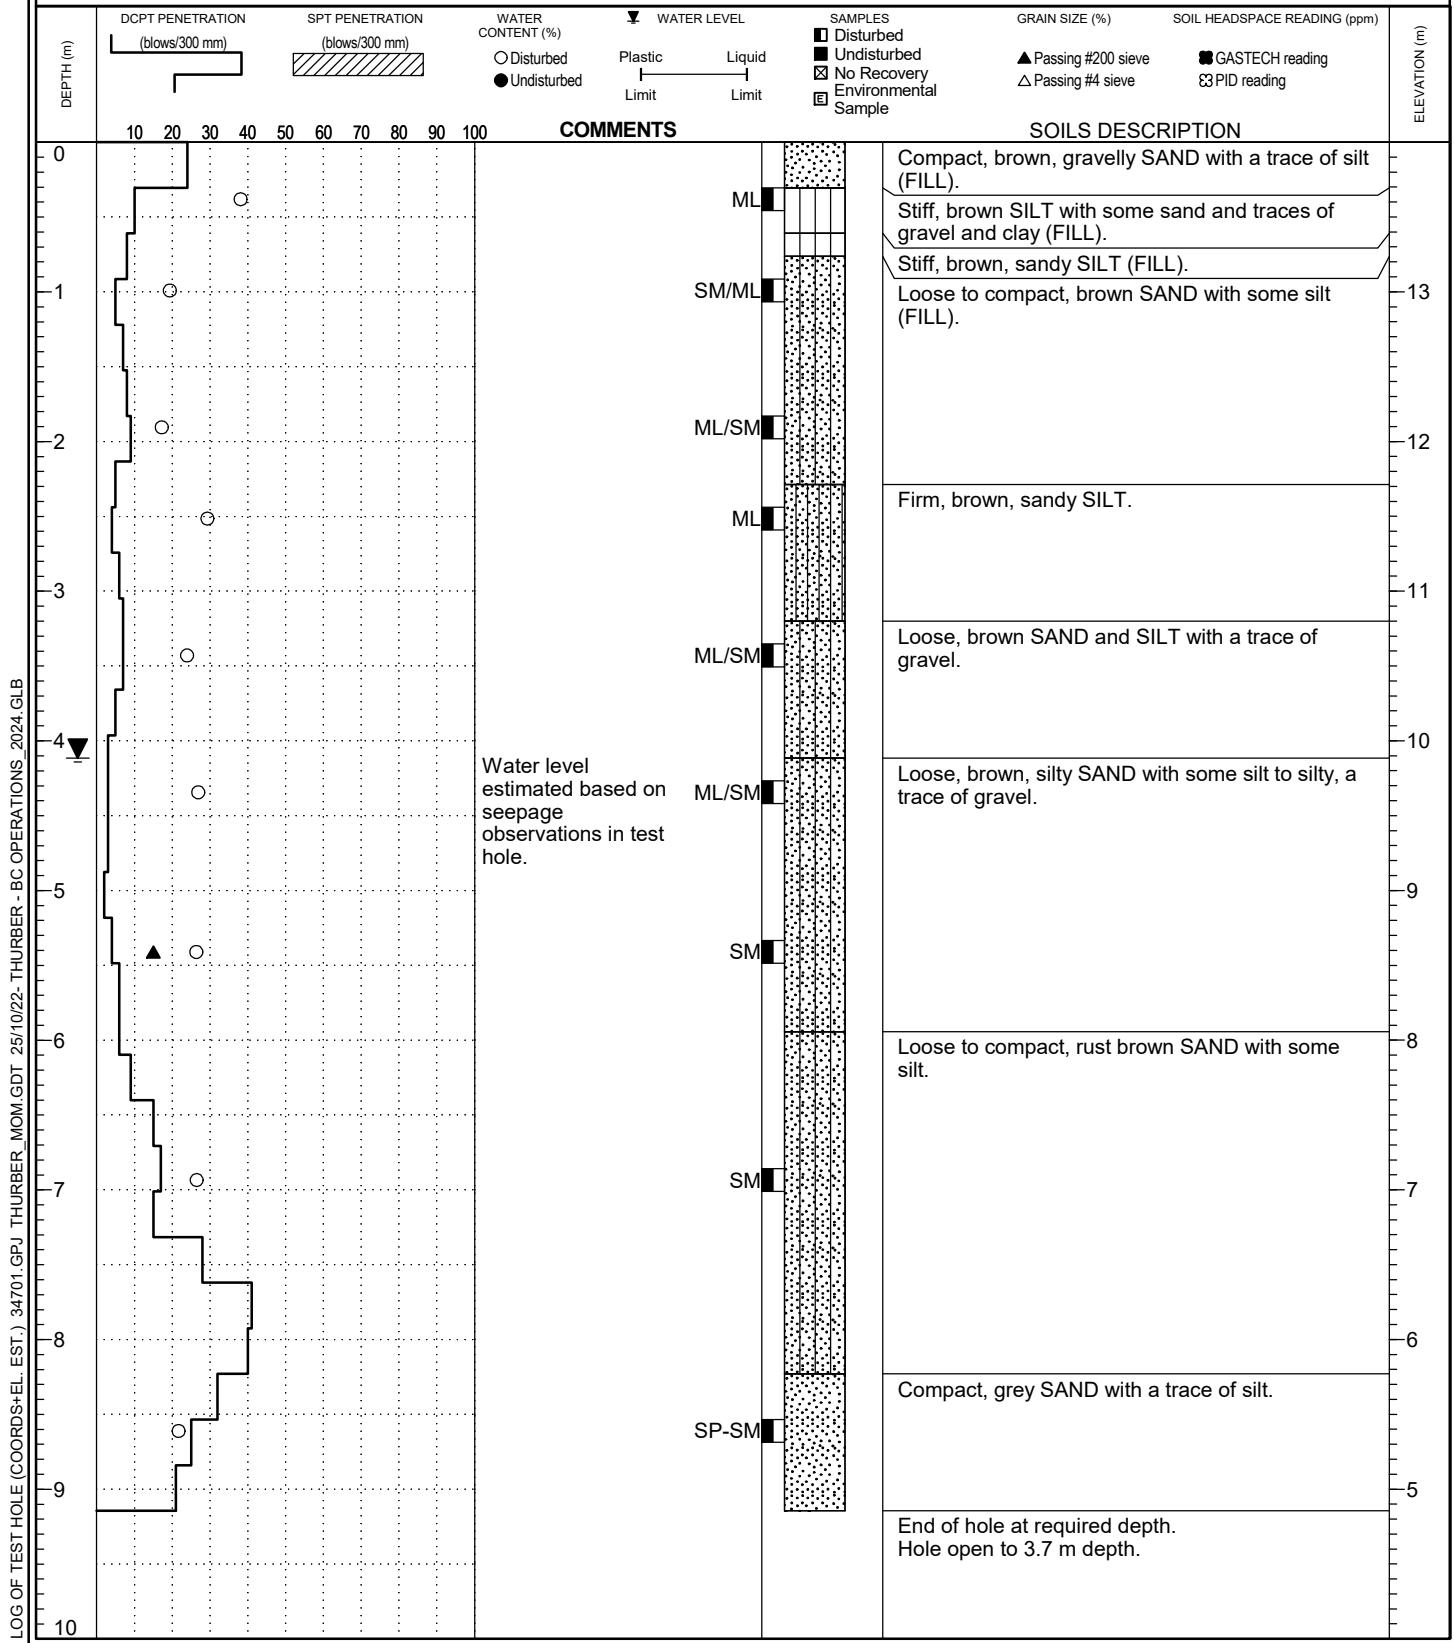
TH23-03

**LOCATION:** See DWG. 34701-1  
N 5461916, E 588935 (Est.)

**TOP OF HOLE ELEV:** 14.0 m (Est.)  
**METHOD:** Solid Stem Auger/DCPT  
**DRILLING CO.:** On-Track Drilling Inc.  
**INSPECTOR:** KTD

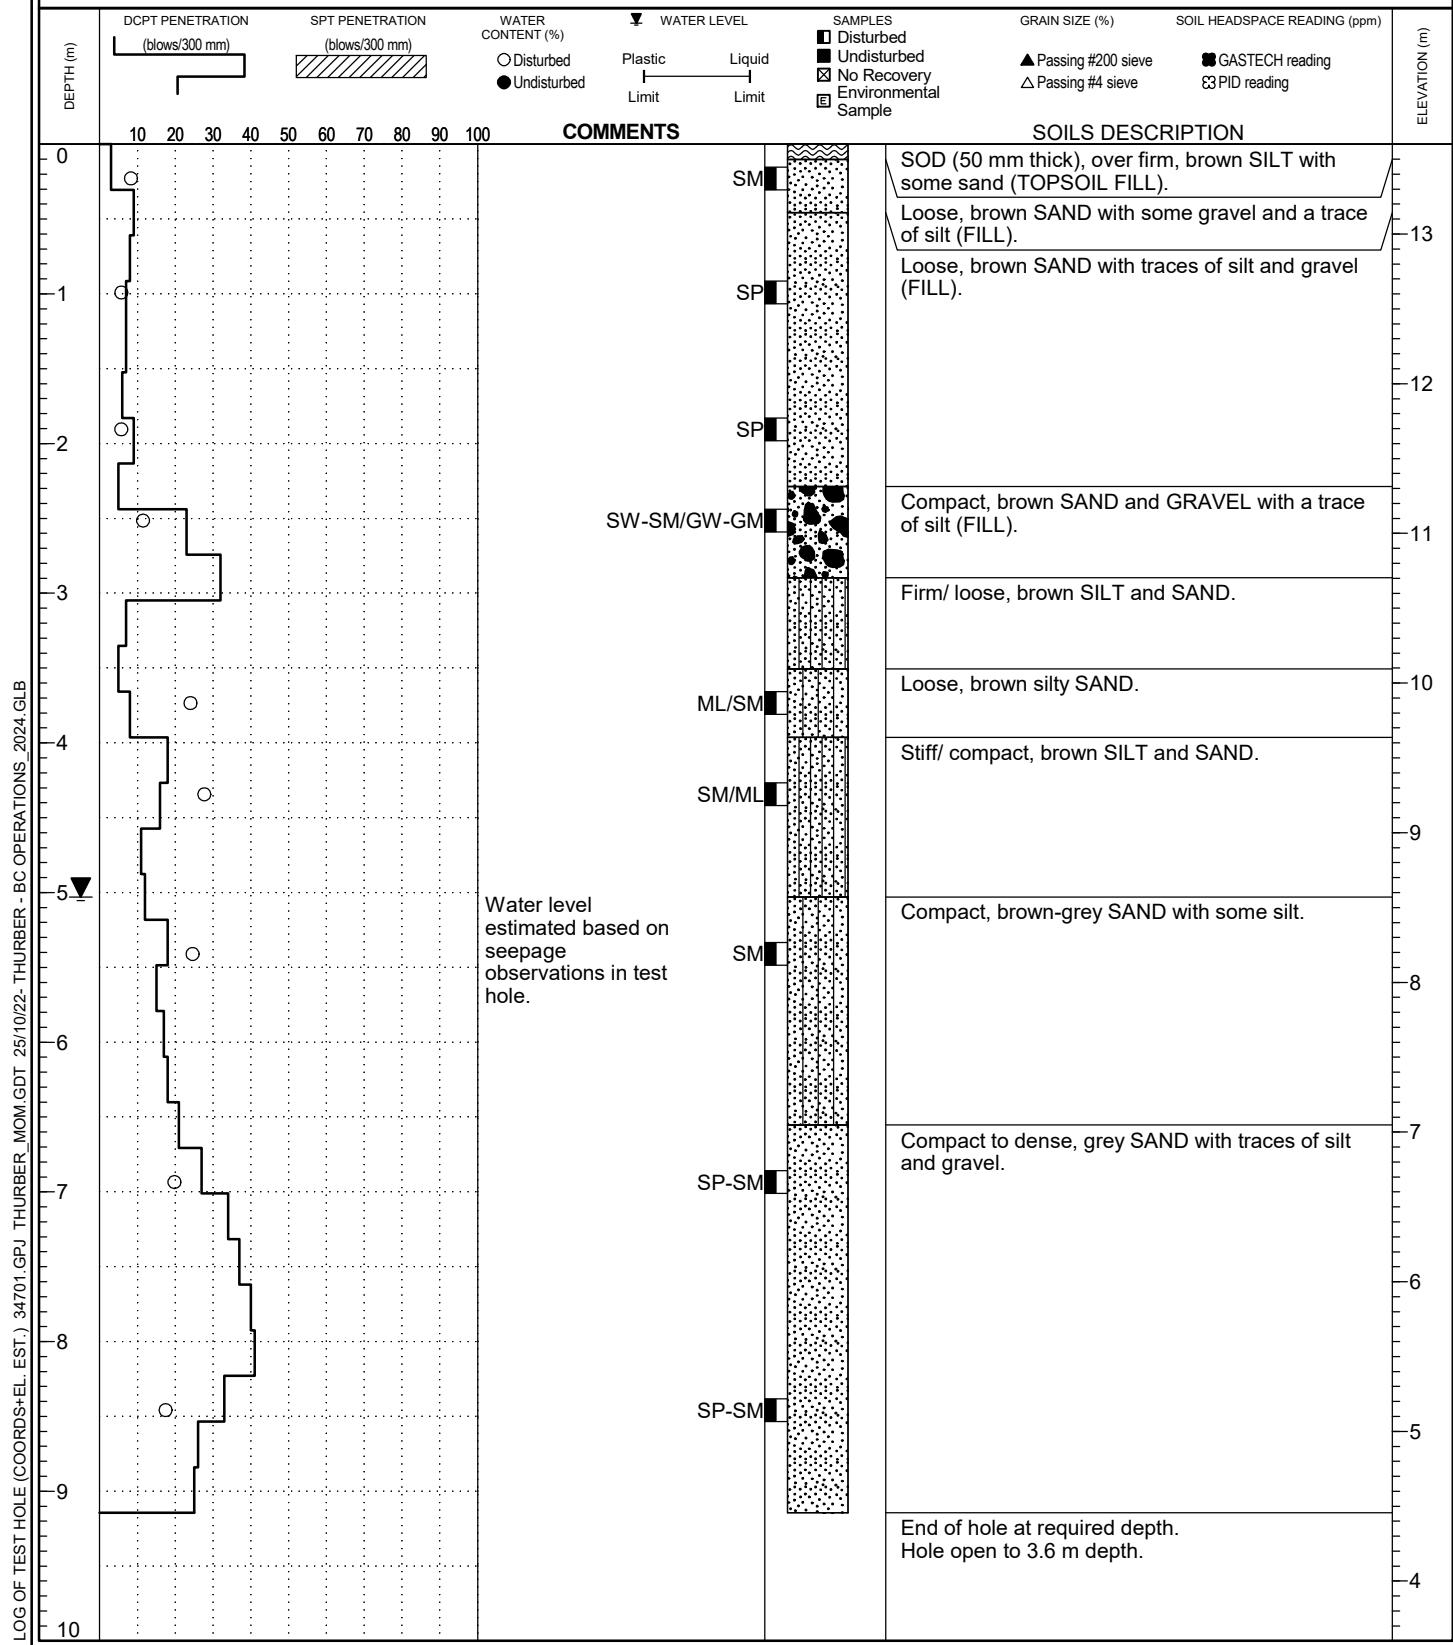
TH23-04

**LOCATION:** See DWG. 34701-1  
N 5461900, E 588838 (Est.)

**TOP OF HOLE ELEV:** 13.6 m (Est.)

**METHOD:** Solid Stem Auger/DCPT

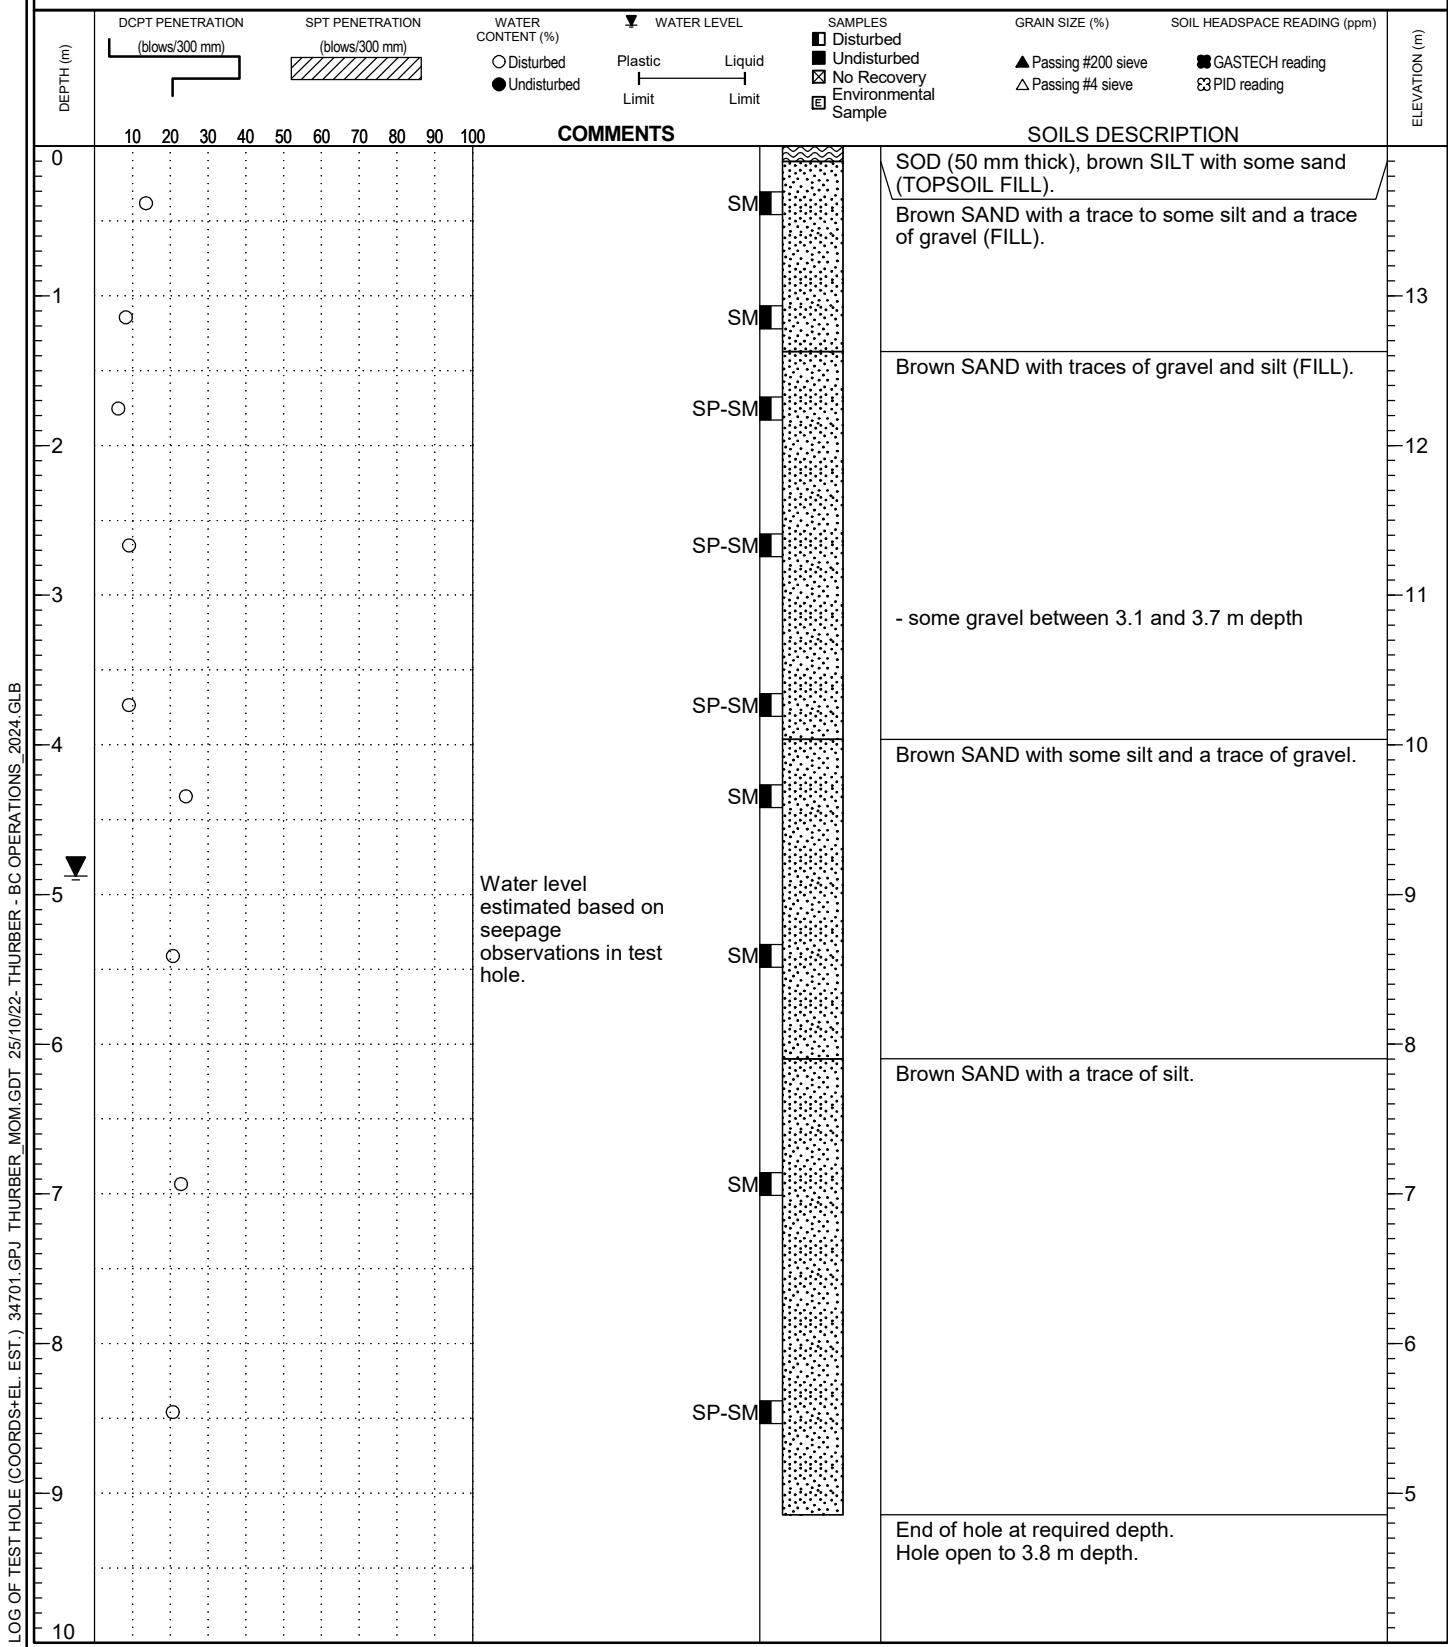
TH23-05

**LOCATION:** See DWG. 34701-1  
N 5461895, E 588755 (Est.)

**TOP OF HOLE ELEV:** 14.0 m (Est.)

**METHOD:** Solid Stem Auger

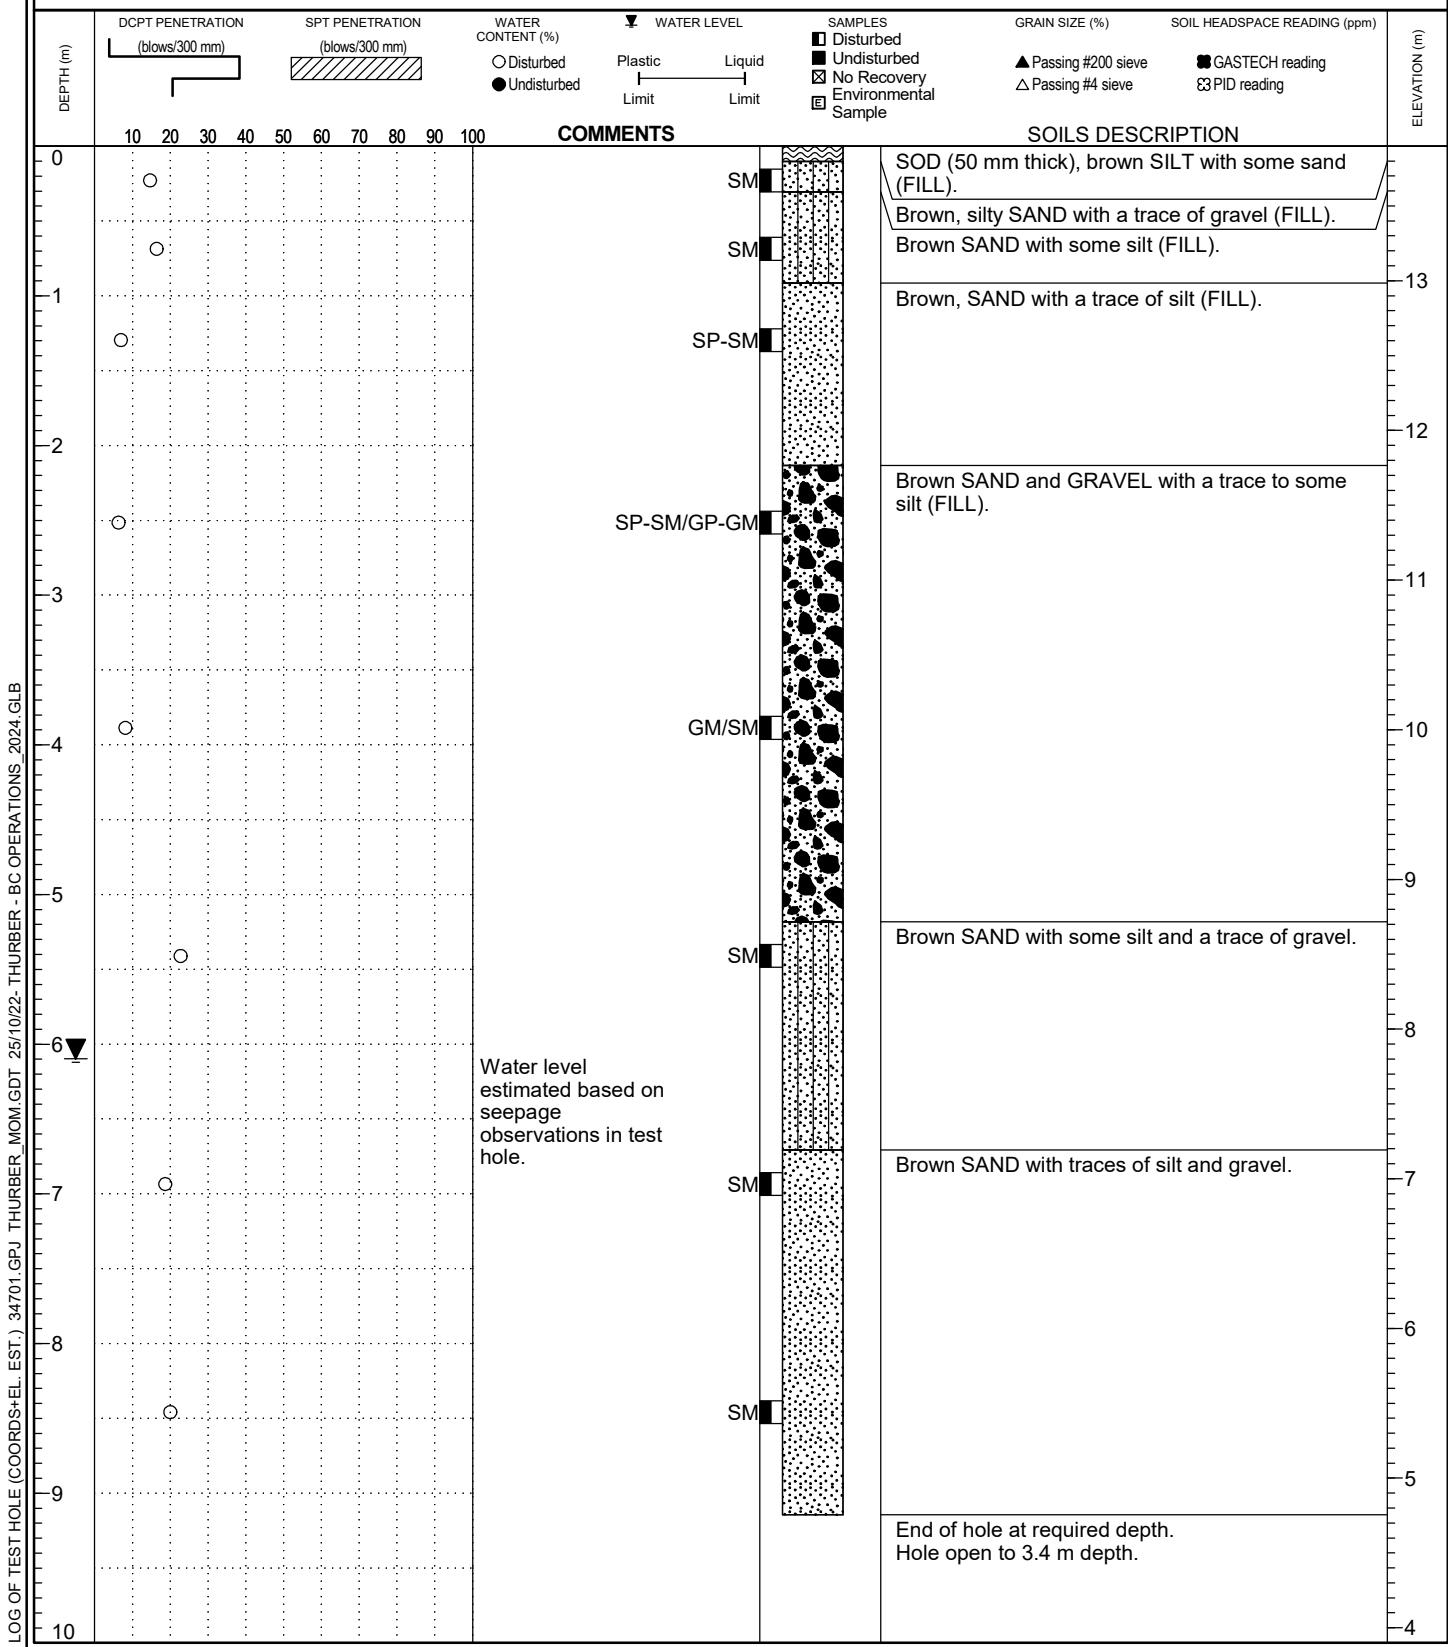
TH23-06

**LOCATION:** See DWG. 34701-1  
N 5461893, E 588669 (Est.)

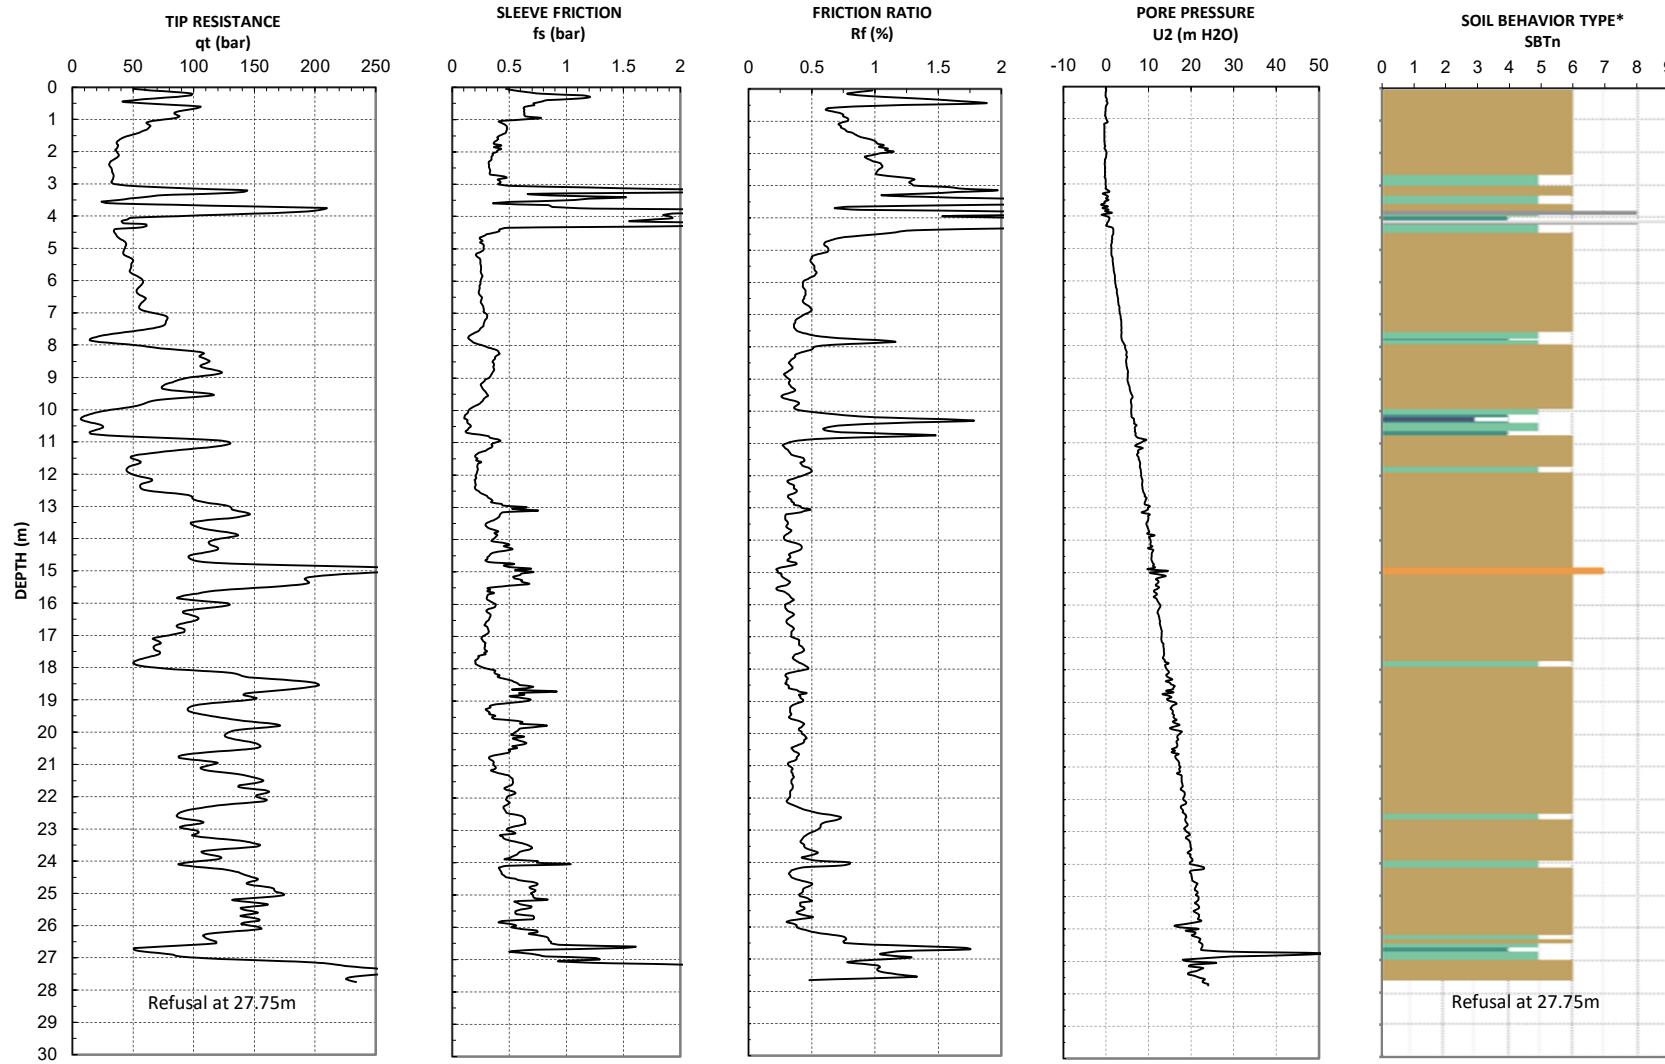
Sounding: SCPT23-05	Client: Thurber Engineering Ltd.
20-Nov-2023	Site: Esplanade Avenue, Harrison Hot Springs, BC

\* Based on Robertson et. al 1990

1. Sensitive Fine Grained	4. Clayey Silt to Silty Clay	7. Gravely Sand to Sand
2. Organic Material	5. Silty Sand to Sandy Silt	8. Very Stiff Sand to Clayey Sand
3. Clay to Silty Clay	6. Clean Sand to Silty Sand	9. Very Stiff Fine Grained

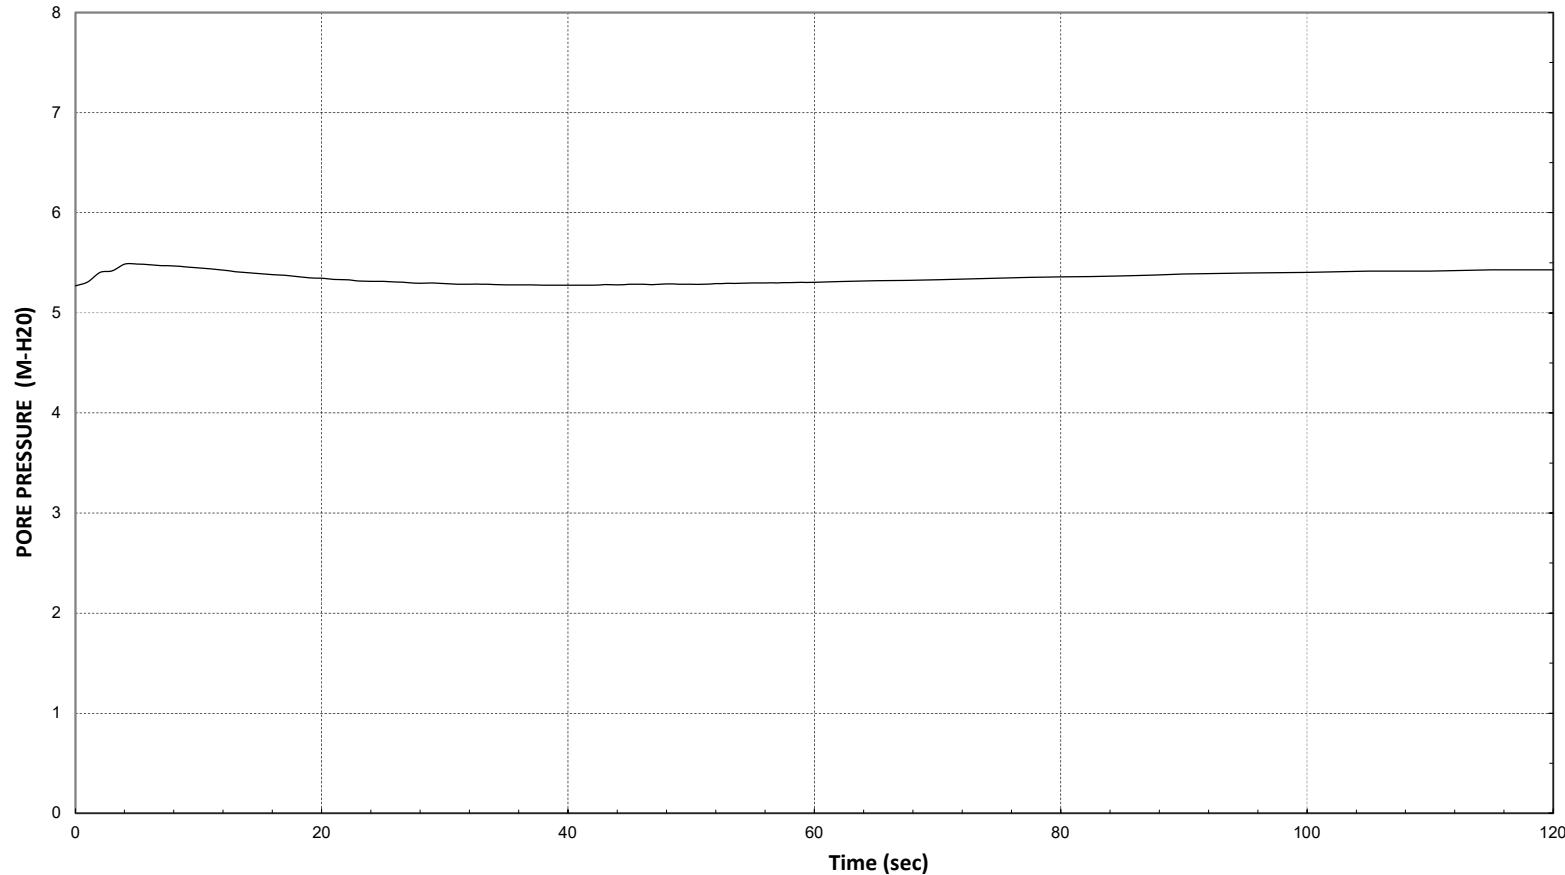
### PORE PRESSURE DISSIPATION TEST

Sounding: SCPT23-05	Client: Thurber Engineering Ltd.
20-Nov-2023	Site: Esplanade Avenue, Harrison Hot Springs, BC

Test Depth:	9.20 m
Duration:	120 s
Cone Area:	10 cm <sup>2</sup>
Cone ID:	DG1522

u Min:	5.27 m
u Max:	5.49 m
u Final:	5.43 m
