## **Harrison Hot Springs Dike Upgrades**

### **Factual Geotechnical Report**

**Client Name:** Northwest Hydraulic Consultants

**Date:** October 21, 2025

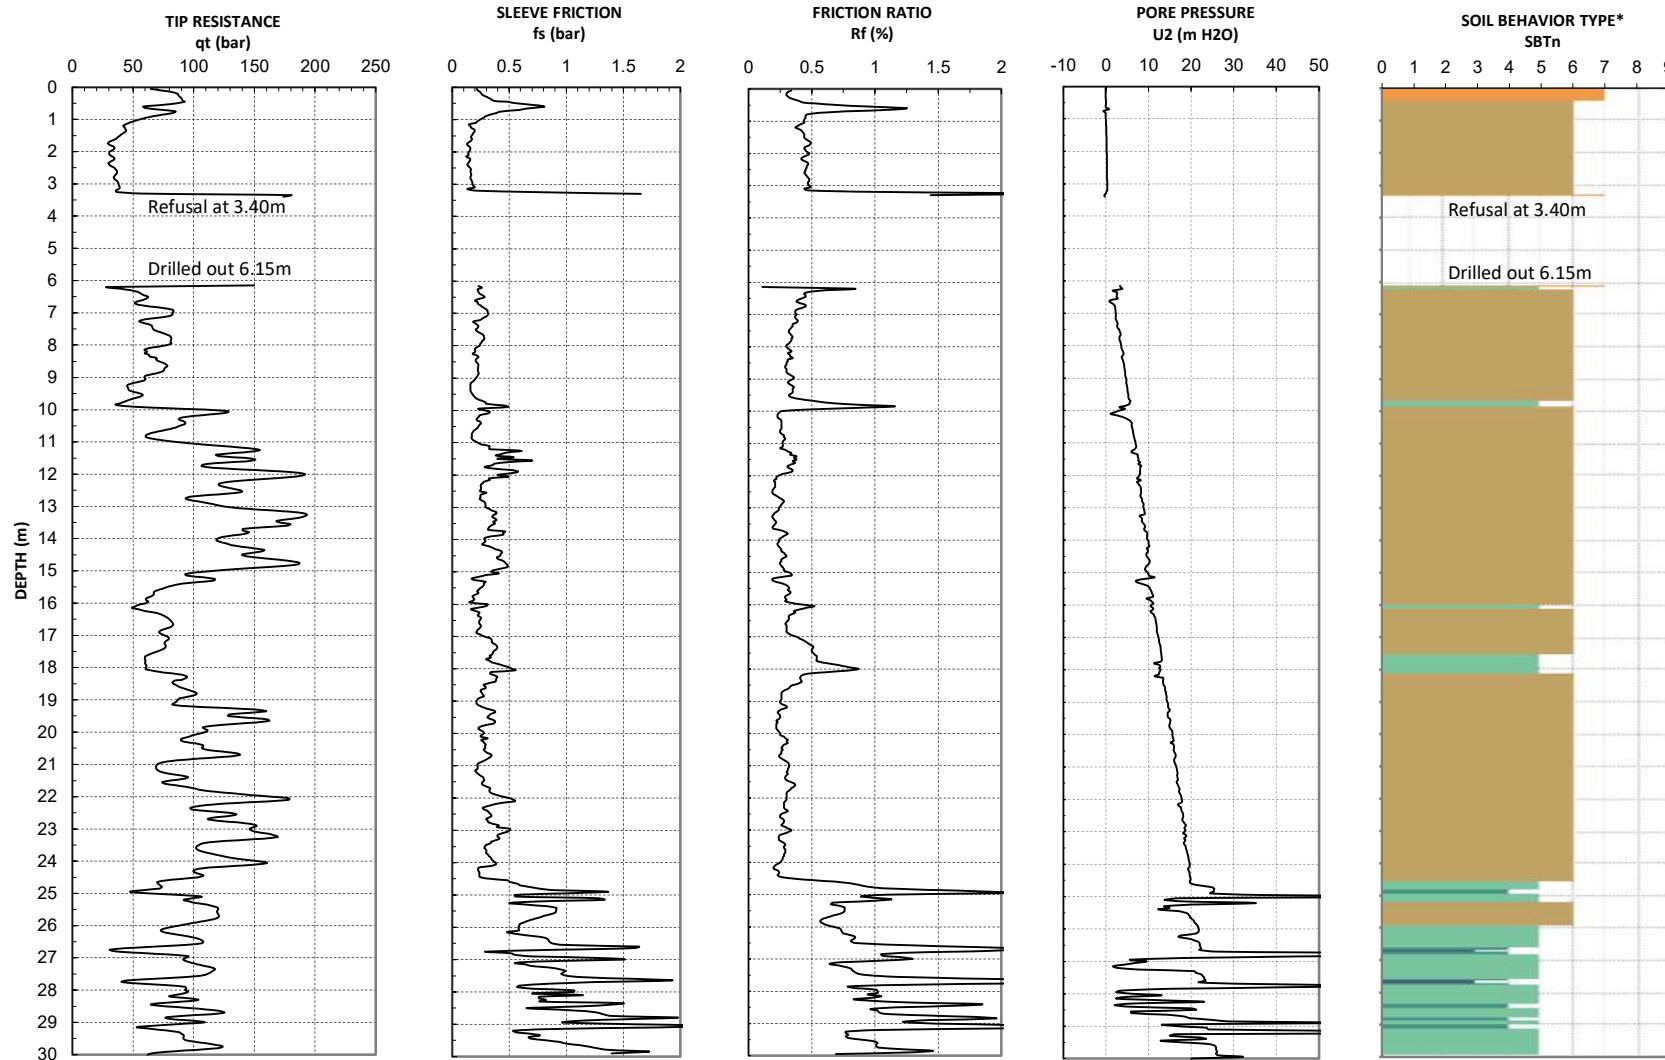
Sounding: SCPT23-11	Client: Thurber Engineering Ltd.
20-Nov-2023	Site: Esplanade Avenue, Harrison Hot Springs, BC

\* Based on Robertson et. al 1990

1. Sensitive Fine Grained	4. Clayey Silt to Silty Clay	7. Gravely Sand to Sand
2. Organic Material	5. Silty Sand to Sandy Silt	8. Very Stiff Sand to Clayey Sand
3. Clay to Silty Clay	6. Clean Sand to Silty Sand	9. Very Stiff Fine Grained

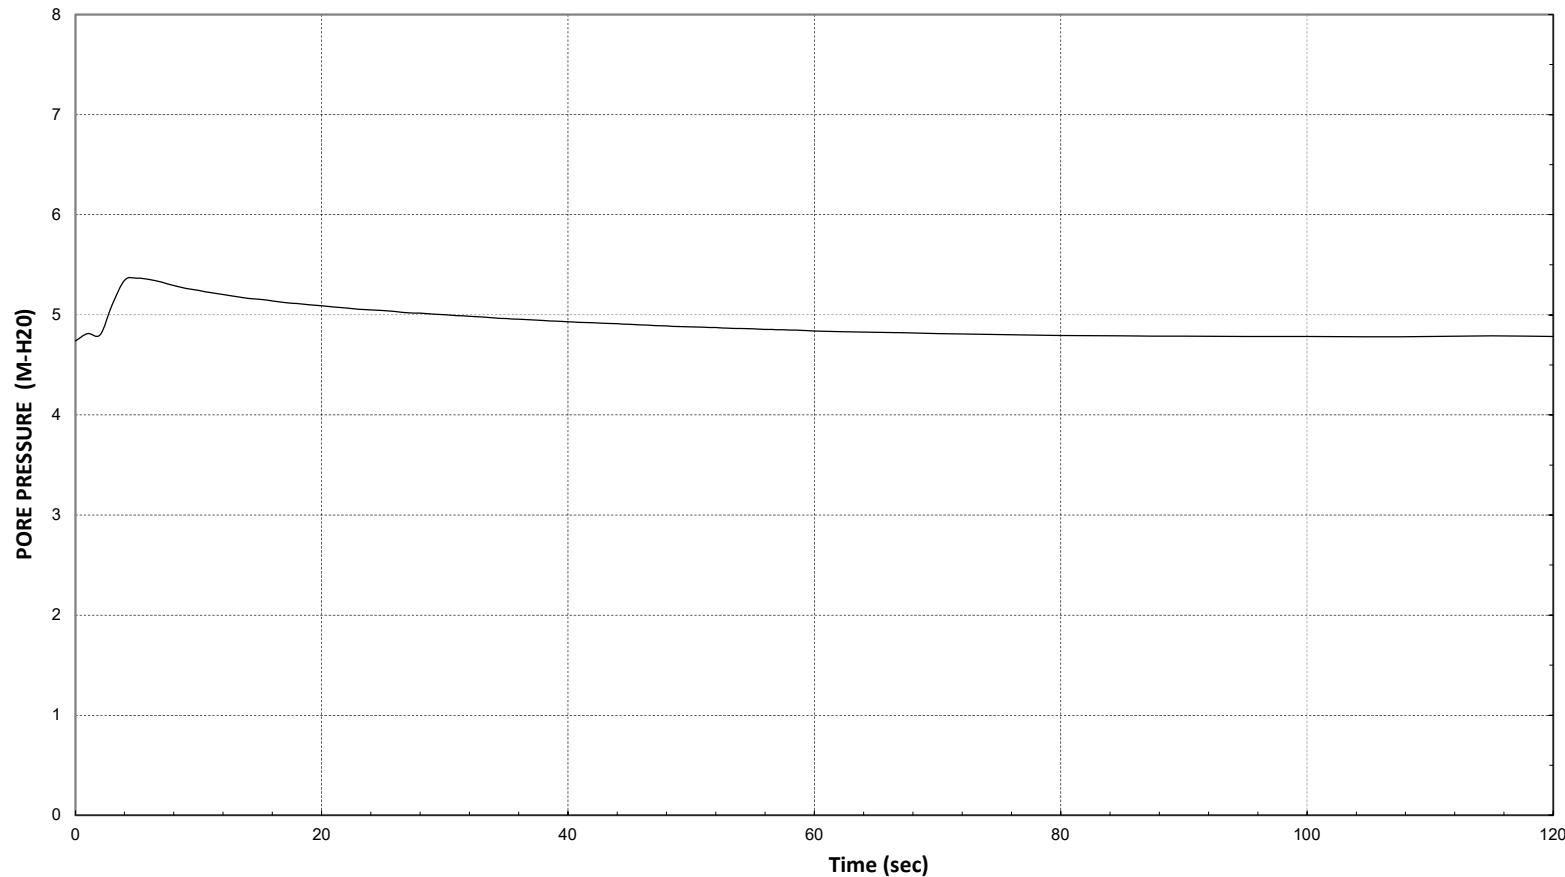
### PORE PRESSURE DISSIPATION TEST

Sounding: SCPT23-11	Client: Thurber Engineering Ltd.
20-Nov-2023	Site: Esplanade Avenue, Harrison Hot Springs, BC

Test Depth:	9.20 m
Duration:	120 s
Cone Area:	10 cm <sup>2</sup>
Cone ID:	DG1521

u Min:	4.74 m
u Max:	5.37 m
u Final:	4.78 m

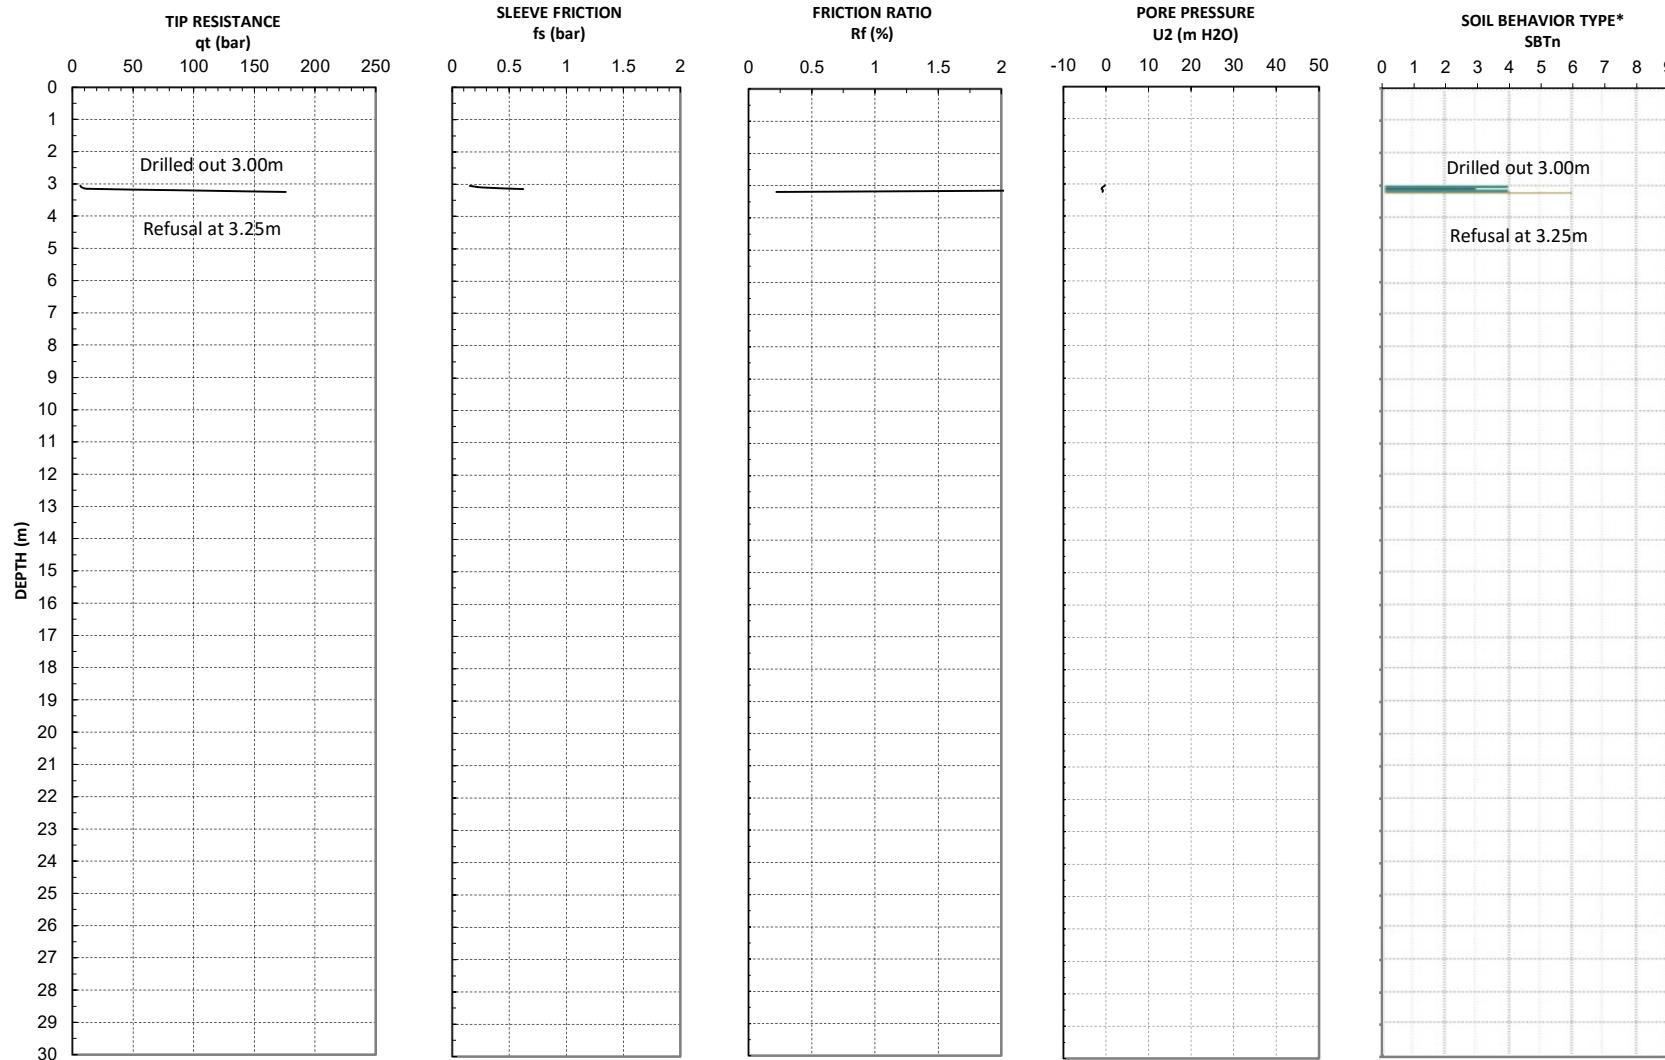
Sounding: CPT23-17

Site: Esplanade Avenue, Harrison Hot Springs, BC

\* Based on Robertson et. al 1990

1. Sensitive Fine Grained	4. Clayey Silt to Silty Clay	7. Gravely Sand to Sand
2. Organic Material	5. Silty Sand to Sandy Silt	8. Very Stiff Sand to Clayey Sand
3. Clay to Silty Clay	6. Clean Sand to Silty Sand	9. Very Stiff Fine Grained
