HOME
report

SINGLE SURVEY
ENERGY REPORT
PROPERTY QUESTIONNAIRE
VALUATION REPORT

Property Address	16 Avonside Drive Denny FK6 6QF
Customer	Dr V Fallon
Date of Inspection	30/03/2026
Prepared by	Stuart Lewis Harvey Donaldson & Gibson Chartered Surveyors

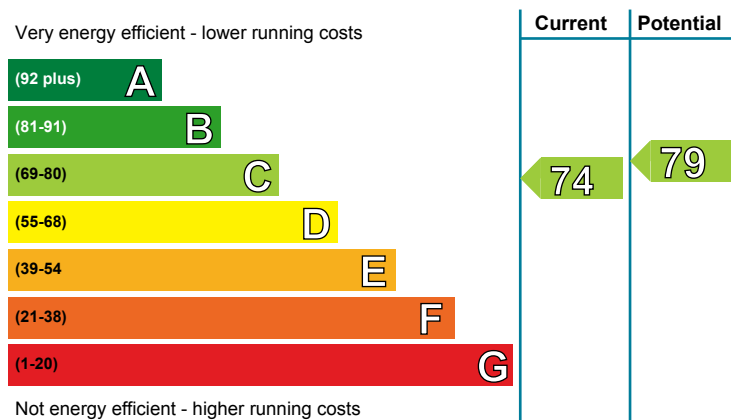
Energy Efficiency Rating

This graph shows the current efficiency of your home, taking into account both energy efficiency and fuel costs. The higher this rating, the lower your fuel bills are likely to be.

Your current rating is **band C (74)**. The average rating for EPCs in Scotland is **band D (61)**.

The potential rating shows the effect of undertaking all of the improvement measures listed within your recommendations report.

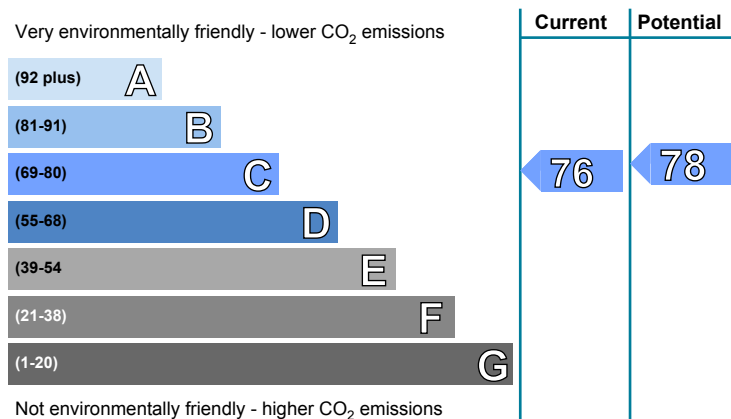
Environmental Impact (CO₂) Rating

This graph shows the effect of your home on the environment in terms of carbon dioxide (CO₂) emissions. The higher the rating, the less impact it has on the environment.
