# Stratford Green Condominium Association

Willowbrook, IL • December 20, 2022

FULL RESERVE STUDY

STRATFORD GREEN

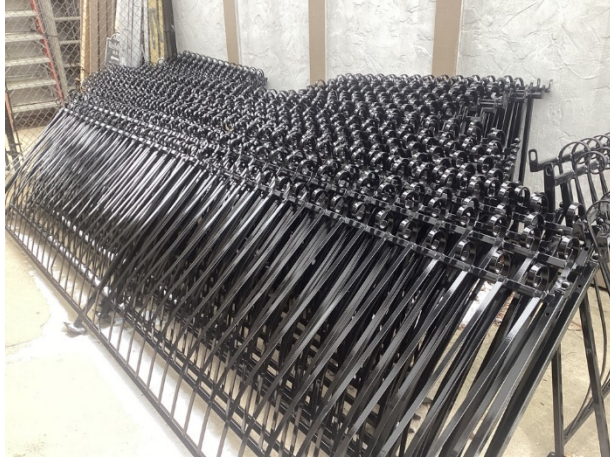
**Conditions:** The replaced railings are in good overall condition but the original railings are in poor overall condition with excessive rust evident.

**Replacement railings for balconies at pool area**

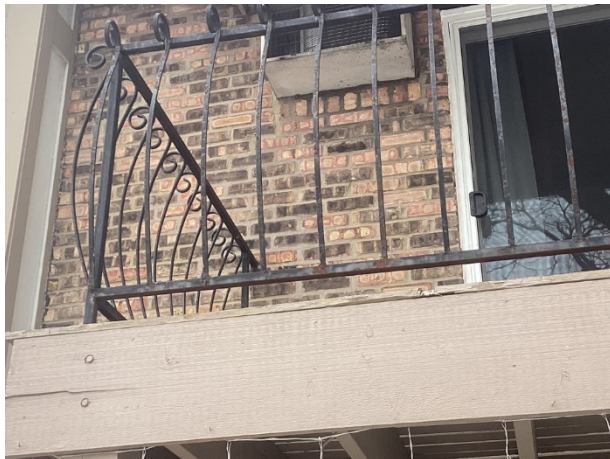
**Railing rust**

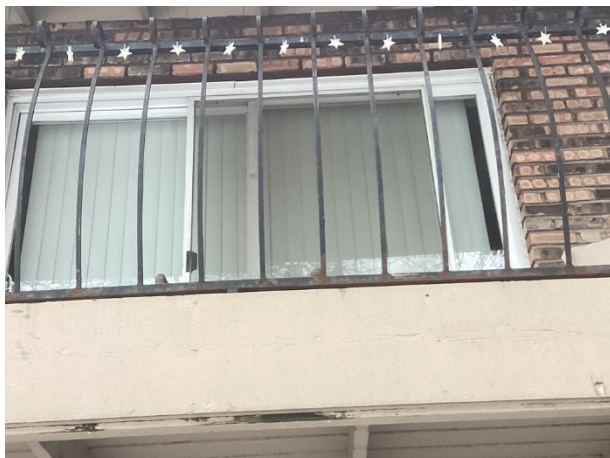
**Railing rust**

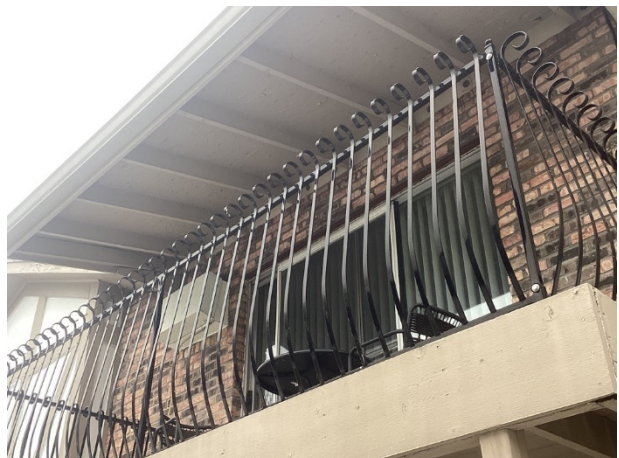
**Replaced railings**

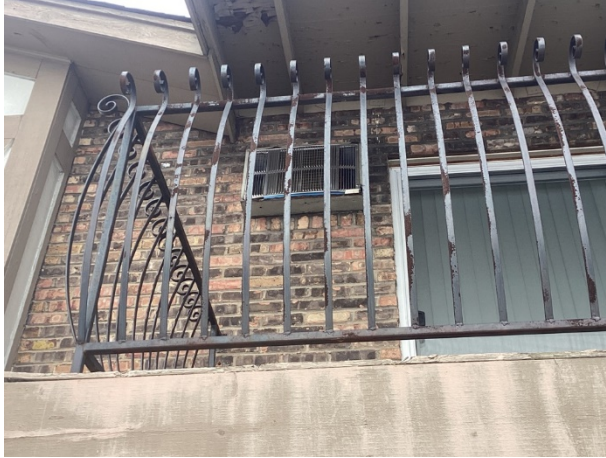
**Railing rust**

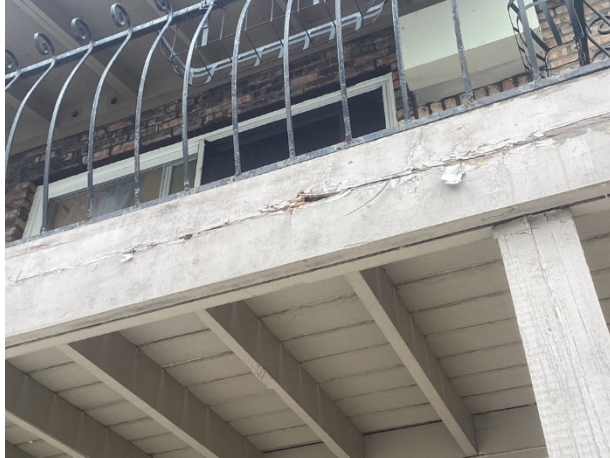
**Condition:** Fair to poor overall with periodic wood rot, damage, finish deterioration, support torsion, and bowed deck boards and supports. We recommend the Association engage a local engineer to inspect the balconies to determine the need for near term replacement and repairs.

**Fascia board damage**

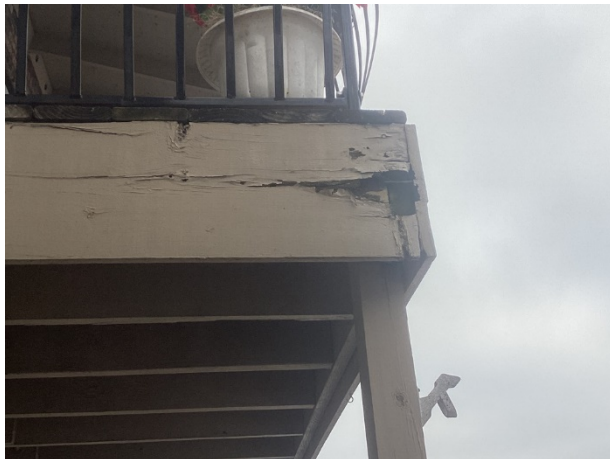
**Fascia rot**

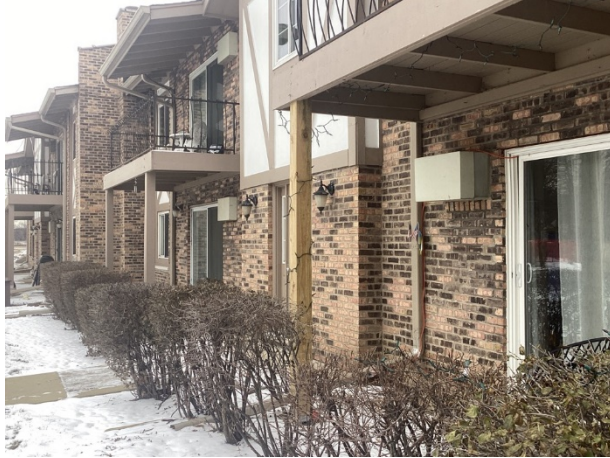
**Replaced support**

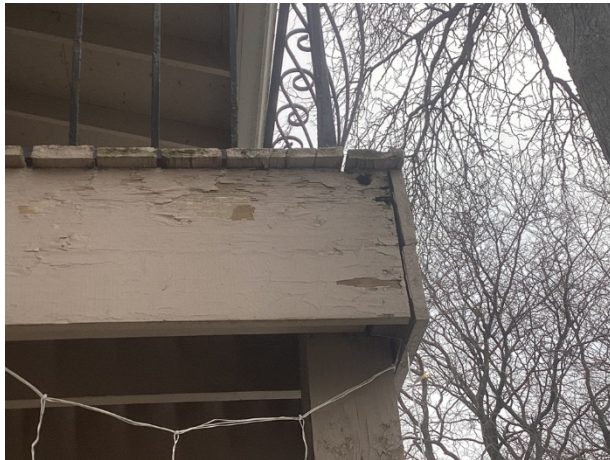
**Deck board and fascia wood rot – note finish deterioration**

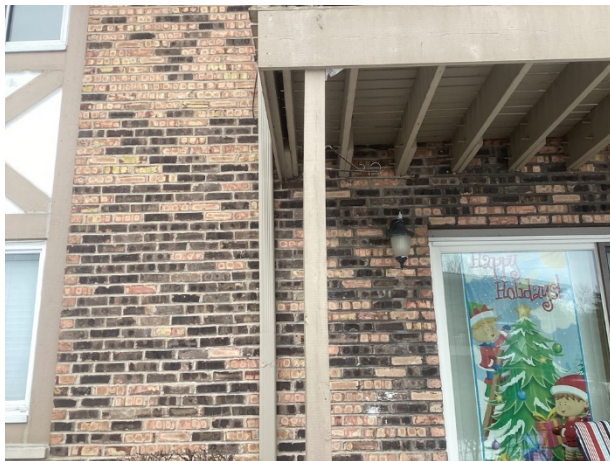
**Bowed support**

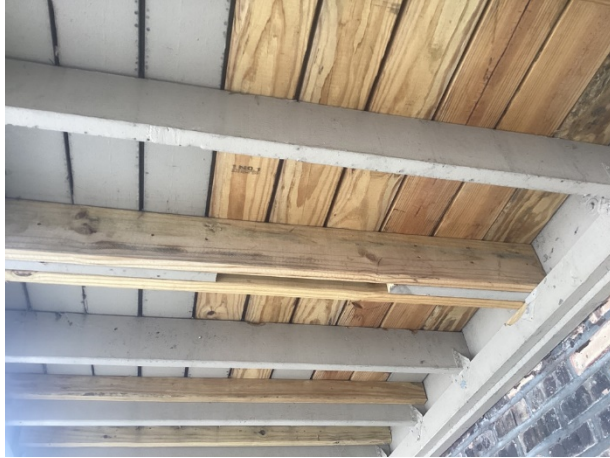
**Replaced deck boards**

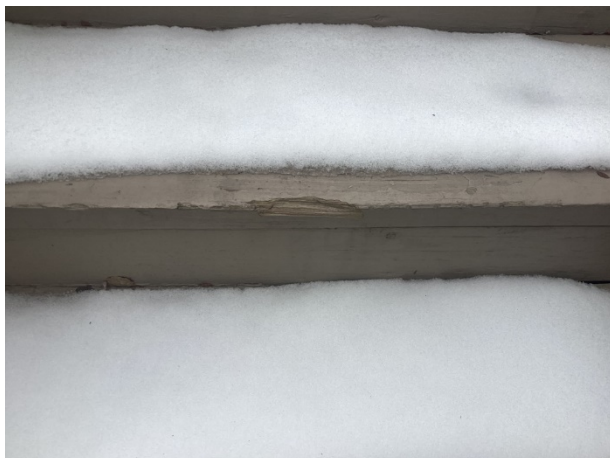
**Stair damage at clubhouse balcony**

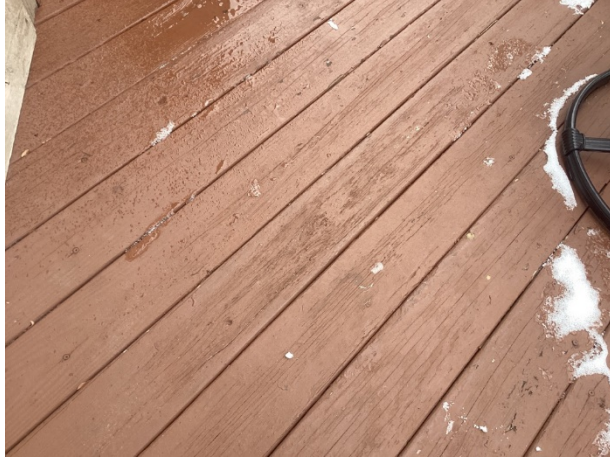
**Bowing deck boards (clubhouse balcony shown)**

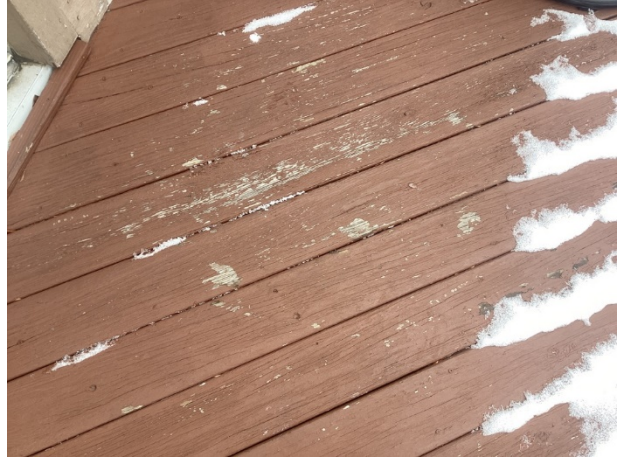
**Finish deterioration**

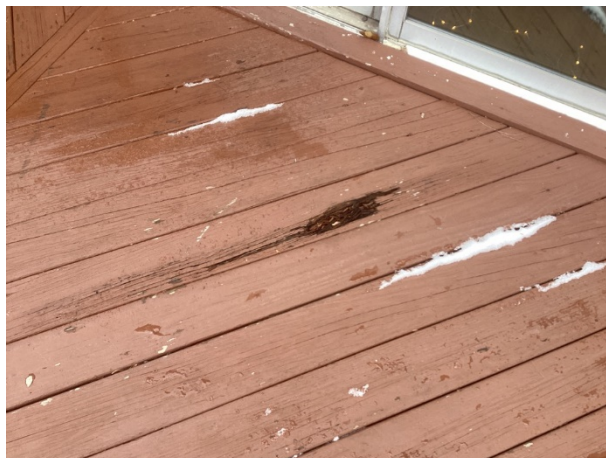
**Deck board rot**

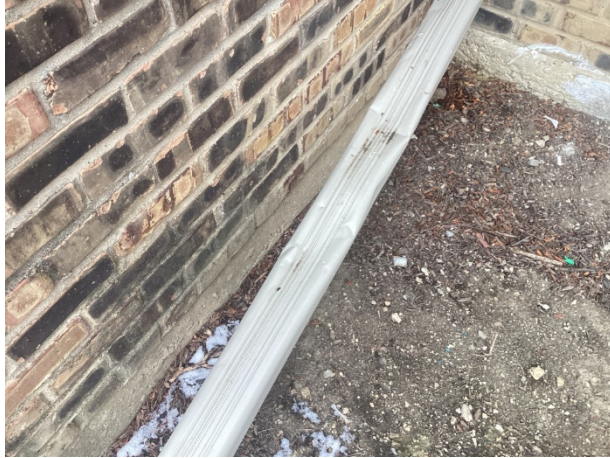
**Condition:** Good to fair overall with isolated disconnected sections, fastener rust and dented sections evident.

**Downspout dents**

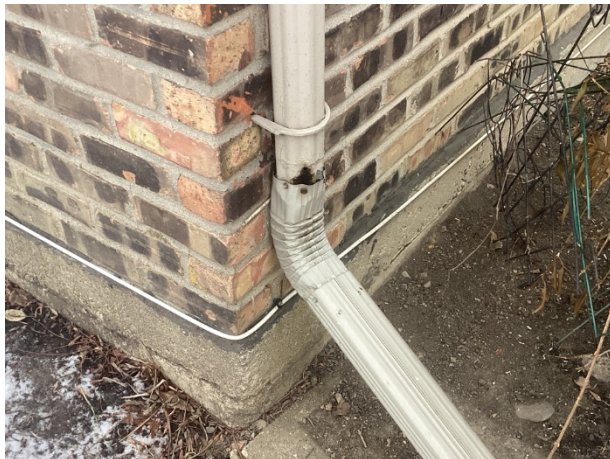
**Downspout damage – note small capacity at building 13**

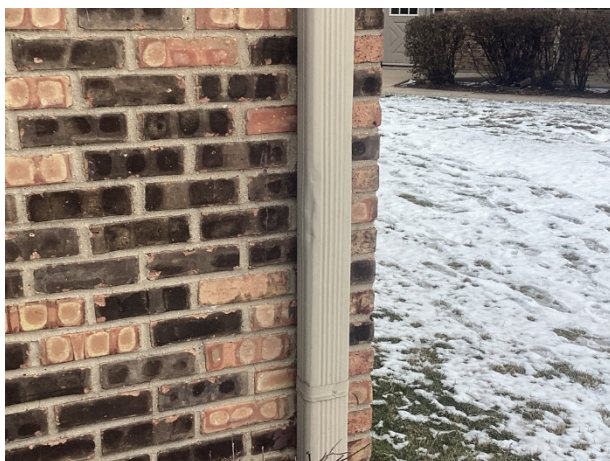
**Downspout dents**

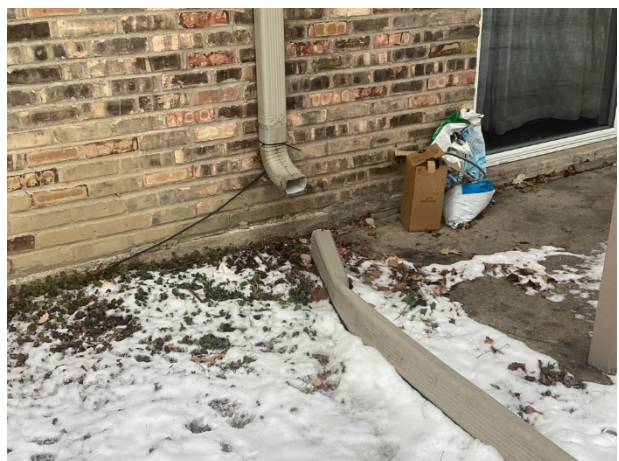
**Disconnected downspout**

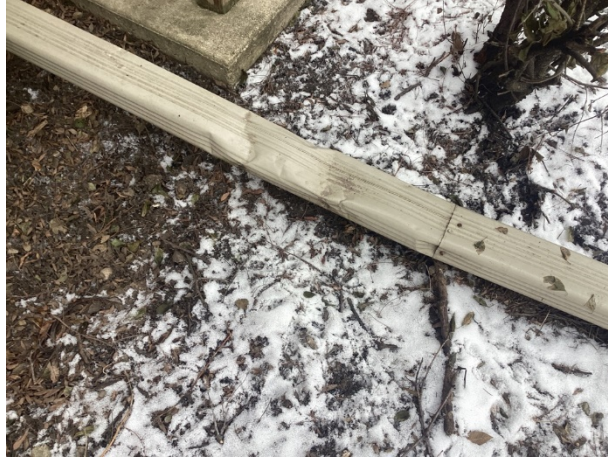
**Downspout dents**

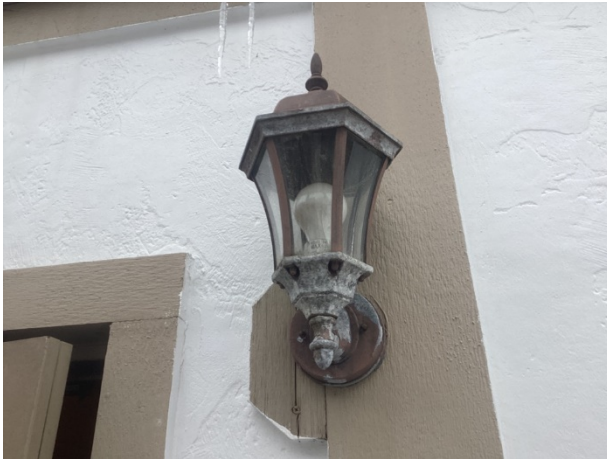
**Condition:** Fair overall with periodic finish deterioration, loose fixtures and mismatched fixtures evident.

**Clubhouse fixture rust**

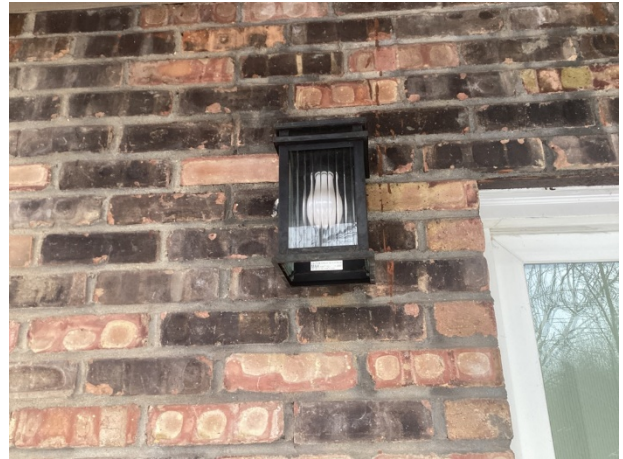
**Mismatch light fixture**

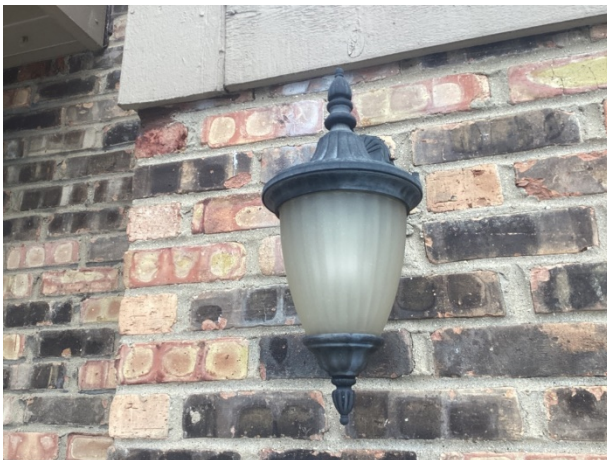
**Typical light fixture**

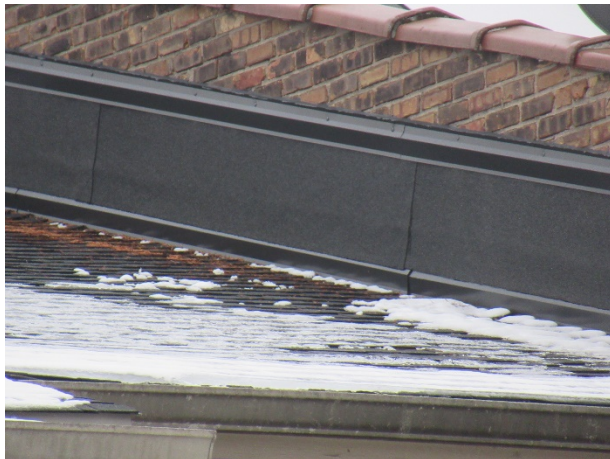
**New flashing at roof parapet (recently replaced shown)**

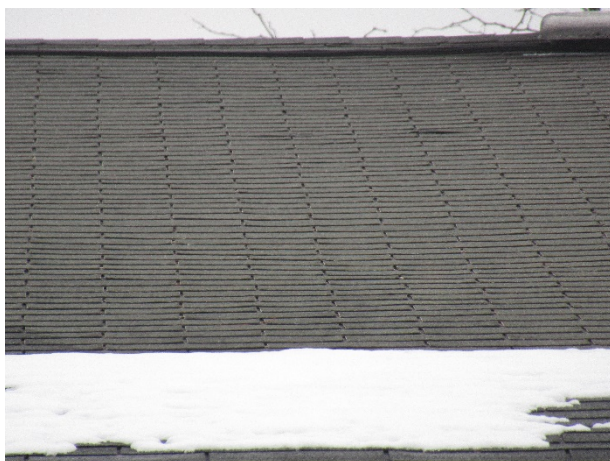
- **Recently Replaced:** 1,230 *squares*<sup>1</sup> replaced from 2020 to 2022 in good overall condition with no significant deterioration evident at the time of our inspection.
- **Remaining:** 1,660 squares at varying ages, though most are near 20 years in age, in fair to poor overall condition with periodic shingle lift and isolated sheathing deflection evident.

**Shingle lift (building 18 shown)**

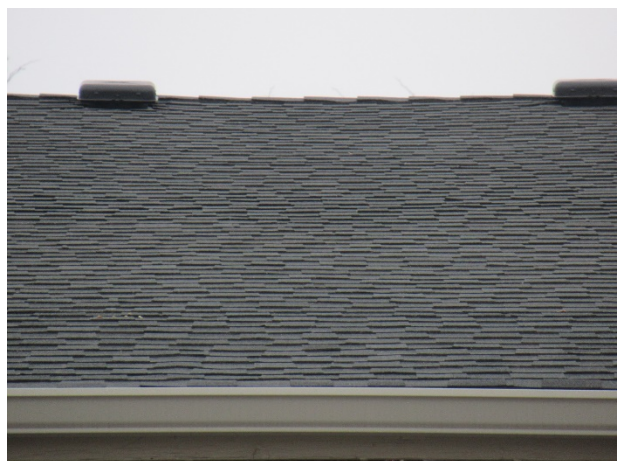
**Recently replaced roof overview**

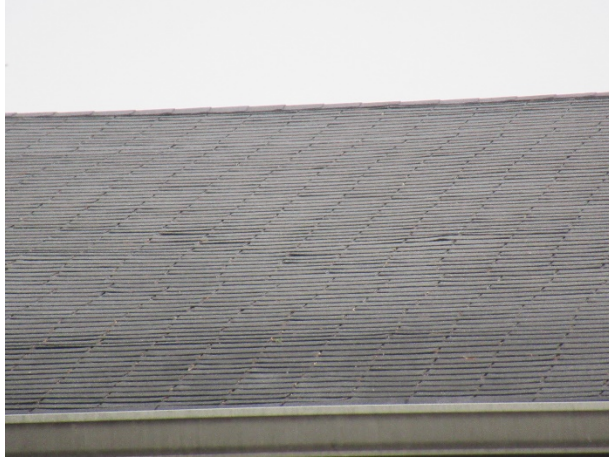
**Shingle lift (building 26 shown)**

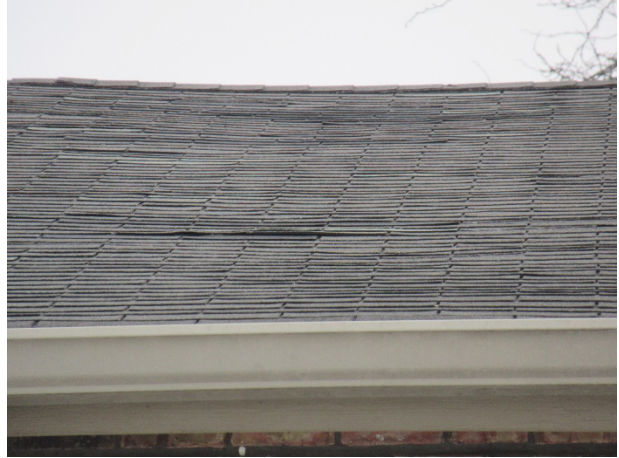
**Shingle lift and shingle lift (building 16 shown)**

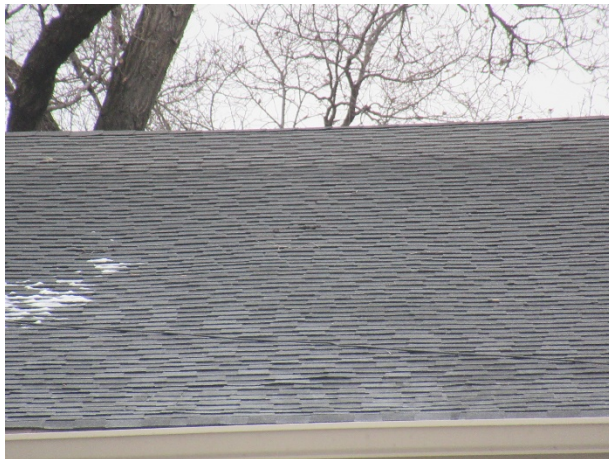
**Building 19 overview (recently replaced shown)**

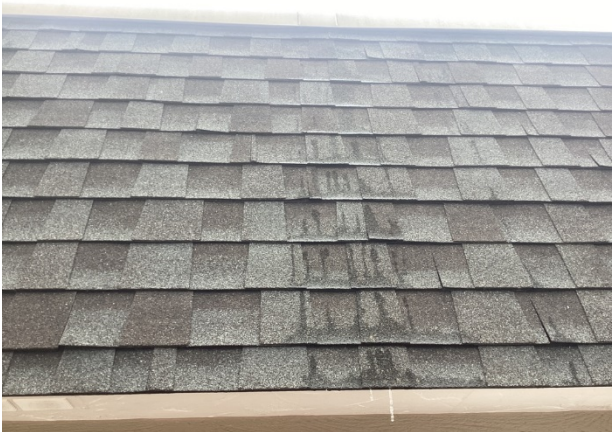
**Condition:** Visually in fair overall condition with isolated organic growth and shingle lift evident. We note we were unable to access the flat roof at the clubhouse at the time of our inspection. The Association does not report any issues with leaks at the clubhouse and garage roofs at this time.

Mansard roof at clubhouse overview

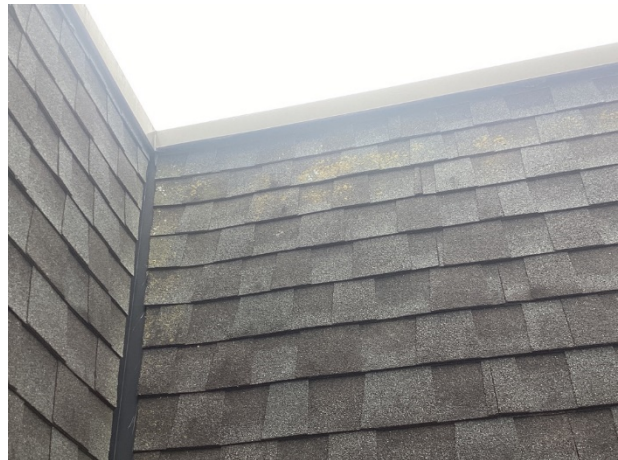
Organic growth at mansard shingles clubhouse

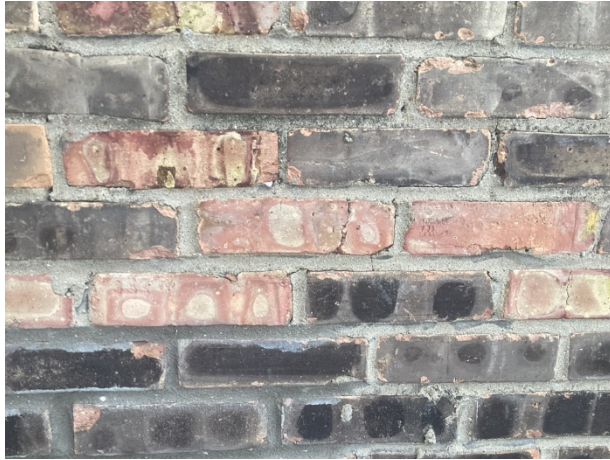
**Condition:** Fair overall with periodic mortar deterioration, cracks, organic growth and efflorescence evident at the time of our inspection. We note that efflorescence is not a safety concern. However, it can be an indication of water infiltration, masonry saturation, improper drainage behind the façade or another underlying issue. We also note isolated sealant deterioration.

**Masonry cracks**

- Complete inspection of the masonry
- Repointing of up to three percent (3%) of the masonry
- Replacement of a limited amount of the masonry (The exact amount of area in need of replacement will be discretionary based on the actual future conditions and the desired appearance.)
- Rebuilding of up to two chimneys per event
- Replacement of up to twenty-five percent (25%) of the sealants per event

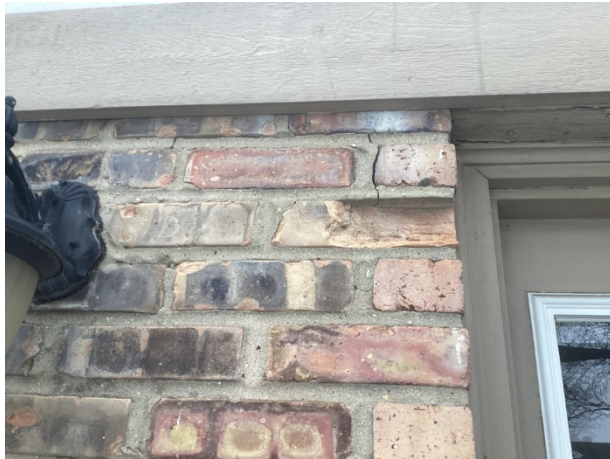
**Mortar deterioration**

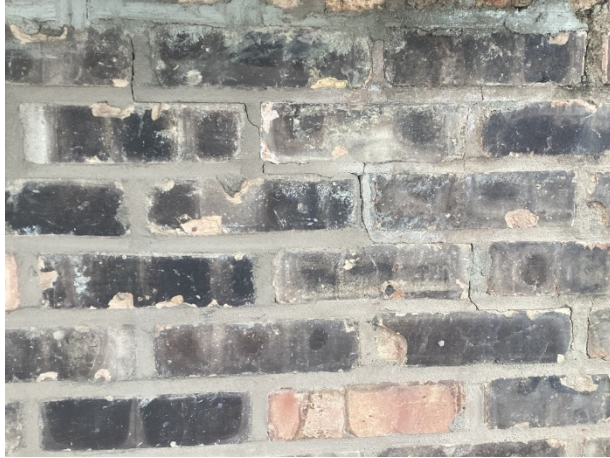
**Masonry step crack**

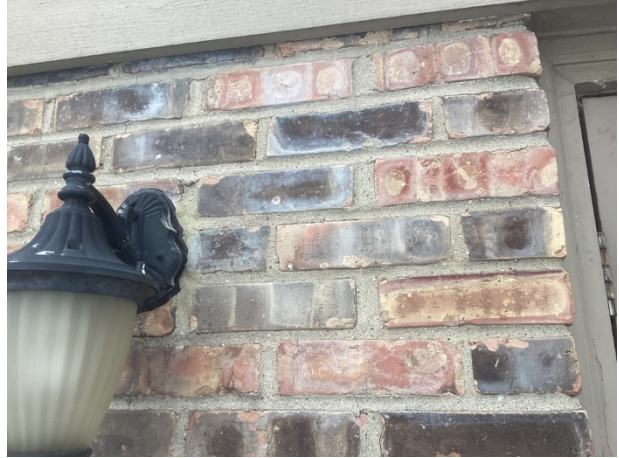
**Masonry efflorescence**

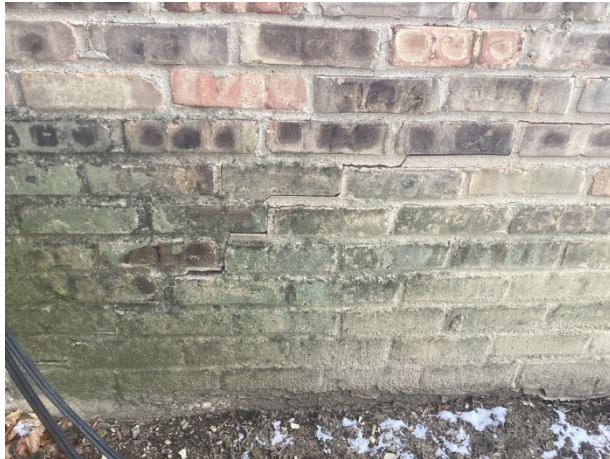
**Masonry cracks**

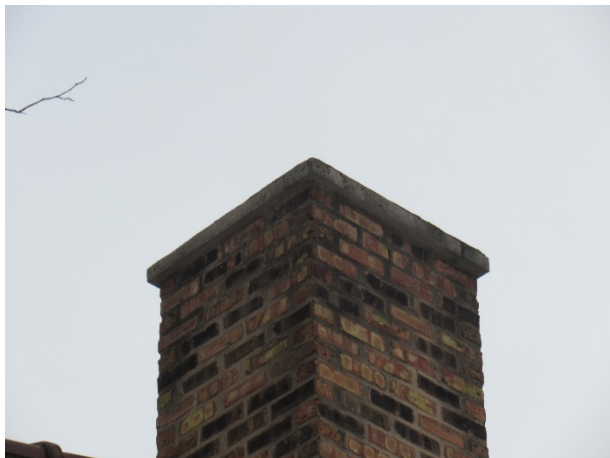
**Typical chimney cap**

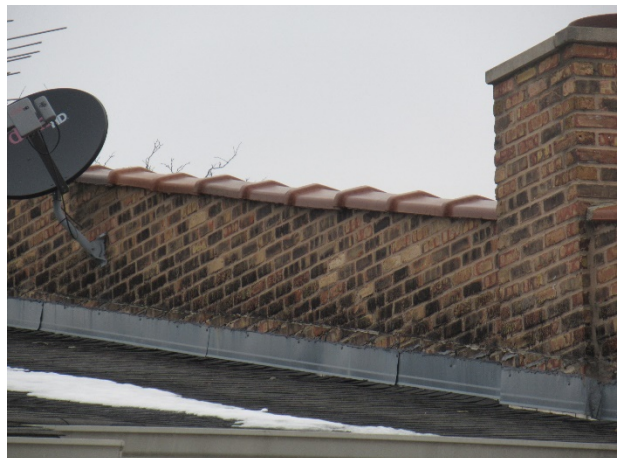
**Fire wall overview**

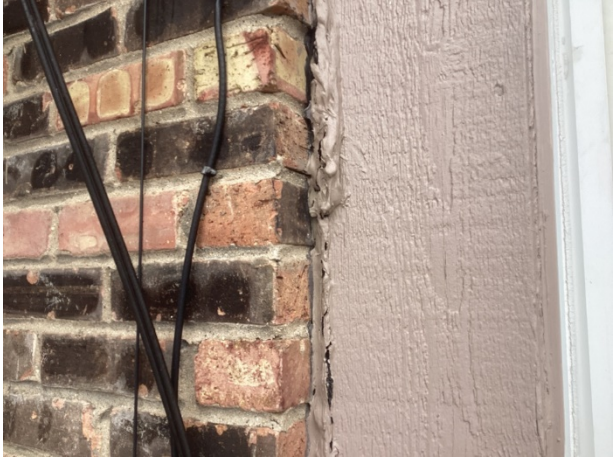
**Sealant deterioration**

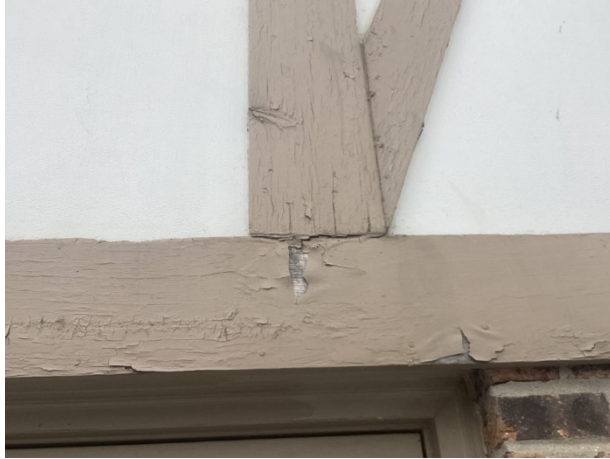
**Condition:** The condition of the hardboard siding and trim varies though mostly in fair overall condition. We note the property comprises multiple materials: fiber cement panels, composite hardboard and plywood with mostly wood trim. We note periodic finish deterioration and isolated areas of deterioration, rot, damage and organic growth.

**Trim finish deterioration**

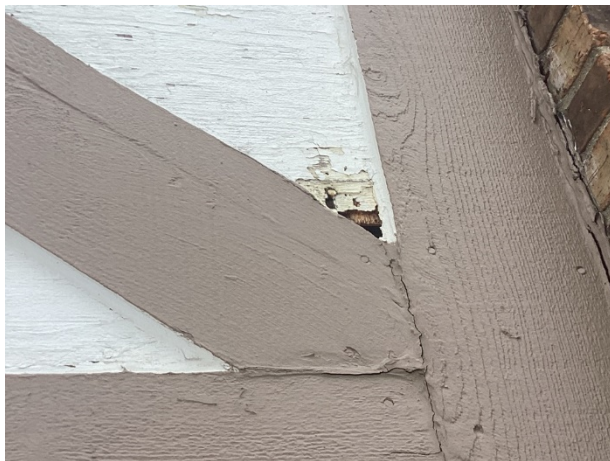
**Plywood siding deterioration**

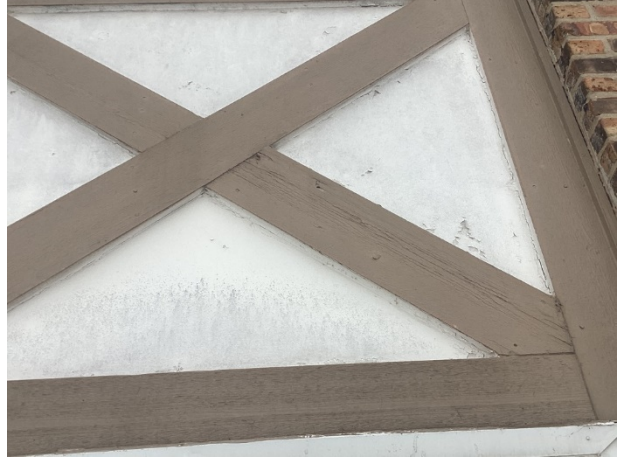
**Finish deterioration and organic growth**

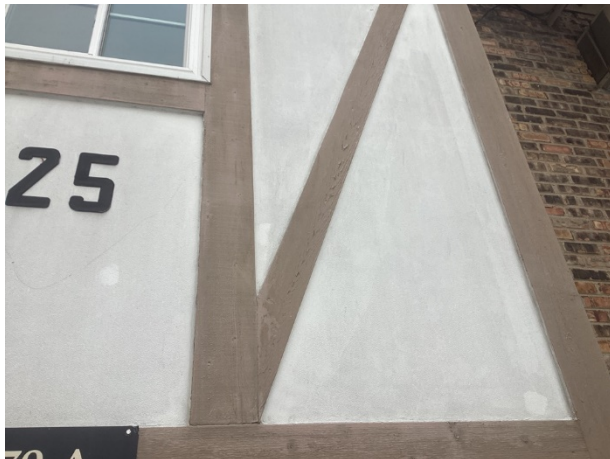
**Composite hardboard siding**

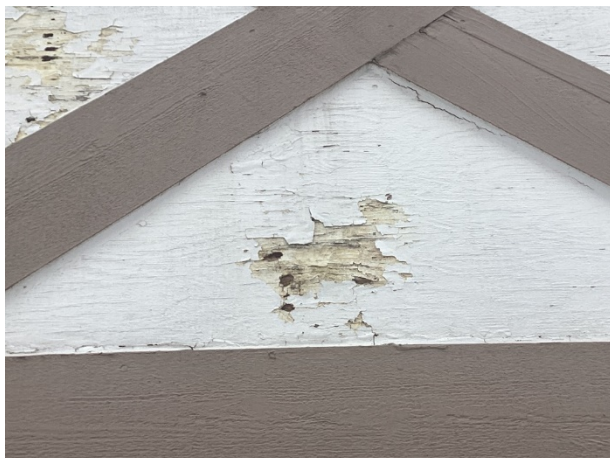
**Plywood rot and finish deterioration**

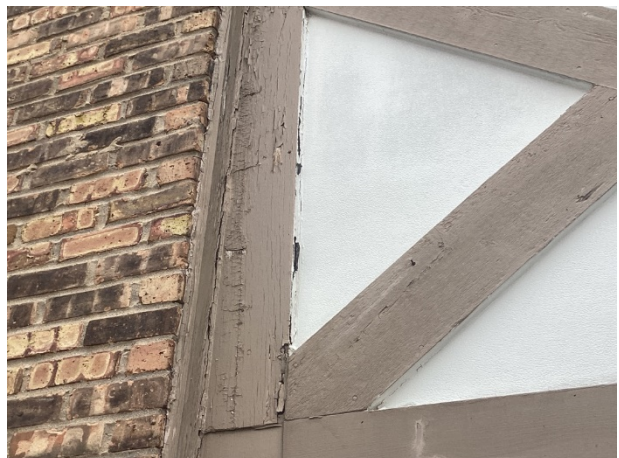
**Trim finish deterioration**

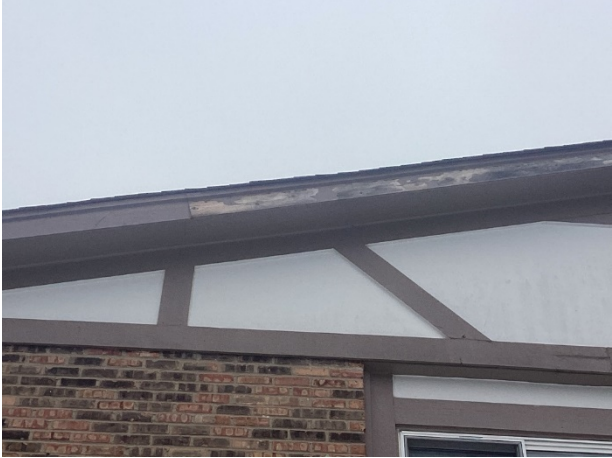
**Fascia trim deterioration**

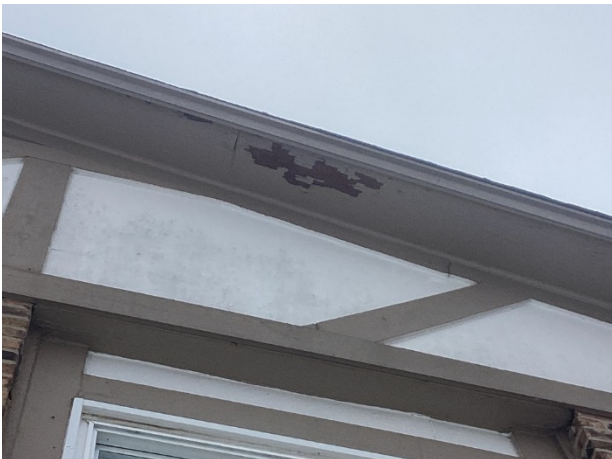
**Wood soffits and fascia – note finish deterioration**

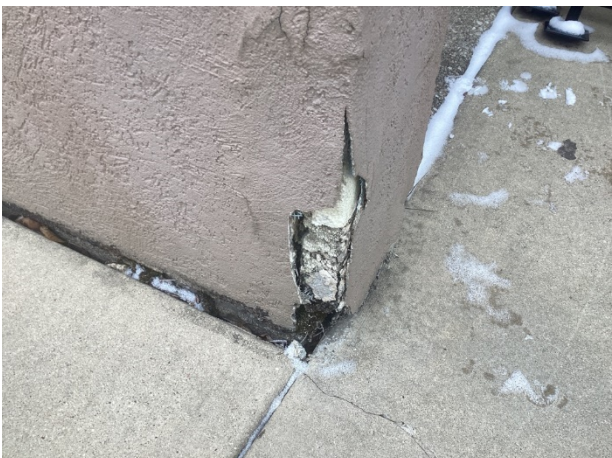
**EIFS damage (clubhouse shown)**

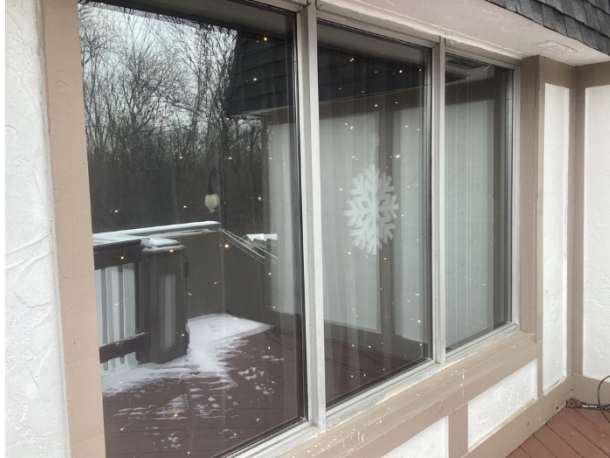
Clubhouse windows at balcony

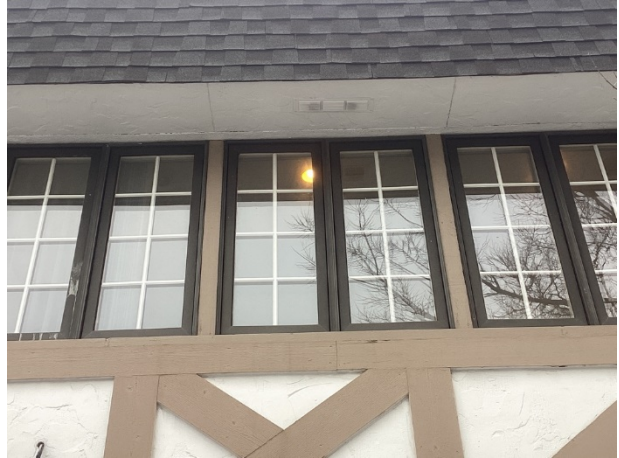
Clubhouse windows

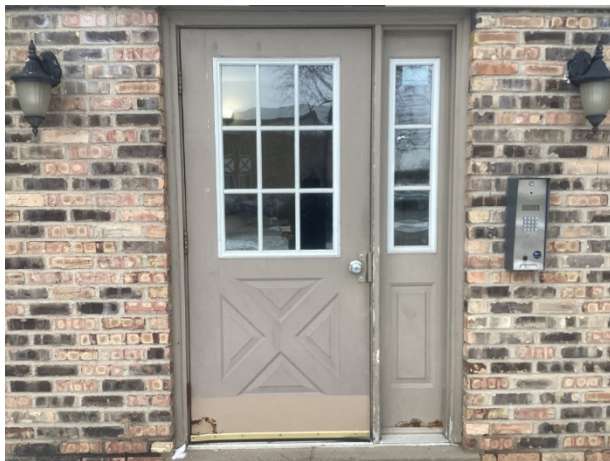
**Condition:** The condition of the windows and doors varies but are primarily good to fair overall with isolated damage and rust evident at the time of our inspection.

Common entrance door rust

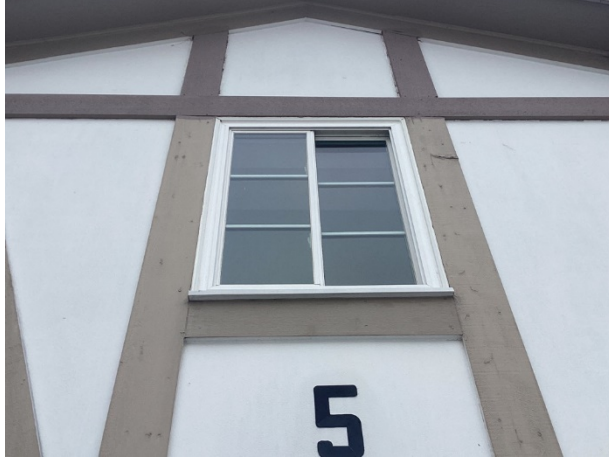
**Common window likely replaced**

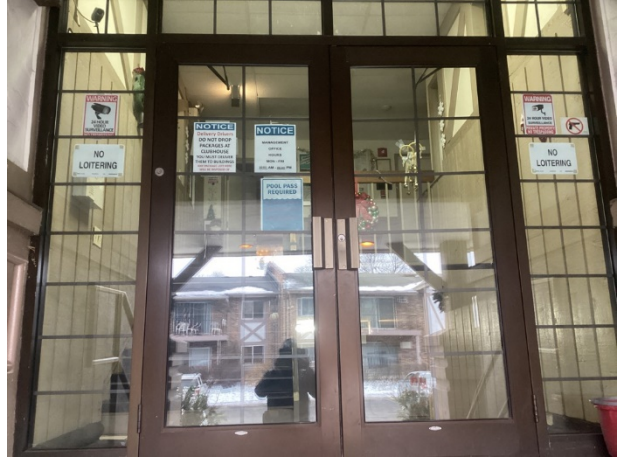
**Clubhouse entrance doors and windows**

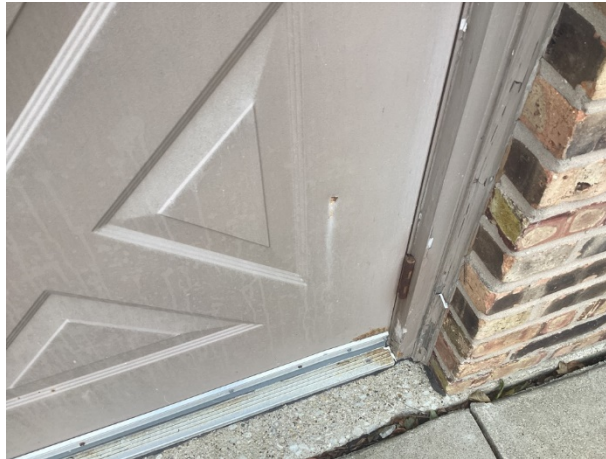
**Common entrance door damage**

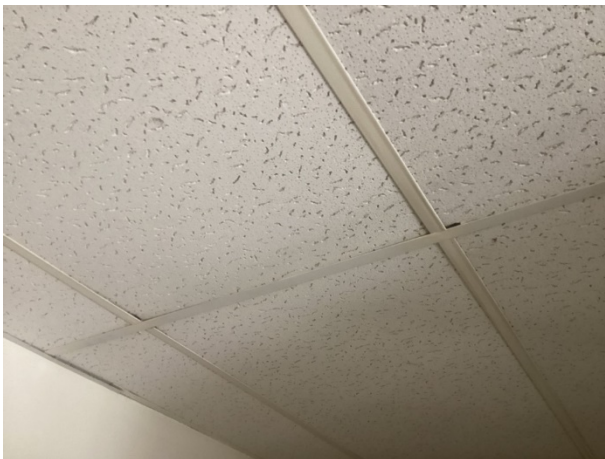
**Condition:** Fair overall with isolated damage evident at the time of our inspection.

**Acoustical ceiling tiles**

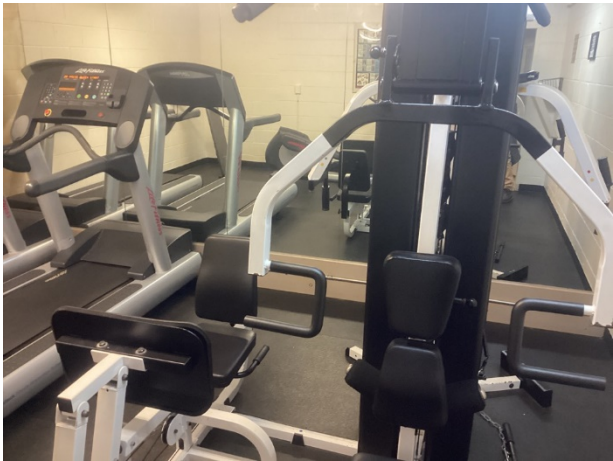
**Conditions:** Fair overall with isolated rust evident. Management does not report any operational deficiencies at this time.

Strength training equipment

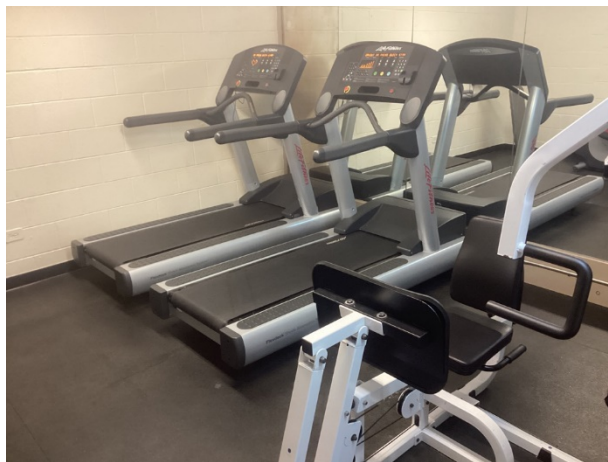
Treadmills overview

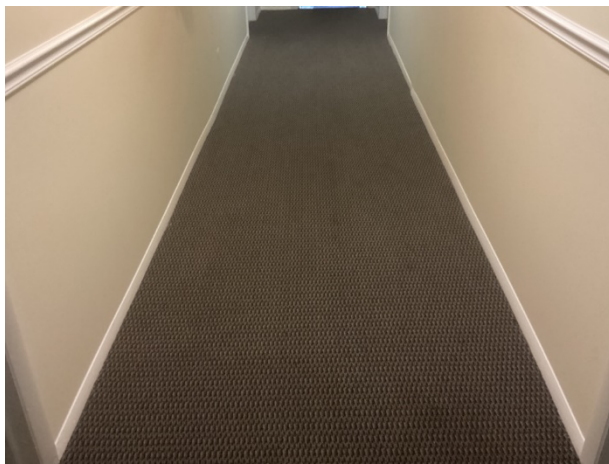
**Condition:** Fair to poor overall with periodic stains and wear evident at the time of our inspection.

**Carpet overview – note stains**

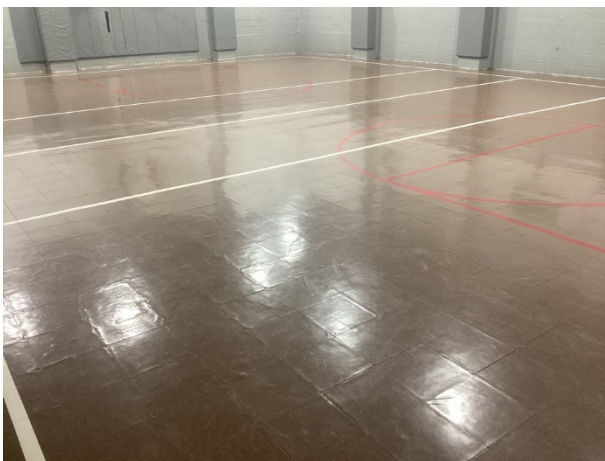
**Condition:** Fair overall with periodic damage evident.

**Gym overview**

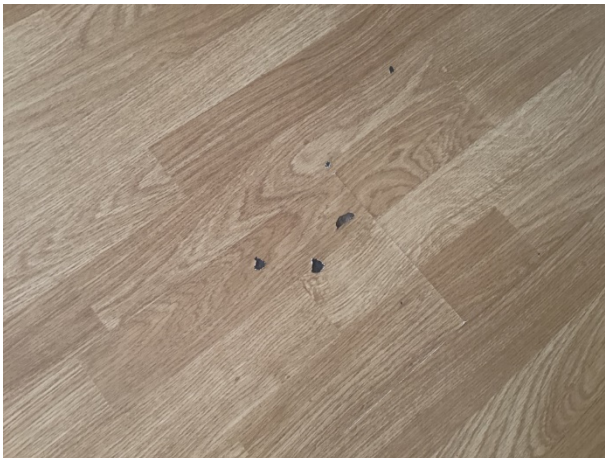
**Condition:** Fair overall with isolated damage evident.

Laminate floor damage

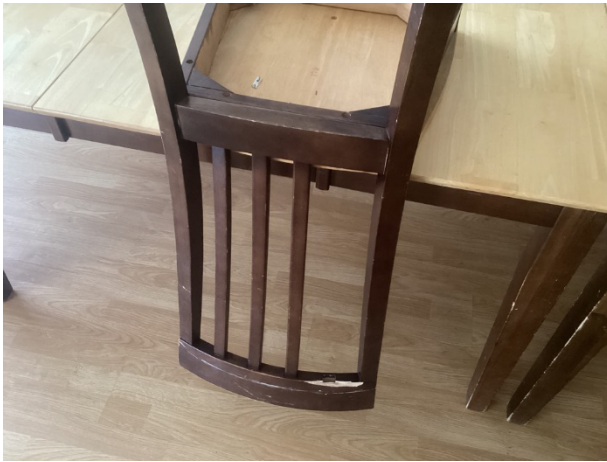
**Condition:** The furnishings are in varying condition with isolated damage evident.

**Missing banister and damage**

**Expenditure Detail Notes:** Expenditure timing and costs are depicted in the **Reserve Expenditures** table in Section 3. Due to varied uses, ages and useful lives, we recommend the Association budget \$14,000 plus inflation for phased replacements of up to fifty percent (50%) of the furnishings per event.

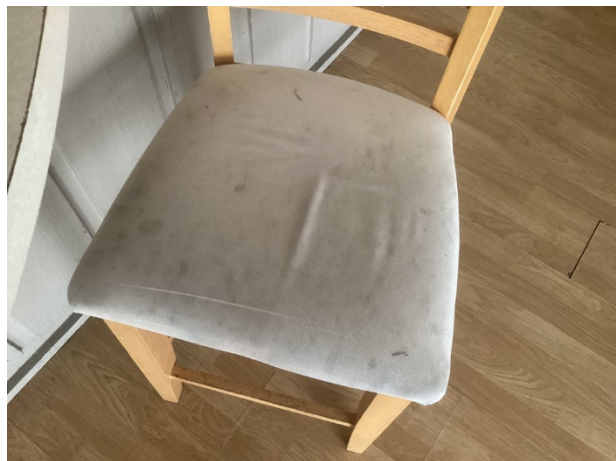
**Chair stains**

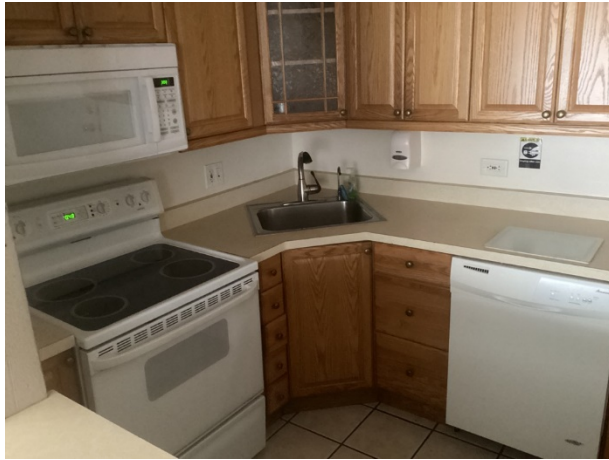
**Condition:** Fair overall with isolated damage.

Kitchen overview

**Expenditure Detail Notes:** Expenditure timing and costs are depicted in the **Reserve Expenditures** table in Section 3. Our cost assumes replacement of the cabinets, countertops, appliances and the sink. We recommend the Association fund interim replacement of the appliances through the operating budget.

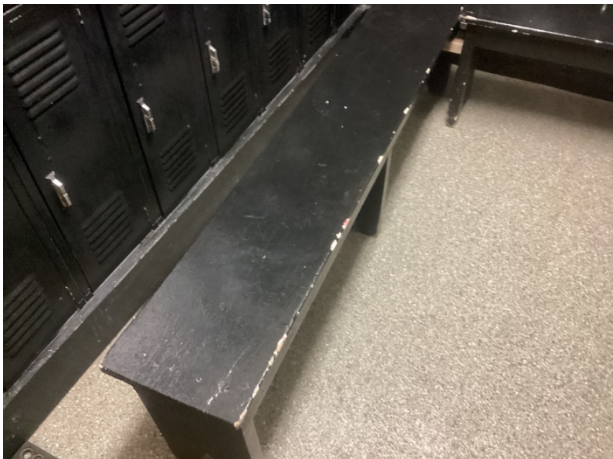
**Condition:** Fair overall with isolated tile cracks, bench damage and finish deterioration evident.

**Benches – note damage and finish deterioration**

**Expenditure Detail Notes:** Expenditure timing and costs are depicted in the **Reserve Expenditures** table in Section 3. Our cost includes replacement of the components listed, paint finish and epoxy floor coating applications and replacement of the tile coverings.

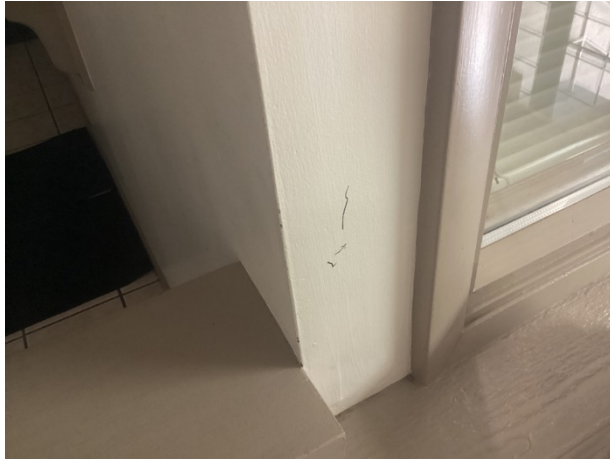
**Condition:** Fair overall with periodic wall scuffs and inconsistent paint finishes evident.

**Wall scuff**

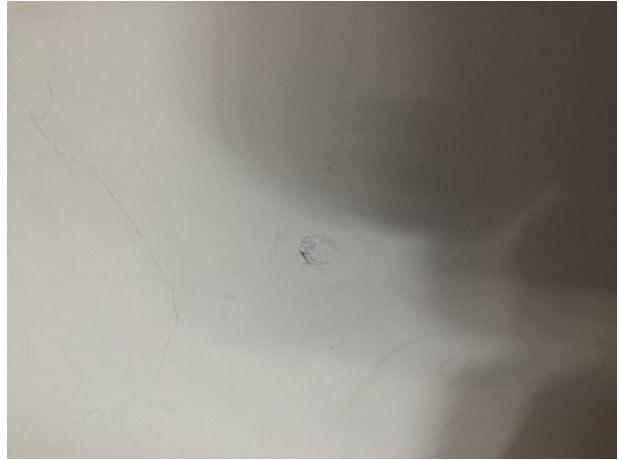
**Wall scuffs**

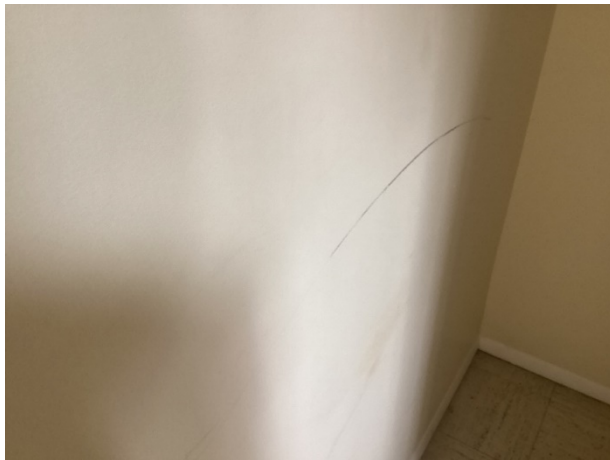
**Wall scuff**

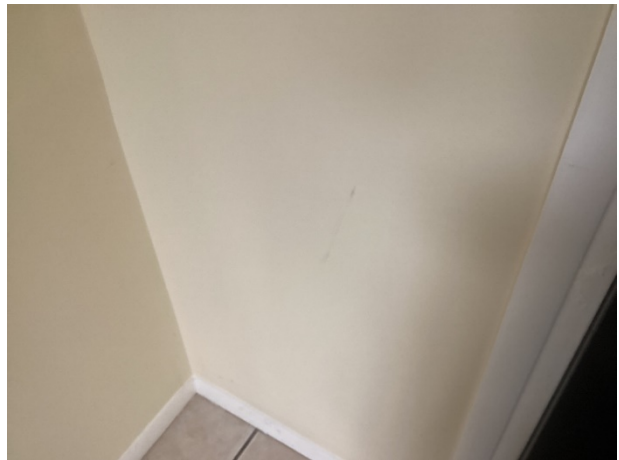
**Wall scuffs**

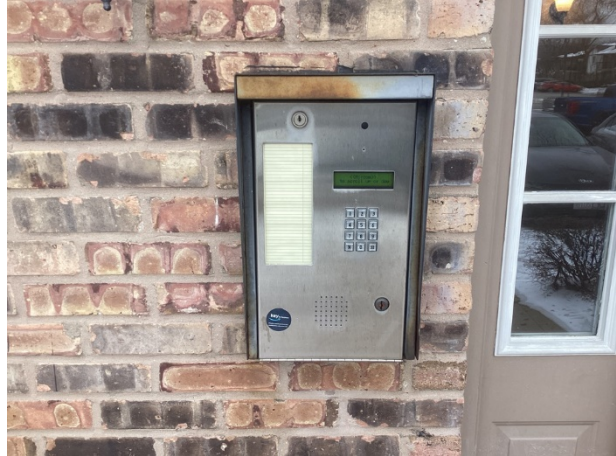
**Condition:** Reported satisfactory without operational deficiencies. We note isolated rust at the control panels.

**Intercom panel – note rust**

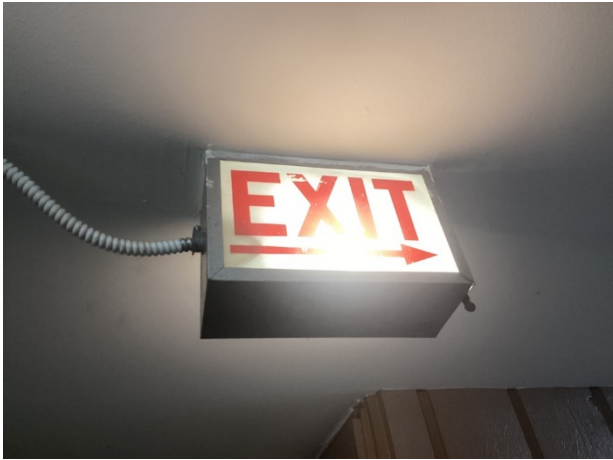
**Conditions:** Reported satisfactory without operational deficiencies. We note some of the components appear aged.

Exit signage – note finish deterioration  
(clubhouse shown)

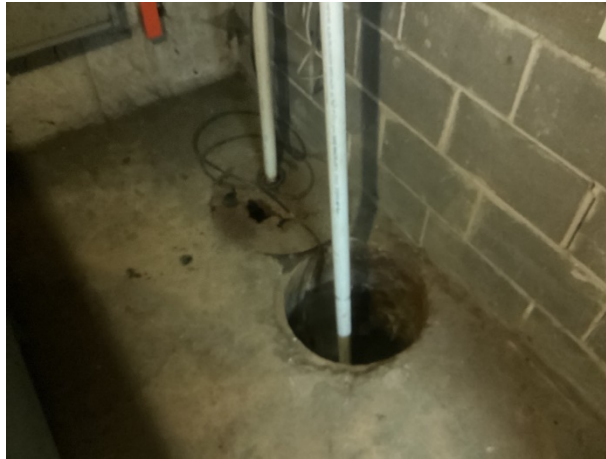
**Condition:** Reported satisfactory at the time of our inspection.

Typical sump pump

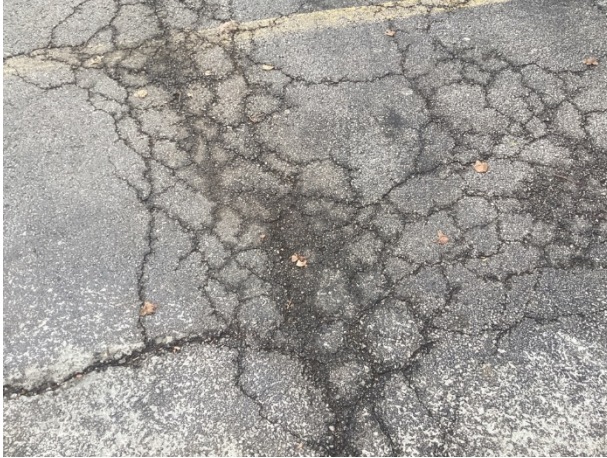
**Condition:** Fair to poor overall with periodic cracks, spalls, settlement and alligator cracks evident.

**Alligator cracks**

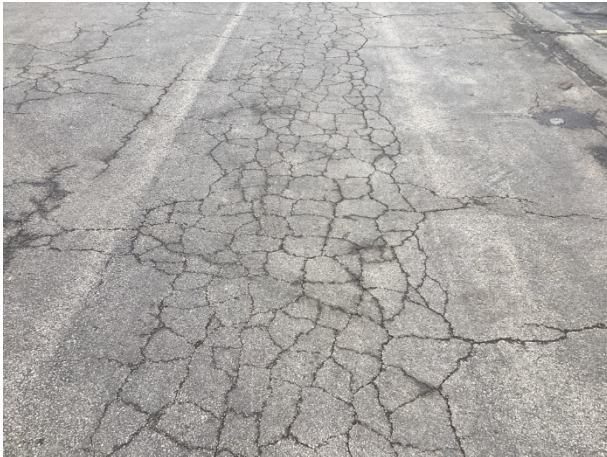
**Asphalt pavement access drive overview – note alligator cracks**

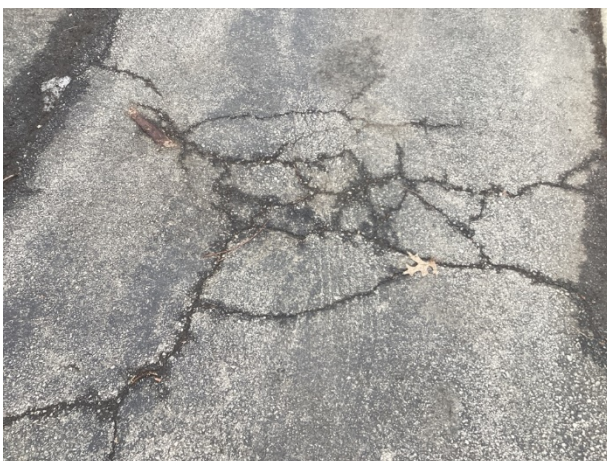
**Pavement cracks**

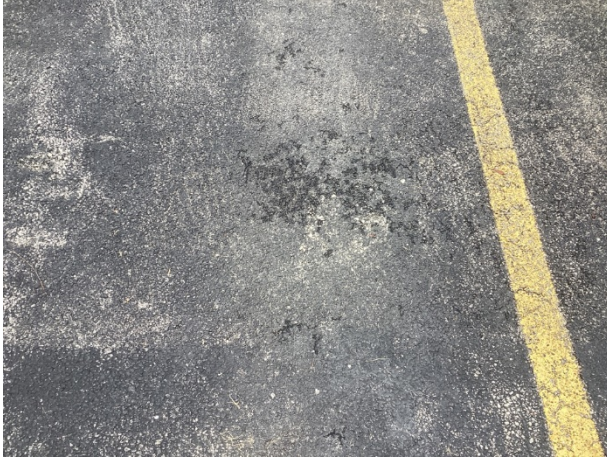
**Pavement spalls**
