# Stratford Green Condominium Association

Willowbrook, IL • December 20, 2022

FULL RESERVE STUDY

STRATFORD GREEN

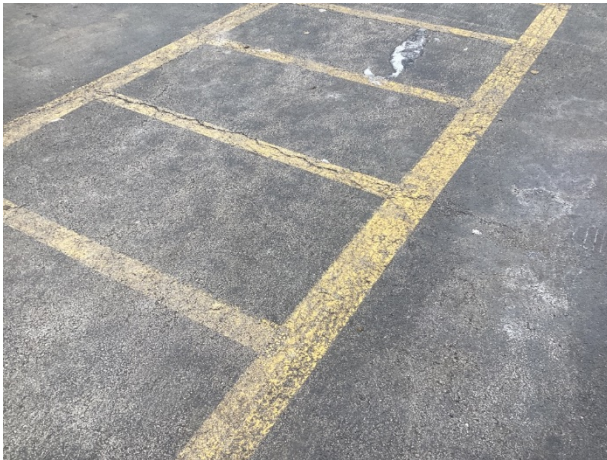
**Pavement cracks**

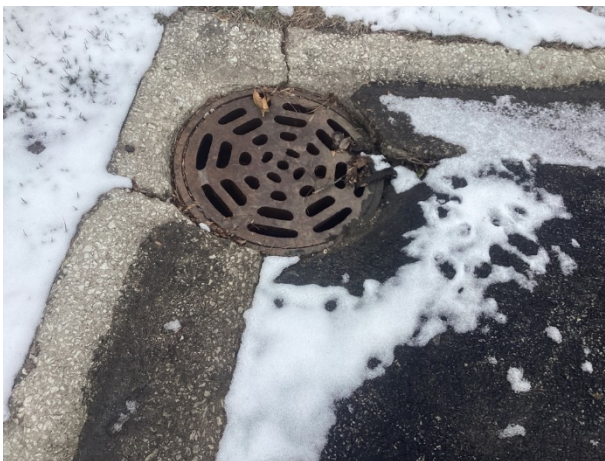
**Condition:** Fair overall with isolated settlement evident.

**Catch basin settlement**

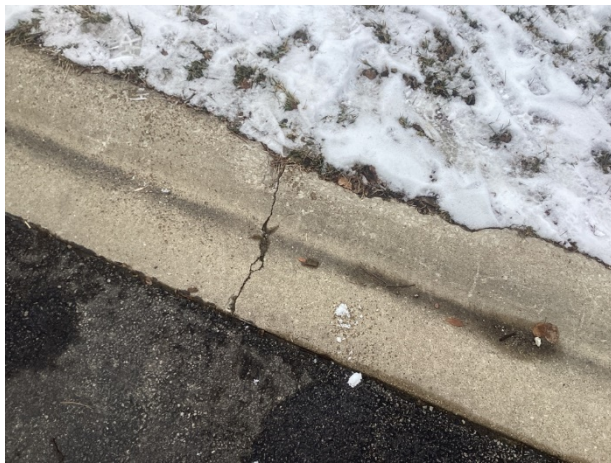
**Condition:** Fair overall with isolated cracks and damage evident.

Concrete curb crack

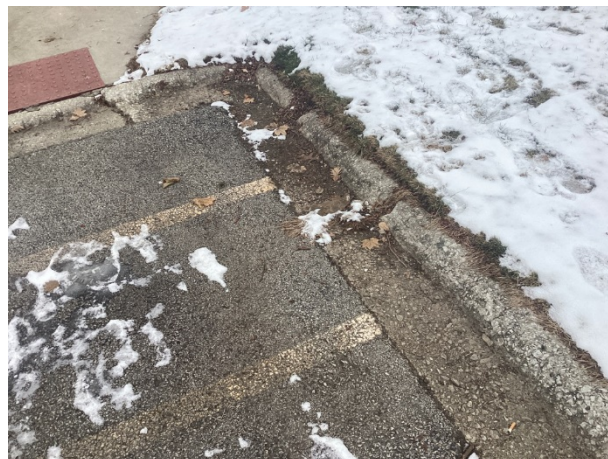
Curb settlement and damage

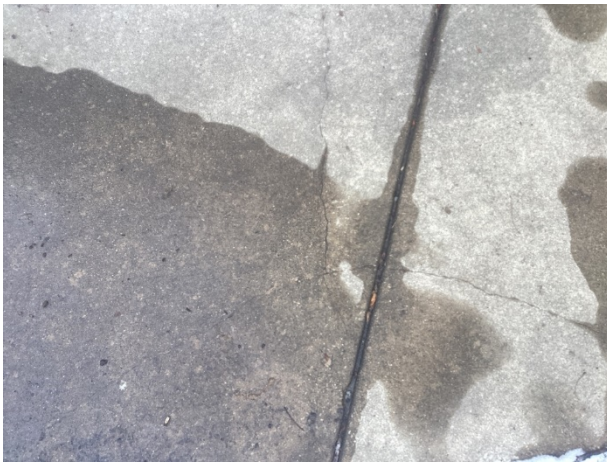
**Condition:** Fair overall with isolated cracks, settlement and spalled concrete evident. We also note isolated patios with carpet coverings. The carpet coverings are prone to retain water and increase the rate of deterioration of the underlying components. Therefore, we do not recommend the use of carpet on patio surfaces.

Concrete sidewalk cracks

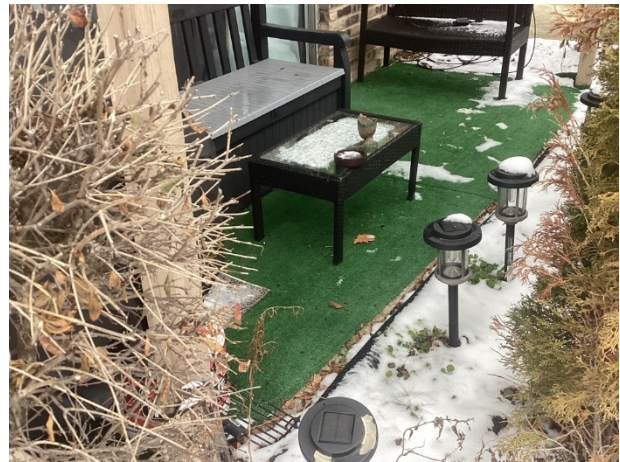
Carpet covering patio

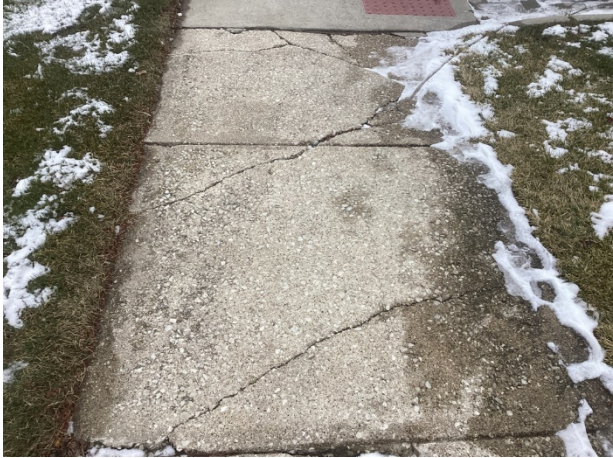
**Sidewalk cracks**

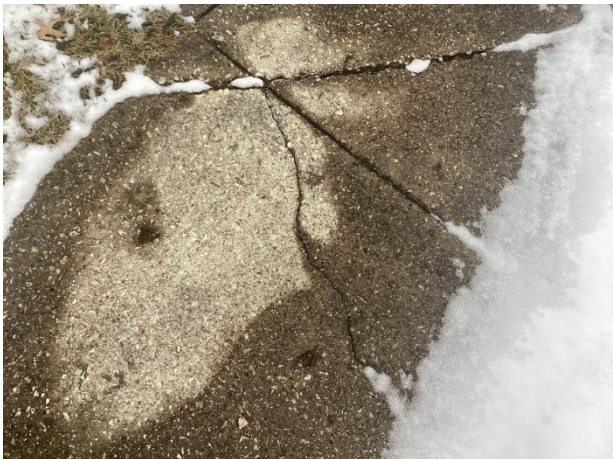
**Sidewalk crack**

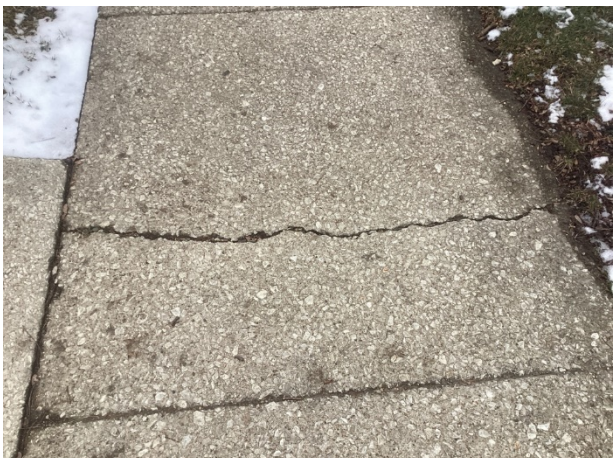
**Sidewalk crack**

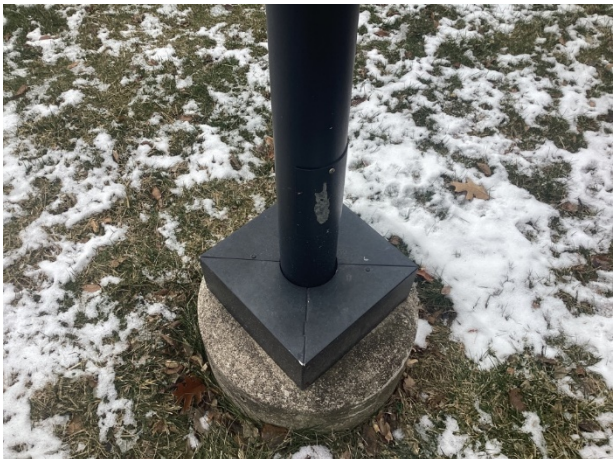
**Condition:** Fair overall with isolated finish deterioration, loose fixtures and replaced fixtures evident.

**Finish deterioration**

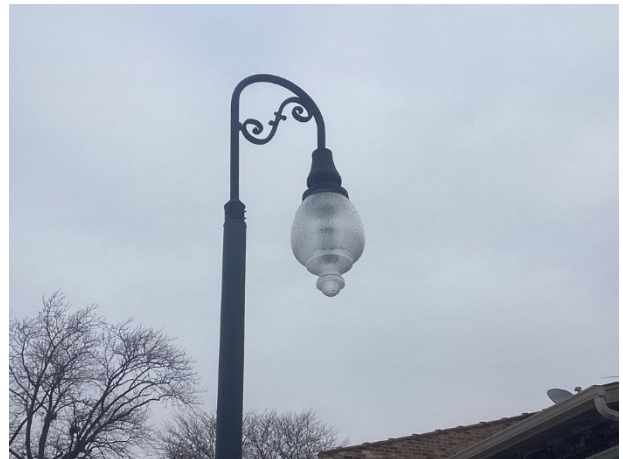
**Replaced fixture**

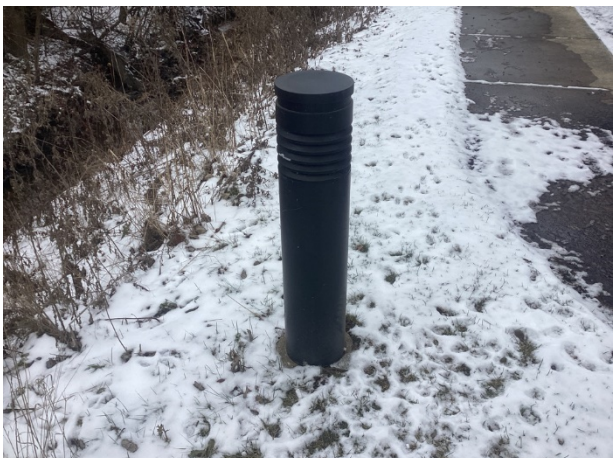
**Bollard light fixture – note finish deterioration**

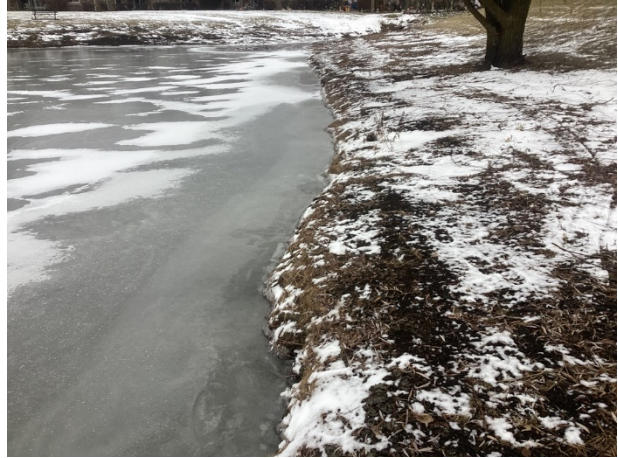
**Condition:** Fair overall with isolated shoreline erosion evident.

**Pond shoreline – note slight erosion**

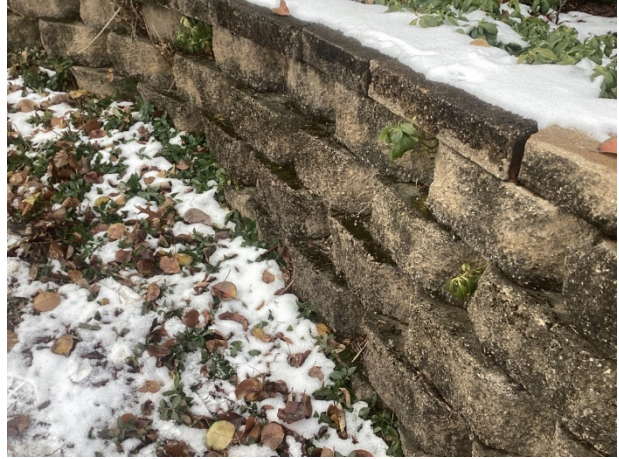
**Condition:** Good to fair overall with periodic organic growth.

**Retaining wall – note organic growth**

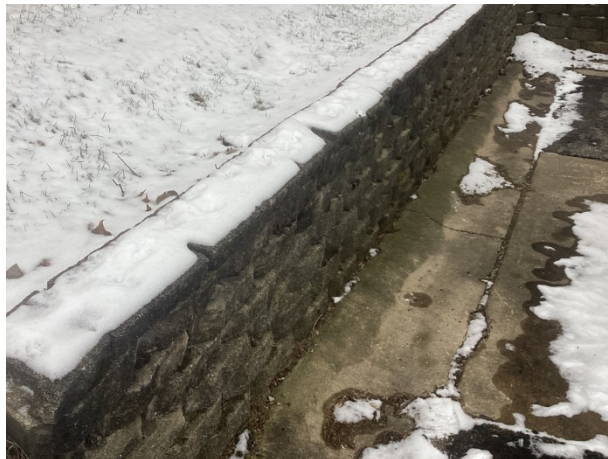
**Masonry retaining wall – note organic growth**

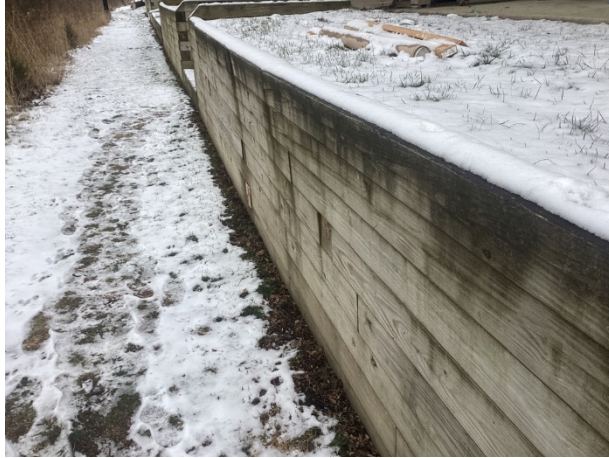
**Condition:** Good to fair overall with isolated bulges, organic growth and wall rot evident.

**Slight wall bulge**

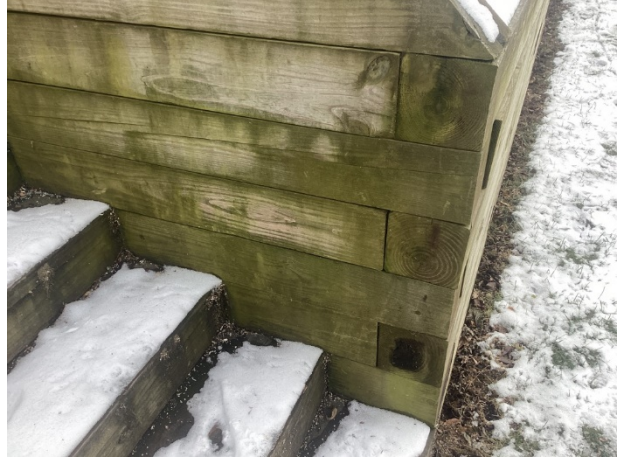
**Organic growth**

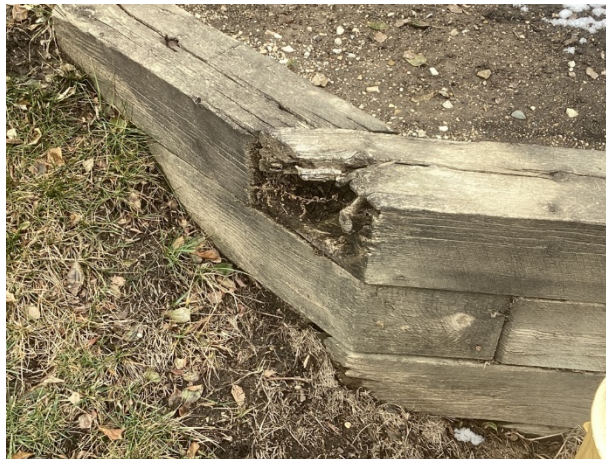
**Retaining wall wood rot**

**Component Detail Notes:** We advise Stratford Green replace with a modular, interlocking dry-set masonry retaining wall system. The cost of dry-set masonry retaining walls is similar to the cost of timber walls. However, dry-set masonry retaining walls offer a longer useful life of up to 35 years and lower total maintenance costs.

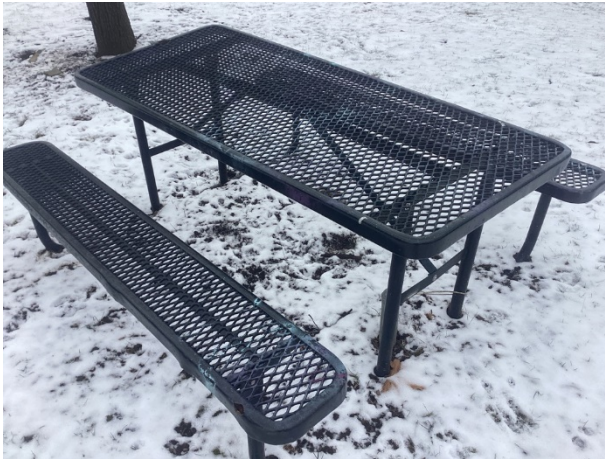
**Condition:** Poor overall with periodic rust and damage evident. We note the site furniture appears aged.

**Picnic table – note deterioration**

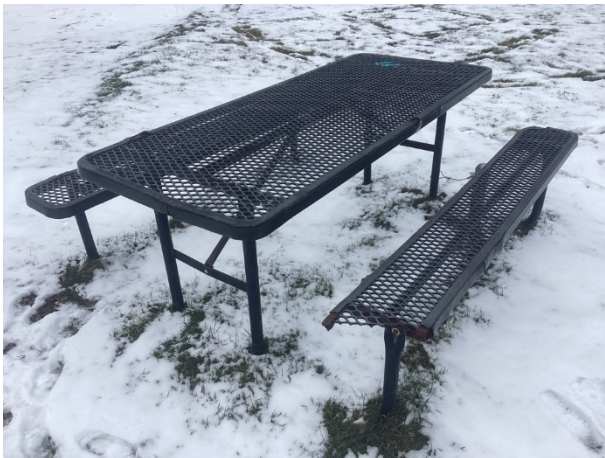
**Picnic table – note damage and rust**

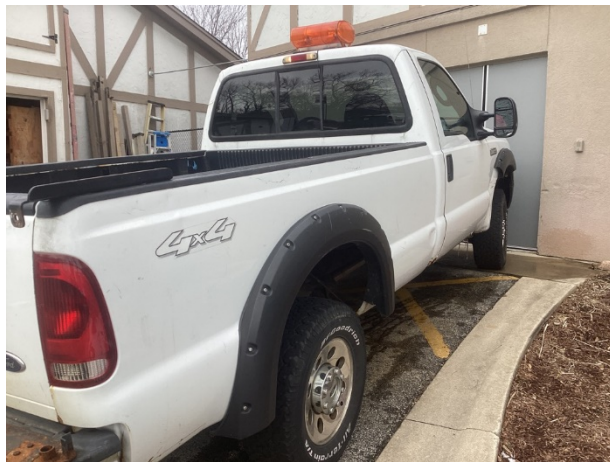
**Condition:** The vehicles are visually in fair condition with isolated rust evident at the maintenance truck. Representatives of the maintenance staff inform us the vehicles are in satisfactory operational condition.

**Maintenance truck overview**

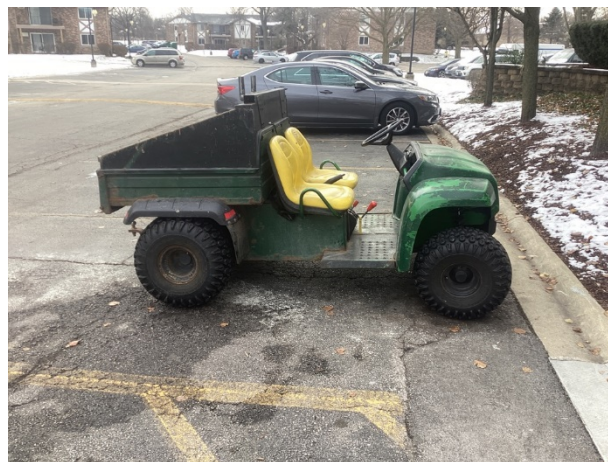
**Utility vehicle overview**

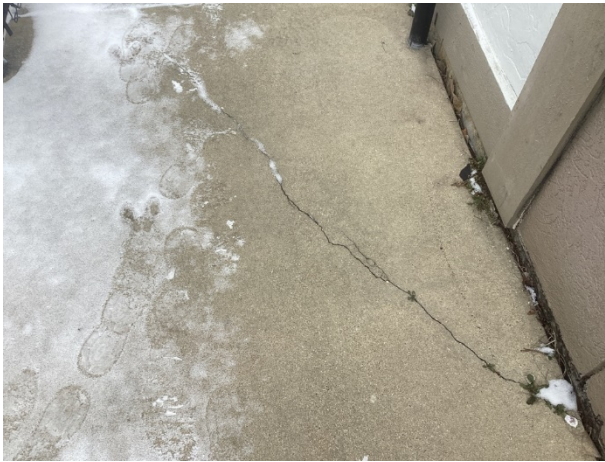
**Condition:** Fair overall with isolated cracks and settlement evident.

**Pool deck cracks**

- Selective cut out and replacements of up to ten percent (10%) of concrete
- Crack repairs as needed
- Mortar joint repairs
- Caulk replacement

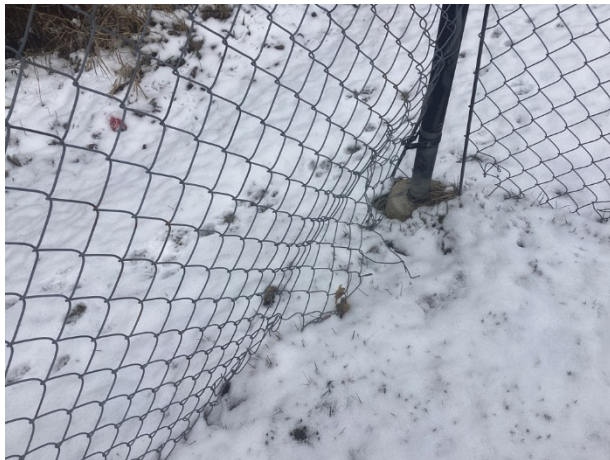
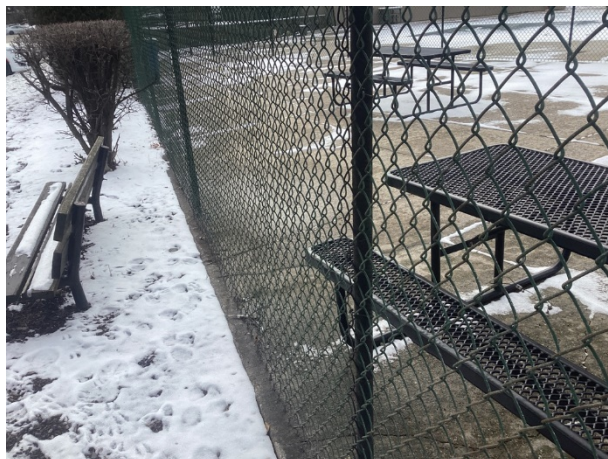
**Condition:** Poor overall with excessive leaning sections, post finish deterioration and warped webbing evident.

**Fence warped webbing**

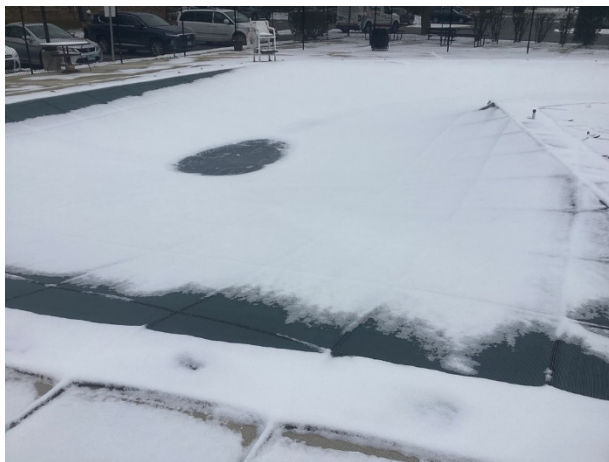
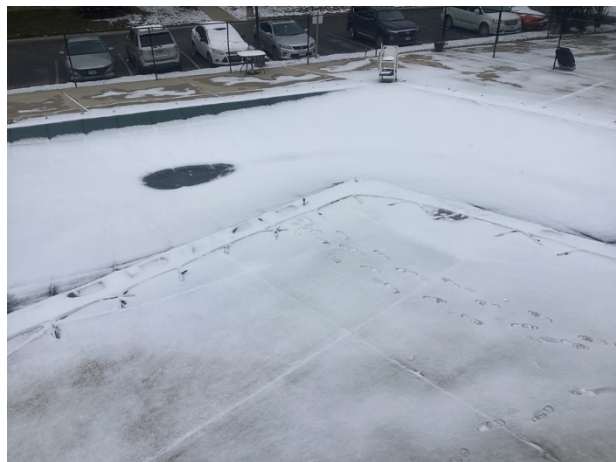
**Condition:** Fair overall as reported to us by the Association. We were unable to fully inspect the pool finishes due to the pool covers. We assume the finish is plaster based on conversations with Management. Updates of this Reserve Study will consider the need for changes in material.

Pool overview

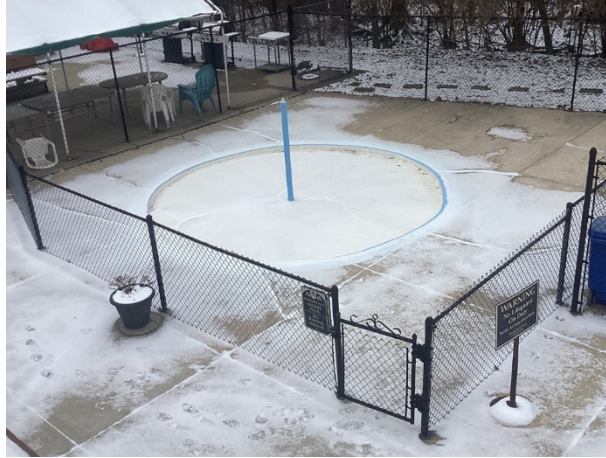
**Kiddy pool area overview**

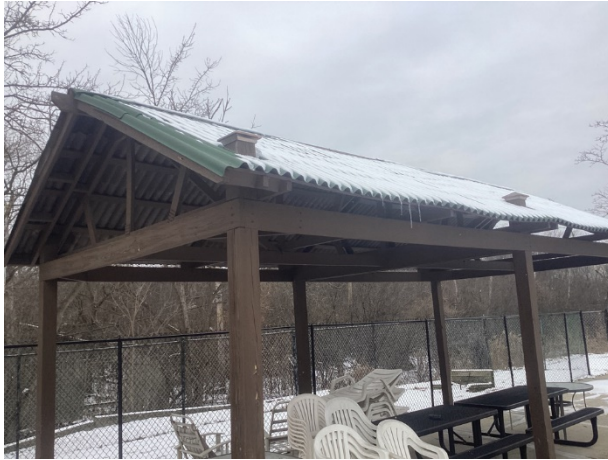
**Condition:** Fair overall with isolated bowed supported evident.

**Shade structure overview**

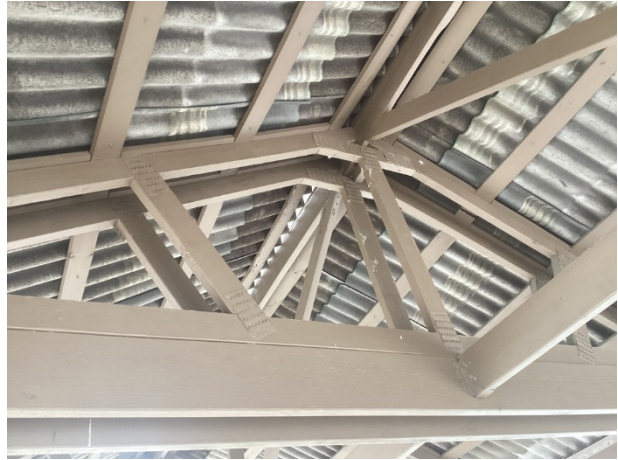
**Underside overview**

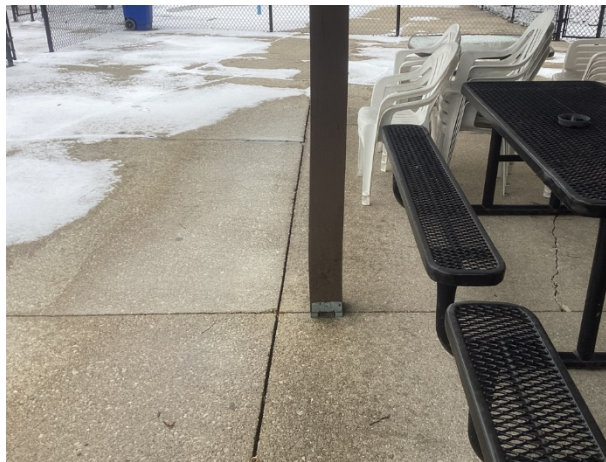
**Bowed shade support**
